Occupational Fatality Report

Truck Driver Fatally Injured When the Forklift He Was Operating Falls off a Loading Dock - Massachusetts

Release Date: February 29, 2016
Investigation: # 13-MA-036-01

Massachusetts Department of Public Health
Occupational Health Surveillance Program

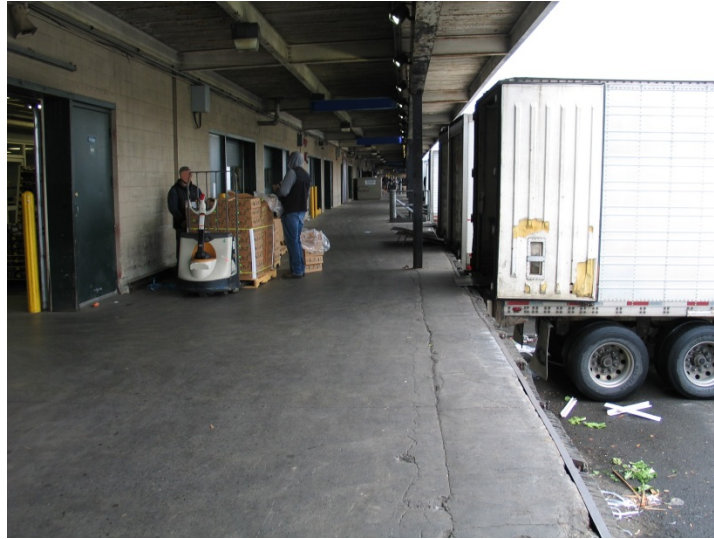
Figure 1 – Loading dock where incident occurred

The facility where the incident occurred was a large produce distribution center that was made up of four rectangular shaped buildings in two rows. The buildings contained warehouse, open loading dock, office and retail space for multiple companies. Each building had loading docks located at the front and the rear of the building, totaling over 100 bays across the four buildings. The open loading docks were about 15 feet wide, and were covered with canopy roofs. Three of the four sides of the loading docks were unprotected from environmental conditions. The fourth side of the loading dock was a wall of the building (Figure 1). The company used loading dock plates when trucks were being loaded and unloaded. The produce center was open 24-hours a day, 7 days a week and was periodically a busy location with many trucks coming and going.

Discussion: In this case, the outdoor loading docks were about 15 feet deep and ran the length of the buildings. The depth of the loading dock made it difficult to keep forklifts a safe distance from the loading dock edge.^{1,2} The loading docks did not have designated or marked locations for trucks to back up to and unload and they were not equipped with barriers at the loading dock edges. It was reported by the employer that these loading docks can become rather congested with multiple trucks, workers on foot, and forklifts and pallet jacks being operated. A congested loading dock combined with unprotected edges greatly increases the hazard of a worker on foot or a machine falling off the loading dock.³

Recommendation #1: Employers should prohibit forklifts from loading dock locations that are not equipped with protective edge barriers.

The best way to prevent an injury is to eliminate the hazard. Ideally in this type of situation, employers would install barriers that would prevent forklifts from falling off loading docks (see Recommendation #2). In the meantime, employers should develop policies that prohibit forklifts from all loading docks with unprotected edges, as this company has implemented. Once a policy is developed and implemented, the employer has the responsibility of ensuring employees are adhering to the policy and enforcing the policy when necessary.

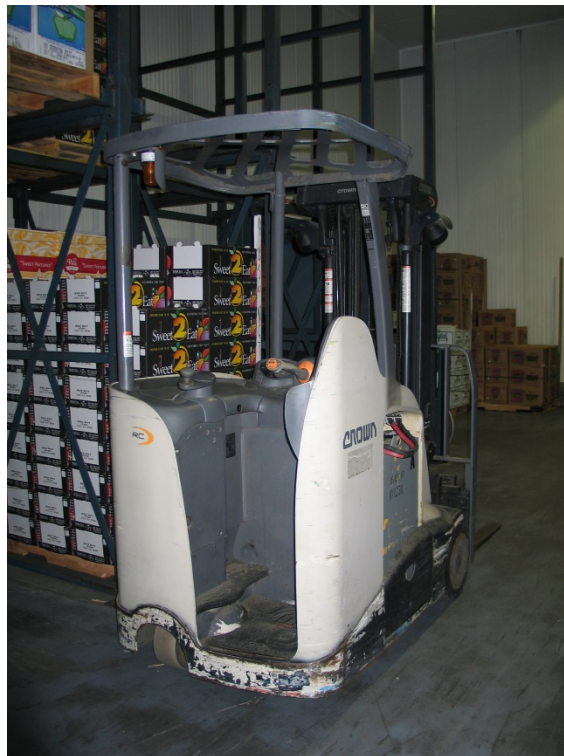
Figure 2 – Similar stand-up counterbalanced forklift

The vehicle involved in the incident was an electric, three-wheel, stand-up, counterbalanced forklift (Figure 2). The forklift was manufactured in 2013 and was being leased by the company. The overall dimensions of the forklift were approximately 3.5 feet wide by 7.3 feet high to the top of the overhead guard by 8.3 feet long, including the length of the 3-foot long forks. The maximum lift height to the bottom of the forks was about 13 feet and it had a load capacity of 3,000 pounds. The forklift weighed approximately 6,400 pounds. The operator's area was designed so the operator would be standing and facing towards the left side of the forklift. The operator's position would allow the operator to look in the direction of travel while operating the forklift with a load on the tines. The operator's area had an opening at the rear of the forklift, which was how the operator's area was accessed. The operator's area was not equipped with a door or some other kind of operator restraint system for when the forklift was in use.

In this case, a stand-up counterbalanced forklift was being operated at the time of the incident. The typical design of this type of forklift does not include a restraint system for the operator. Therefore, when stand-up forklift falls off an elevated surface, power unit first, the victim is usually ejected out of the operator's area with the forklift landing on top of the victim. In the operator's manual, the forklift manufacturer states "tip overs and fall from docks can cause serious injury or even death. Immediately exit and move away from the truck in these emergencies." OSHA also references this hazard in their Powered Industrial Truck eTool that states "operators of stand-up forklifts with rear-entry access should step backwards off the forklift if a tip over occurs."³ In this case, the actions these statements direct the forklift operator to take during a stand-up forklift tip over would not have prevented the victim's injuries.

It appears that most new stand-up counterbalanced forklifts are being designed and manufactured with at least three overhead guard support posts in an attempt to prevent the under-ride hazard. The forklift involved in this incident was manufactured with three supports for the overhead guard, but the design still leaves one corner of the operator's area potentially vulnerable to intrusion. If the overhead guard was designed with four posts or a support structure protecting the operating area, then the intrusion hazard would be eliminated.

Recommendation #3: Manufacturers of forklifts should adopt and implement the concept of Prevention through Design (PtD) and redesign the operator area of stand-up counterbalanced forklifts to include restraint systems.

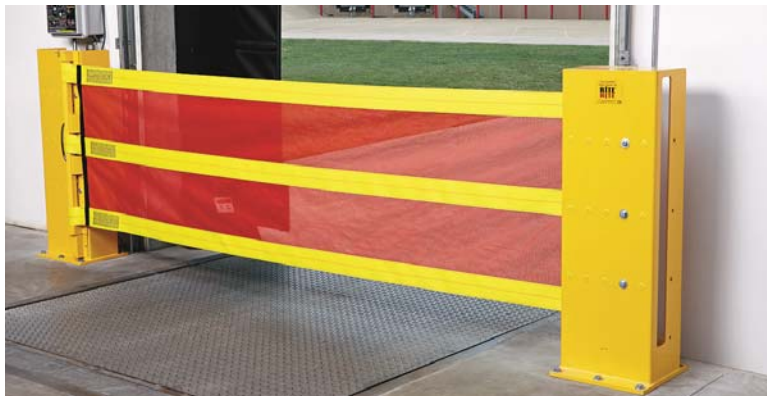
Figure 3 – Example of a protective fabric barrier

There are a wide variety of products available to provide protective edge barriers for loading docks, including dock guard posts with a protective heavy duty fabric barrier. The protective fabric barrier is bright in color and designed to withstand, depending on the barrier, up to 30,000 pounds. The fabric barrier is anchored by two posts and can be manually retracted into one of the posts when access is needed to the loading dock section.

Recommendation #2: Employers should consider installing barriers at the loading dock edge to minimize the possibility of employees and equipment from falling off the loading dock.

In this case, one possible option would be to first create designated locations for trucks to back up to the loading docks. On each of these designated locations a post would be installed with a fabric barrier to span across the posts. Guardrails can be installed at the locations of the loading dock that are not designated as loading areas (Figure 3). Any loading dock safety improvements performed at the incident location should also be implemented throughout the entire produce distribution center where appropriate.
