## OREGON FATALITY ASSESSMENT AND CONTROL EVALUATION

# Fatality Investigation Report

OR 2015-02-1

## Crane operator killed by falling steel beam

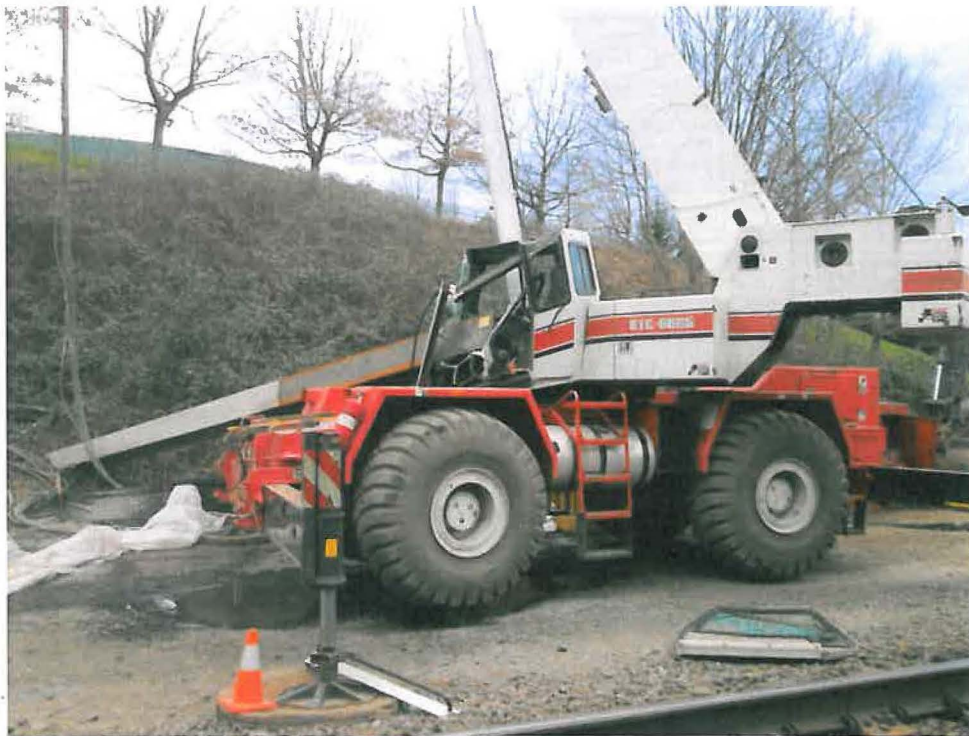
A 40-year old crane operator was killed when a 35-foot (5600 lb) H-beam fell crushing the crane cab and striking him in the head. During a pile driving operation, the H-beam pile had been placed in a drilled 25-foot hole. While using a vibratory hammer to force the pile further into the hole, the pile shifted. After several failed attempts to correctly position the pile it was extracted using the hydraulic clamp of the vibratory hammer and moved 12 feet from the hole. It was held in a vertical position with the bottom of the pile resting on the ground. The clamp holding the top of the pile unexpectedly released. The pile was not rigged to the clamp housing or attached to the whipline. The 5600 lb pile fell, struck and crushed the crane cab, and killed the operator.

Figure1. Crane cab struck by H-beam.

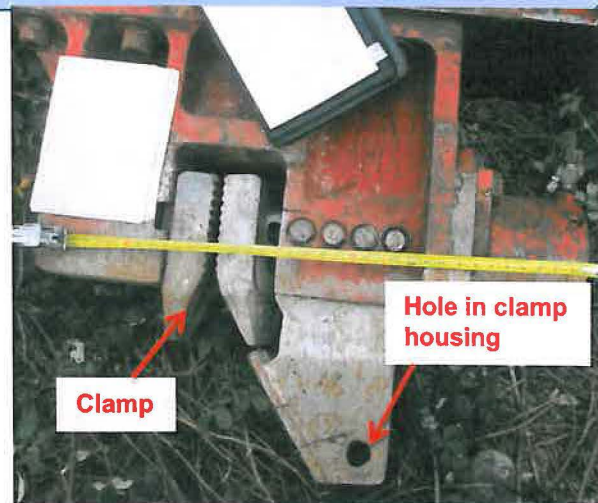
Figure 2. Close up of the vibratory hammer clamp housing.

The pile was extracted while it was clamped to the vibratory hammer. The pile did not have a safety chain or line connecting it to the vibratory hammer housing nor was the crane's whip line attached to the pile. The pile was lowered approximately 12 feet away from the hole and set in a vertical position with the lower end resting on the ground. The track drill was then moved back into position and the crew began re-drilling. The crew worked within the fall zone of the pile. At approximately 5:30 pm the vibratory hammer clamp unexpectedly released the pile which fell, struck the crane cab and killed the operator.

- (1) Air could have entered the hydraulic system during the site assembly of the hydraulic power unit. Specific instructions in the manufacturer's Operation, Maintenance and Parts Manual (p. 12) states *"Whenever the hydraulic lines of the system has been reconnected THE CLAMP CYLINDER CIRCUIT MUST BE BLED OF ENTRAINED AIR..... CAUTION: FAILURE TO*

**COMPLETELY BLEED THE CLAMP CIRCUIT OF AIR MAY IMPAIR CLAMPING FORCE AND DAMAGE JAWS."** When interviewed during the investigation, the crew was not aware of this requirement.

- The manufacturer's Operation, Maintenance and Parts Manual stated that the hydraulic lines should be bled of entrained air at each set-up. None of the crew was aware of this requirement.
- It is unknown whether the vibratory hammer operating manual was reviewed or discussed during pre-task planning or when a change-in-plan occurred. A suggested practice is to highlight manufacturer's safety recommendations in the manual for review and discussion during planning or change in process.
- Hazards may be different for the various crane attachments and there may be a gap in time between each use. Therefore, the hazards, their controls and safe practices should be reviewed and communicated to the crew before each use.

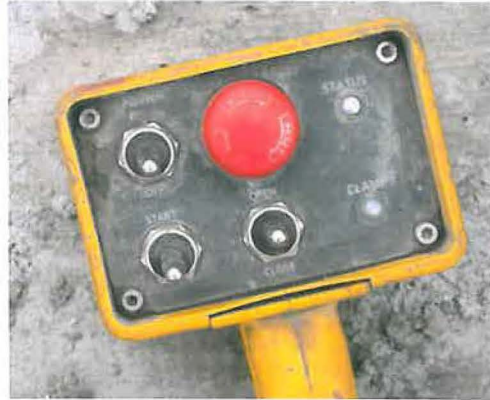
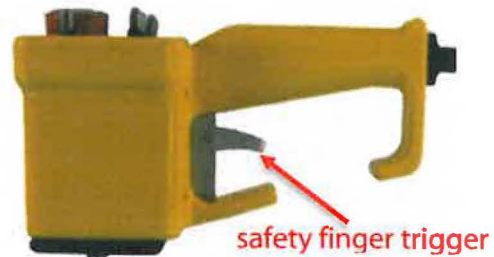
A hydraulic vibratory model MKT V-17/HP-325 hammer (MKT Manufacturing Inc., St. Louis, MO) was then attached to the crane rigging and swung into place over the pile. The vibratory hammer was built in 1979, and was powered by a diesel driven, hydraulic power unit with a 150-foot hydraulic hose bundle. It was originally operated through a control panel located on the power unit or remotely with a 50-foot electrical control pendant cable assembly. However, the employer had contracted a company to design and supply a wireless remote control (see Figure 4) to replace the pendant device. The design options for the remote control included an optional safety finger trigger that must be activated before any vibratory hammer action controls would function. However, this "safety trigger" (see Figure 5) option

was not selected for the wireless remote control unit that was ultimately used during the incident.

Figures 4 and 5. Vibratory hammer wireless remote control. Below is a drawing with the safety trigger option.

- (2) The toggle switch on the wireless remote control (see Figure 4) may have been inadvertently activated by brushing against an object while hanging on the foreman's belt releasing the clamp on the vibratory hammer. For this investigation the vibratory hammer manufacturer was contacted to determine whether remote controls for vibratory hammers were available. A picture of their remote control was provided (see Figure 6) and the safety features they described included recessed buttons and two buttons, PTO and clamp or vibro, must be pressed simultaneously to initiate action. This prevented inadvertent action when only one button is pressed. Whereas the remote control unit used in the incident had toggle switches extending beyond the case (See figures 4 and 5) and it did not include a safety trigger, a two switch safety feature, to prevent action of the vibratory hammer when the toggle switch was inadvertently pressed.

- The replacement of the pendant control on the vibratory hammer for a wireless remote was a significant modification. The unexpected release of the pile by the vibratory hammer clamp may have been as a result of an inadvertent movement of the toggle switch or radio frequency interference. For critical and hazardous equipment, the manufacturer should be consulted before devices/equipment alterations or modifications occur. In a telephone conversation with the vibratory hammer manufacturer, they indicated that they were not contacted prior to the incident. In this case, the manufacturer would have offered their unit or recommended what safety features should be incorporated in a remote control.

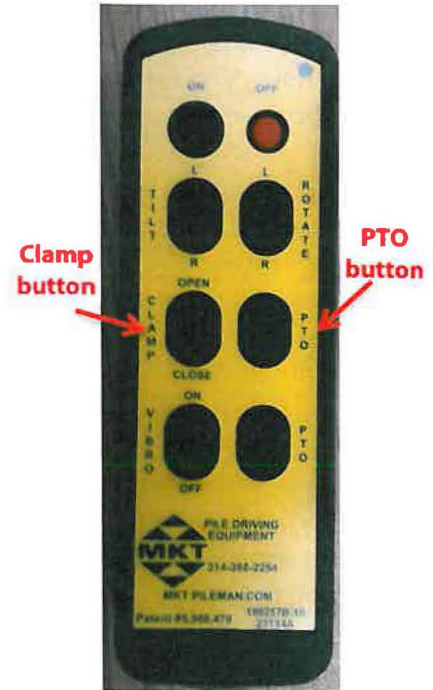
Figure 6. MKT remote control for a vibratory hammer
