# Granite Installation Company Owner Struck by Falling Granite Slab

**Incident Number: 15KY020**

**Release Date: October 6, 2015**

**Subject: Granite Installation Company Owner Struck by Falling Granite Slab**

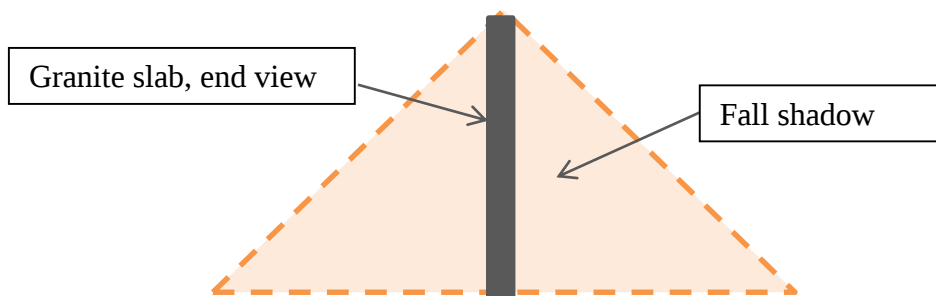
OSHA defines the fall shadow zone as “the area on both sides of the slab where the slab could land and topple if it were to fall.” The higher the slab is lifted from the ground, the larger the fall zone. Standing outside of the fall shadow at either end of the slab is the best practice to prevent being crushed or hit with the stone slab.

**Recommendation No. 1: Employers should identify a fall shadow zone, and restrict employees from placing themselves in that zone, while stone is being loaded, unloaded or moved.** <sup>1</sup>

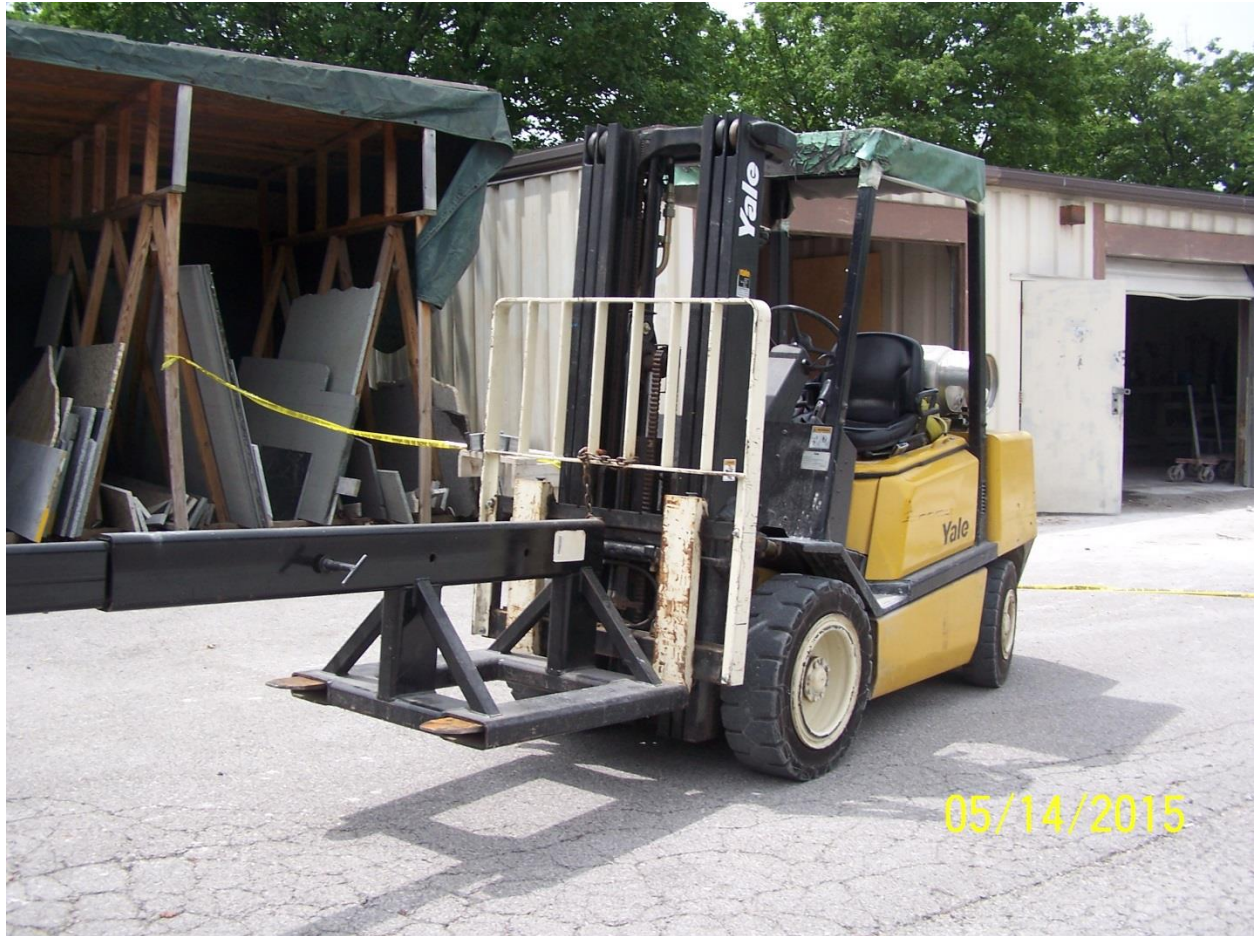
Photo #1: Forklift and boom used

On Thursday, May 14, 2015, a granite delivery driver arrived at the employer's business around 9:30 am, to deliver previously ordered granite. The victim and the forklift operator brought out a forklift truck to unload five slabs of granite. The forklift had a boom with a slab clamp to move the granite slabs (see photos #1 and #2).

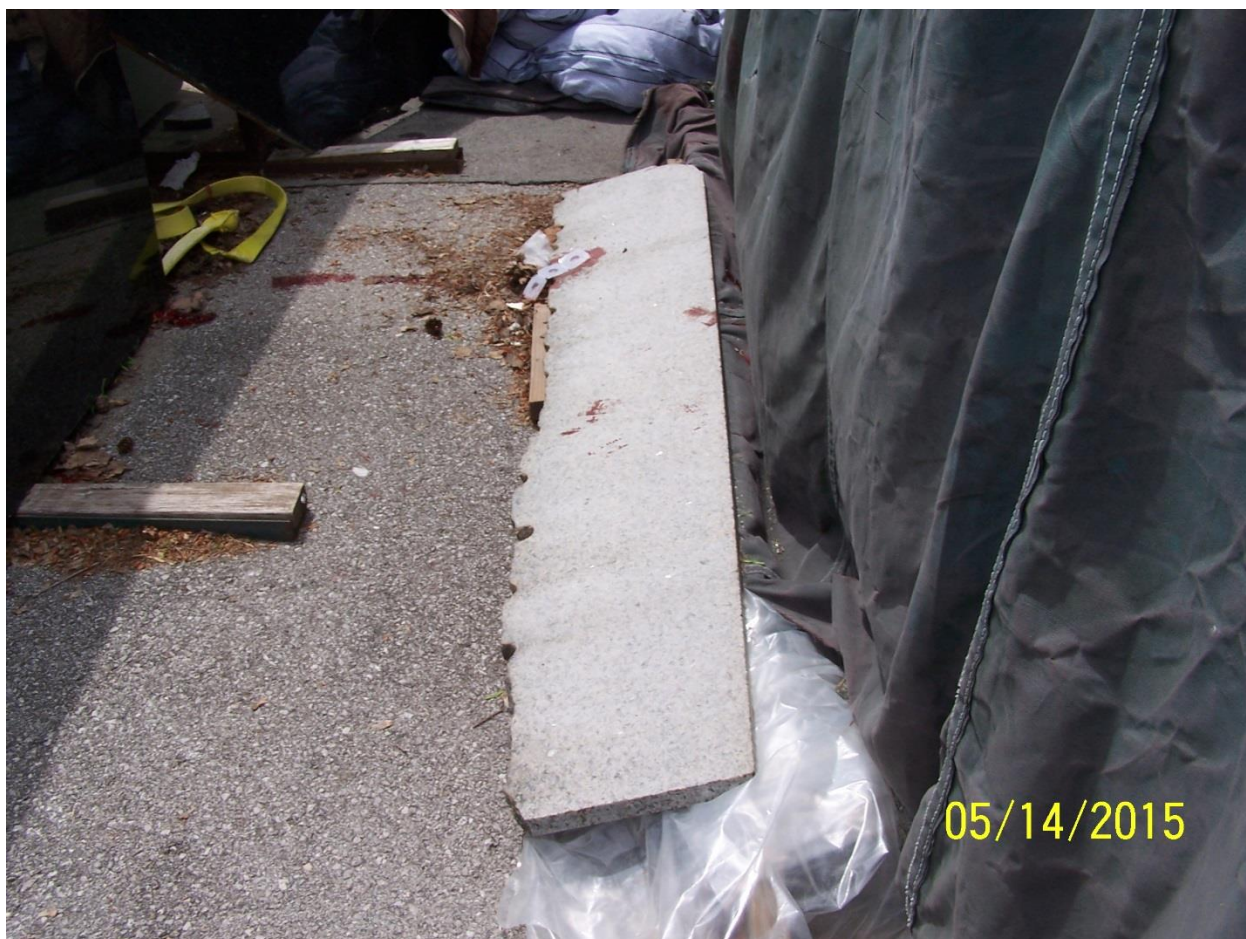
Photo #4: incident scene

The incident scene was the company parking lot. There was a makeshift storage area on the right hand side of the lot. The storage area had a roof and tarps on two sides, leaving the front side exposed to outside winds. This is where granite was placed as it was unloaded from trucks. The area where the incident occurred was outside the covered storage area and inside a chain link fence and in an open area to the left of the covered storage area.
