SUBJECT: A Welder Dies When He Is Struck by a Projectile from a Truck's Hydraulic Tank

SUMMARY
California FACE Report #13CA003

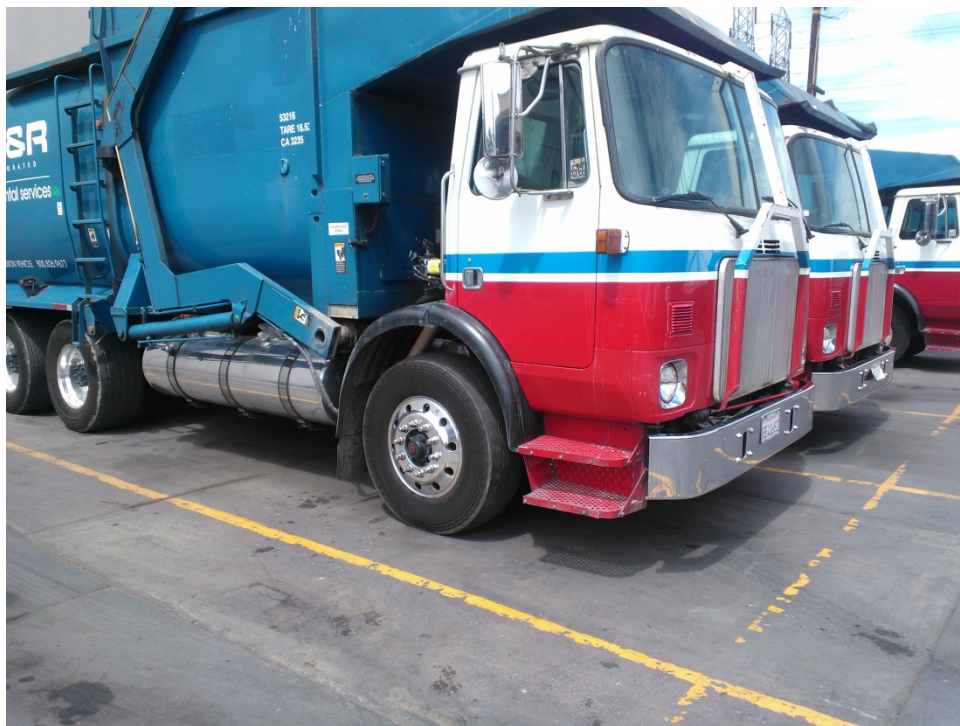
Exhibit 1. A waste collection vehicle with fuel and hydraulic tank similar to the one involved in the incident.

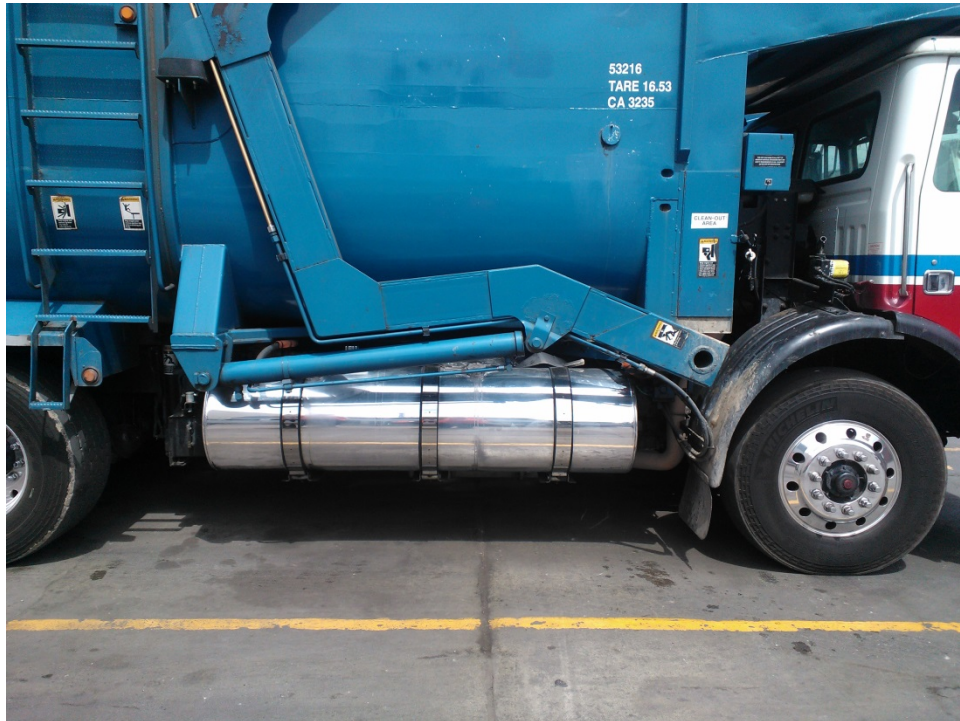
Exhibit 2. Close-up of fuel and hydraulic tank on the side of a vehicle.

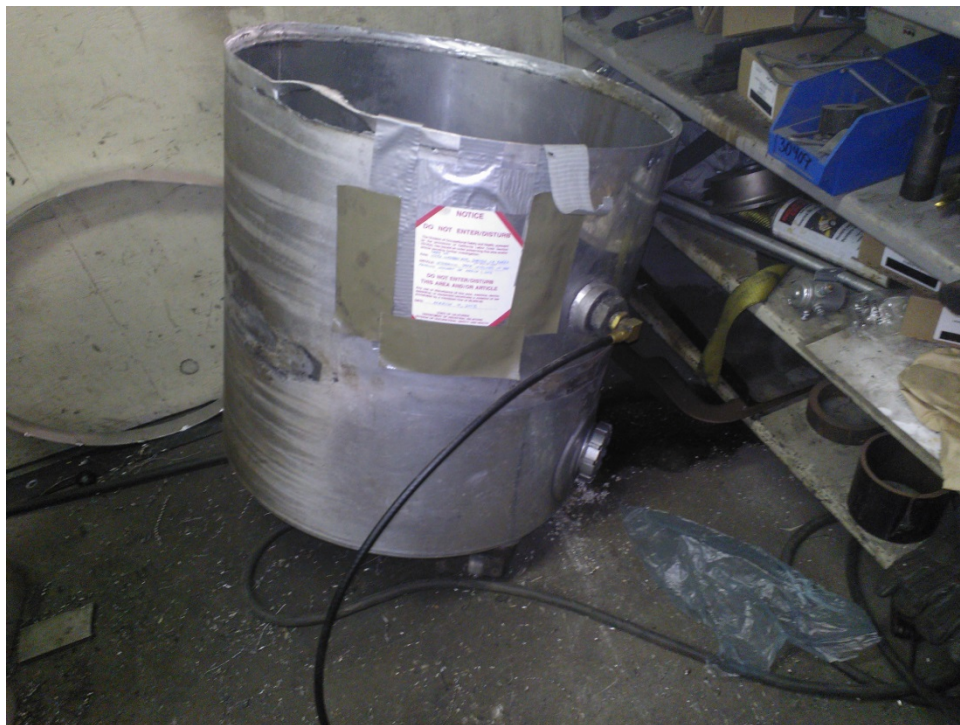
On the day before the incident, the victim was assigned the task of repairing a leak in an aluminum hydraulic tank from a waste collection vehicle. He had performed this task in the past on several occasions. The victim removed the 55-gallon hydraulic tank from the truck, then emptied and disassembled it, welded the leak, and reassembled the tank. On the day of the incident, the victim filled the tank with water and pressurized it with air from the shop air compressor to check for additional leaks. The air line used to pressurize the tank did not have a regulator or gauge, and it is not known how much air pressure was used. As the victim was leaning over the tank checking for leaks with a flashlight, the rear end plate of the tank blew off under pressure and struck the victim in the head. Other welders in the shop ran to the victim's aid and called 911. Emergency responders transported the victim to the local hospital where he was pronounced dead from his injuries.

Exhibit 3. The hydraulic tank involved in the incident.

Recommendation #1: Hydraulic tanks are not internally pressurized to check for leaks.

Discussion: In this incident, the victim performed a hydro-pneumatic pressure test on a hydraulic tank to check for leaks. A hydraulic tank used to hold liquid contents is not designed to be pressurized. When the victim checked for the adequacy of his weld, he used an unsafe procedure that he had done in the past without incident. Rather than the use of both water and air to pressurize tanks such as this, an alternative method would have been to fill the tank from an elevated water column. Using this method, excess pressure could not occur inside the tank. Had the victim used this alternate method, the tank could not have been pressurized, causing an explosion.

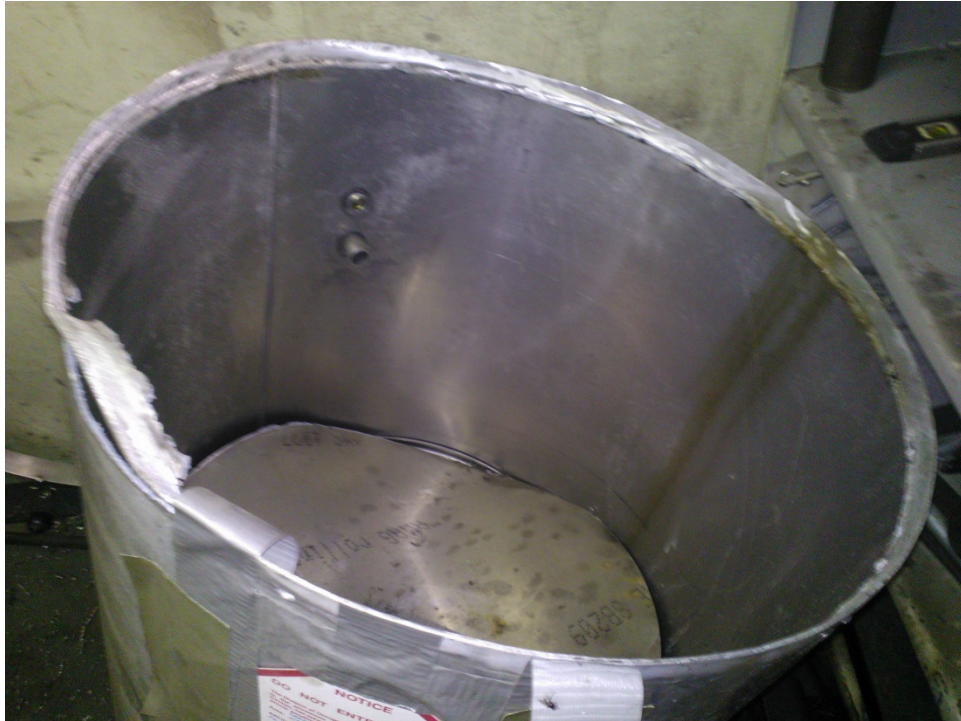
Exhibit 4. The portion of the hydraulic tank that came off under air pressure.

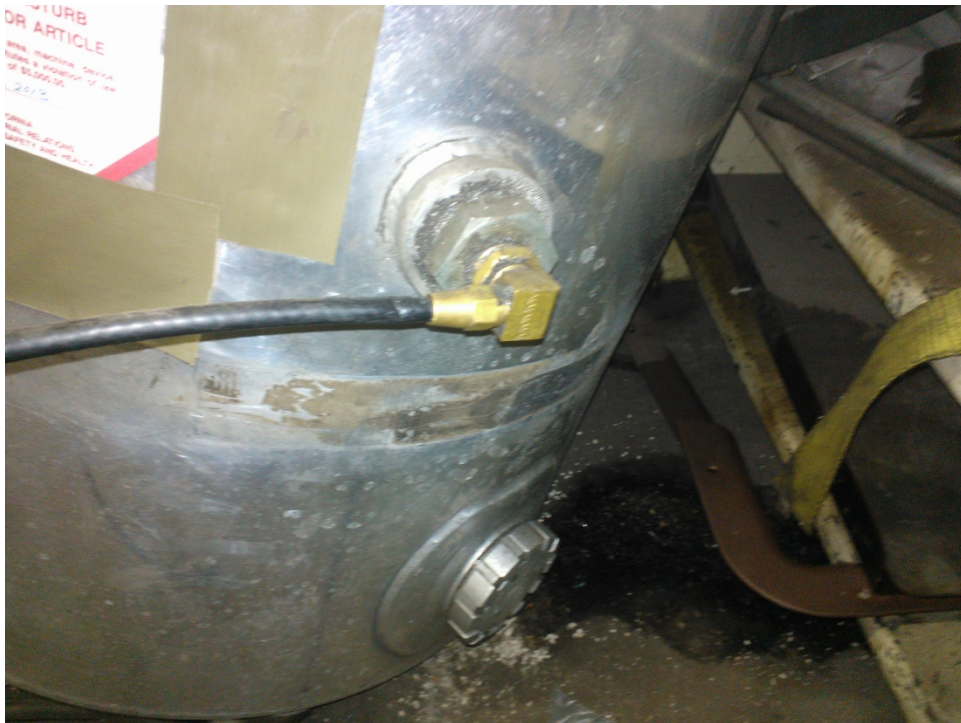
Exhibit 5. The air hose connected to the hydraulic tank.

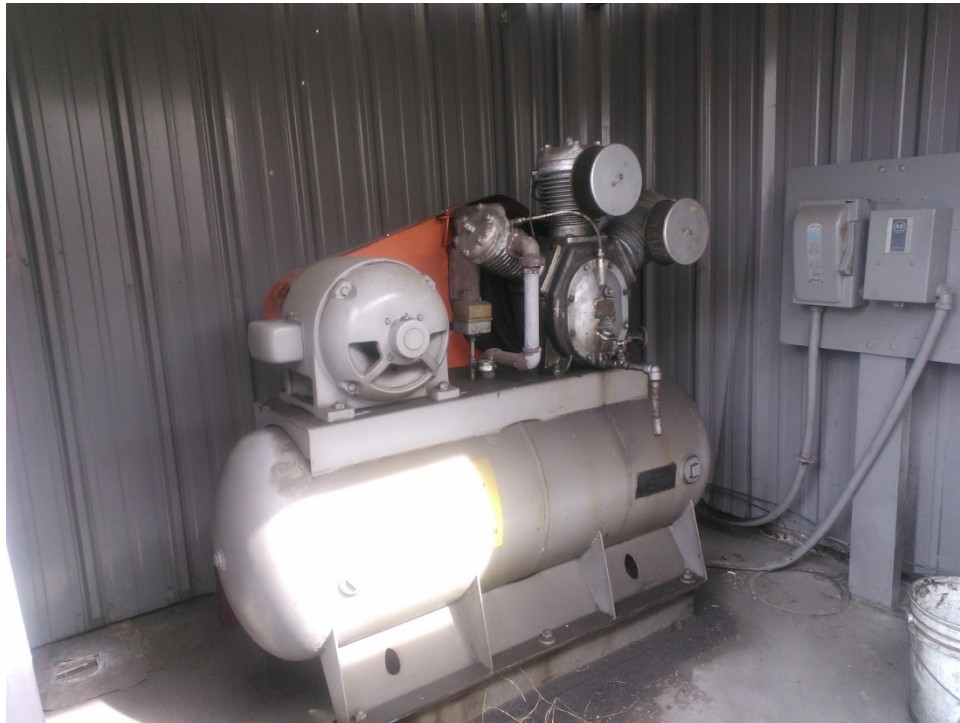
Exhibit 6. The air compressor that supplied air to the entire shop.
