**FROM:** Iowa FACE      Case No. 2012 IA 009      Report Date: 11 September 2012

**SUBJECT:** Bathtub refinishing technician died from inhalation of paint stripper vapors

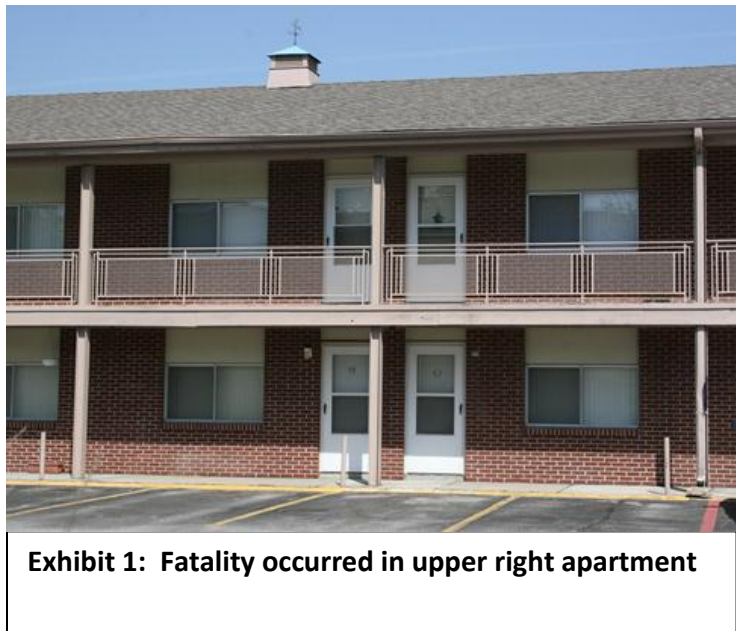
The fatality occurred during early 2012, in a second-story apartment of a multi-apartment complex (Exhibit 1). The apartment was accessed by a single exterior door, via an exterior stairway at the end of the building. The manager of the apartment complex noted that it was common practice to contract for bathtub refinishing services when needed, in preparation for leasing to new renters. The day of the fatality was the third or fourth time this resurfacing business had worked at this apartment complex. The apartment manager recalled that the decedent had worked at the apartment complex on at least one of those occasions prior to the fatality.

**Exhibit 1: Fatality occurred in upper right apartment**

- c) she may have opted to avoid obstructing access to other second story apartments by not placing the blower's flexible duct along or across the walkway (Exhibit 1); however, if it was not possible to effectively ventilate this small bathroom areas without obstructing the exterior hallway, an alternative chemical or mechanical stripping method should have been used; or

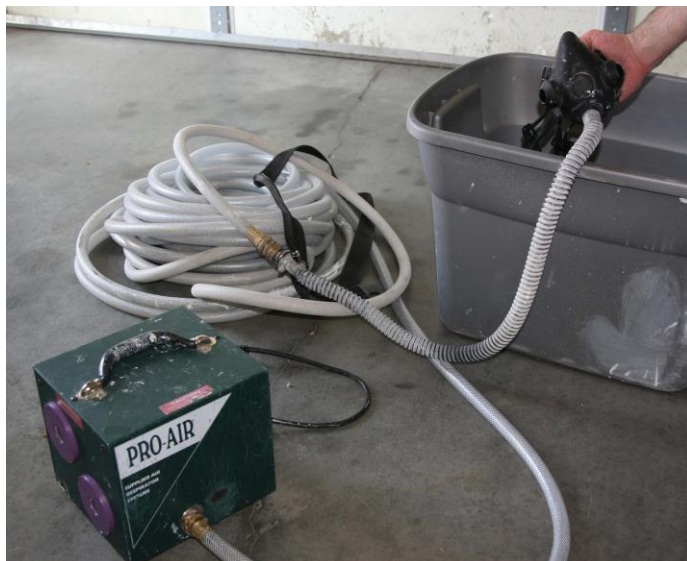
**Exhibit 2: ProAir 40 Fresh Air Respirator was to be used while stripping bathtub surface**

There are several shortcomings of the half-face Pro-Air 40 respirator device available to the surface refinishing employees. The Pro-Air 40 is not included in the NIOSH Certified Equipment List and does not meet minimum respiratory protection requirements for methylene chloride exposure. (The Pro-Air 40F – “F” designating for use with full face mask – is currently certified with approval number 19C -0320.) Pro-Air 40 systems are marketed online at several vendors and described as “NIOSH-approved” respirators, which misleads prospective users of the capabilities and protection provided by the respirator.

The configuration and protection factor of the Pro-Air 40 Fresh Air System does not meet criteria for methylene chloride exposure that may reach IDLH concentrations. Additionally, half-face mask configurations do not protect the eyes from irritation caused by methylene chloride vapors. The proper respirator for exposures up to 5000 ppm is an atmosphere-supplying respirator with full face mask, operated in pressure demand or positive pressure mode.

The Pro-Air 40 system used by the company instructs users to place the turbine in fresh ambient air of Grade D quality<sup>4</sup> or better. The Pro-Air 40 turbine unit includes two high efficiency particulate air (HEPA) filters that are replaceable but users do not have good indication to gauge a pressure drop if airflow is restricted or decreased due to turbine malfunction or filter loading. Using this system

A formal respirator program would have assigned responsibility for proper selection, maintenance, use, and employee training, and assured that proper fitting full-face respirators were available for employees. The appropriate respiratory protection for methylene chloride exposures that could reach IDLH concentrations is a full-face, supplied-air respirator.

If methylene chloride-based paint removers continue to be used, they should be used only with positive pressure supplied air systems such as self-contained breathing apparatus (SCBA) or airline respirators with SCBA backup, especially when exposure concentrations are not known or if it is not possible to effectively ventilate the work area. Workers and bystanders should not rely on odor as a warning property for dangerous exposures, as the odor threshold (250 ppm) is 10 times the OSHA Permissible Exposure Limit (PEL, 25 ppm) and near the 15-minute short term exposure limit (STEL, 125 ppm). Direct-reading equipment would be needed to determine hazardous concentrations of methylene chloride on site. Examples of direct-reading equipment include detector tubes, which allow “grab samples” or air to be collected that show the presence and concentration of vapors tubes that change color, or portable direct reading instruments

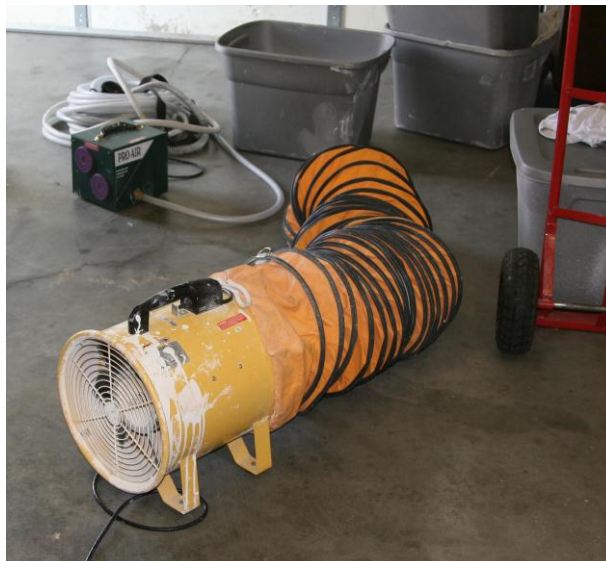
**Exhibit 3: FlowPro utility blower (in foreground) was to be used to exhaust chemical vapors from the work area**

Employees were also directed to use a portable Q Standard Utility Blower (12-inch diameter fan, 2905 cubic feet per minute, 4/7 horsepower, Model 39012) with Q Standard Ventilating Hose (12-inch diameter, 20-foot, Model 177771) flexible duct to remove contaminated air from the work area and exhaust it outside to a location remote from the respirator air supply source (Exhibit 3).

Technicians were instructed to place the blower unit fan in their work area, with the ducting extending out through a door or window to exhaust contaminated air from (i.e., blow air out of) the room. Makeup air – which would replace the air being exhausted by this utility blower – was not mechanically provided for during the procedure, but theoretically would passively enter the room or apartment via any open doors or windows, including the exterior door through which the blower ductwork was extended.

A 2905-cfm utility ventilation blower with two 20-foot sections of flexible ductwork was found in the work van that the technician drove to the site. This equipment was in the van with a portable hand cart to transport her storage totes of supplies and equipment. It is not known why, on this occasion, the decedent did not use ventilation controls and respiratory equipment, since apartment personnel had on prior occasion seen her use this equipment. Since the utility blower was not known to have malfunctioned or had operating problems, possible explanations may be that:

with the technician, would be an improvement to no ventilation, but provisions must be made for clean supply or “makeup air” for the exhaust system to work properly. A better option is to locate a local exhaust hood closer to the stripper product, since the tub wall and even the technicians themselves could potentially block the direct pathway of contaminated air at the source to the fan.

Using appropriate makeup air and local exhaust ventilation in a push-pull system would have diluted methylene chloride vapors in the room. Because methylene chloride has a high vapor pressure and is heavier than air<sup>3</sup>, the better alternative is to position an exhaust hose to the side and as low to the interior of the tub as possible to draw vapors down and away from the worker who may be leaning over the tub to work. Capturing and removing vapors closer to the source is a more effective exhaust.

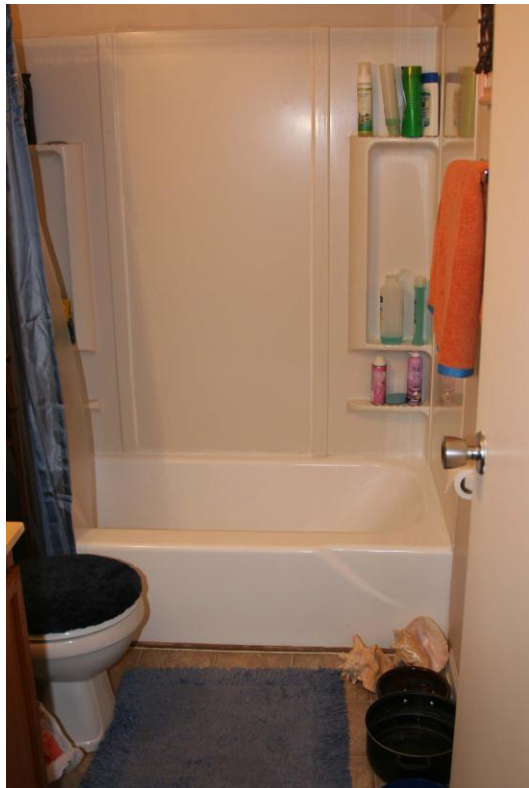
**Exhibit 4: Configuration of bathroom**

The decedent had been working in a small bathroom that was approximately 5' wide x 7.5' deep x 8' high (Exhibit 4). The standard size bathtub (29" wide x 60" long) was on the far end of the room and extended the width of the bathroom. The room had a ceiling exhaust fan which was not turned on. Most of the original tub finish had been removed, and the decedent's scraper and knee pad (presumably used as a cushion) were found in the tub (Exhibit 5).

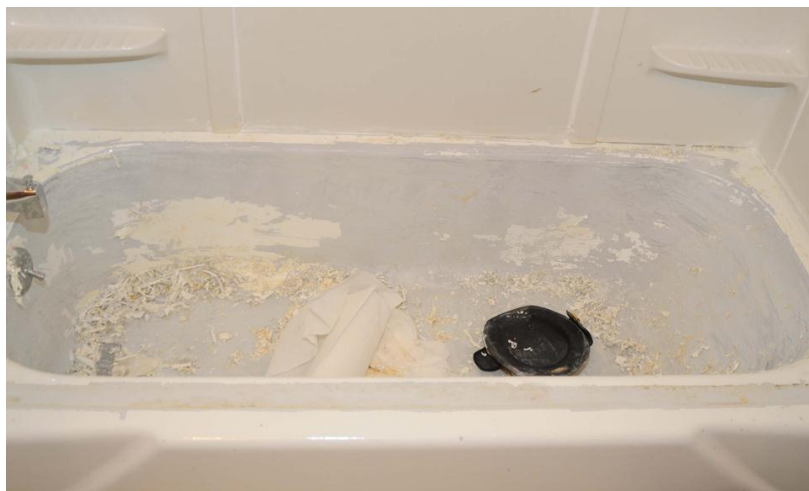
**Exhibit 5: Bathtub where technician was found**

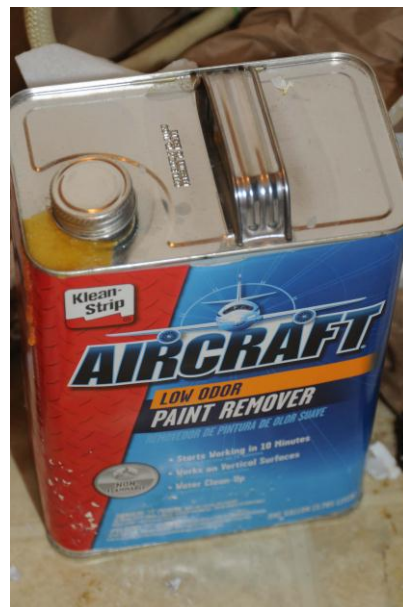
Responders described a strong chemical odor in the apartment. An open one-gallon can of Klean Strip Aircraft® Low Odor Paint Remover was found in the room, with about 105 ounces of product remaining in the 128-ounce can (Exhibit 6). The door and windows of the apartment were closed, and there was no supplemental ventilation supply or exhaust in use.

**Exhibit 6: Recapped can of methylene chloride paint remover found in room**

Based on the product volume removed from the gallon can, the Iowa DOL Occupational Safety and Health Bureau calculated a potential concentration of 23,000 parts per million methylene chloride in the room, in excess of the IDLH concentration (2300 ppm), OSHA STEL (125 ppm) and PEL (25 ppm). [Air in this room would be flammable when methylene chloride concentrations reached 120,000 ppm.]

Methylene chloride-based paint remover is part of a proprietary process of the parent company selling the distributorship. The methylene chloride stripper is viewed as a preferred stripping method in preparation for a bonding agent and urethane coating, in contrast to acid-etching procedures to remove finishes in preparation for epoxy coatings. This aircraft grade paint remover that was recommended by the parent company and used by the local business is marketed for large scale work in outdoor or high-volume areas where high concentrations are less likely to occur than in small bathrooms of apartments, residences, hotels, or other bathrooms where refinishing may be an attractive low cost option to replacing bathroom fixtures.

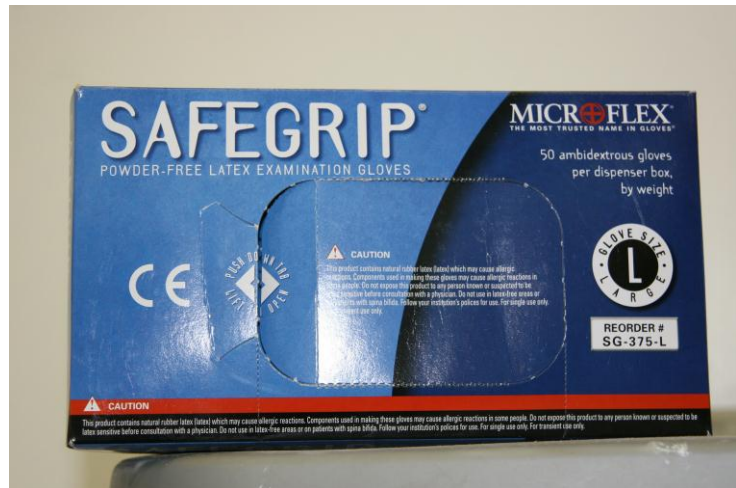
The decedent was wearing a short sleeved tee-shirt, painter pants, and two layers of latex gloves (Exhibit 7). She wore no respiratory protection or eye protection. The decedent's cup of fountain pop was on the counter of the vanity in the room. The employee's Pro-Air 40 Fresh Air Respirator with two 40-foot sections of supply tubing and FlowPro utility blower with two 20-foot sections of flexible duct were found in the cargo area of the company van the decedent had driven to the site.

**Exhibit 7: Gloves used by technician**

Adherence with the standard would have also provided guidance for clothing and gloves to protect exposed skin. The technician's work clothing did not provide coverage to her forearms; the latex gloves she wore were not chemically resistant to methylene chloride. Long gloves made of butyl rubber, polyethylene/ethylene vinyl alcohol (PE/EVAL, 4H™ and Silver Shield™ brand), or Teflon™ would protect the hands and forearms from contact with methylene chloride and methanol.
