# MIFACE INVESTIGATION REPORT: #09MI085

## Subject: Truck Driver Struck by Semi-Tractor When Walking in Parking Lot

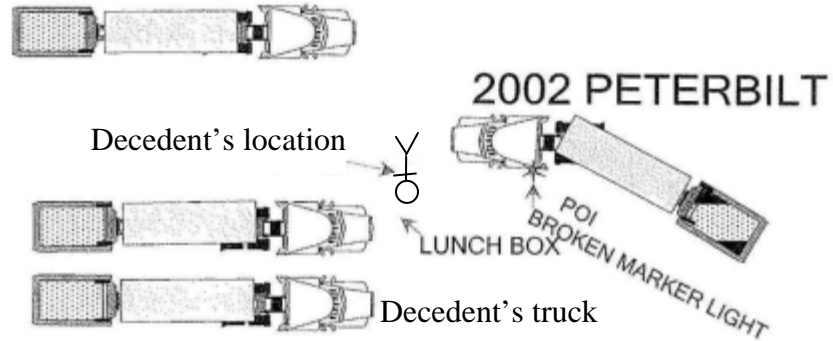
Figure 1. Sheriff report drawing of incident scene. Company and decedent identifiers removed.

parking lot was dark and inadequately lit because two corner pole lights located at each corner end at the rear of the parking lot were not functional. There was one white mercury vapor lamp functional; the light was located behind the open parking space to be used for the gravel train. The parking area was located west of the maintenance shop and had two wide driveways located at its north and south to provide access to the lot. There were two truck rows with a large open area between them. The driver of the Peterbilt was a truck mechanic who had a suspended driver's license and did not have a commercial driver's license (CDL). He was driving the recently repaired gravel train from the maintenance shop, utilizing the north driveway, to park the vehicle two spaces to the north of the decedent's parked vehicle. The semi-tractor's amber/running lights were on but the tractor's headlights were turned off. The mechanic drove past the open parking space, turned the truck around in the wide open area, and headed back to the open parking space. As he began to make his turn into the open space, the driver's side of the tractor struck the decedent (See Figure 1). Emergency response was called and the decedent was declared dead at the scene.

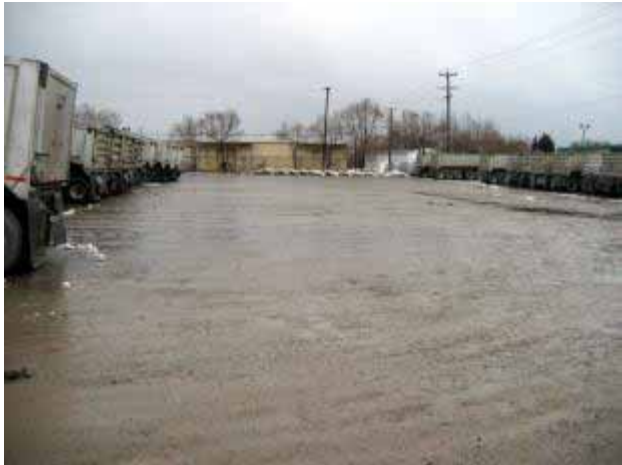
Figure 3. Open area used for turning Peterbilt between two truck rows

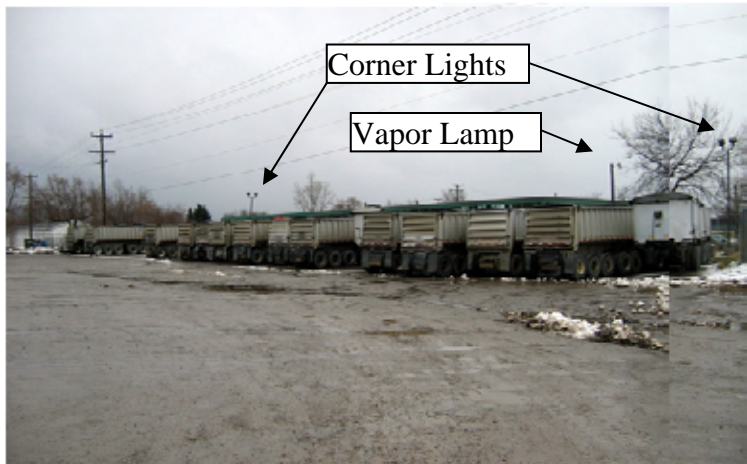
The parking area was a secured lot by a chain link fence around the property and was restricted to employee access (Figure 2). The surface was dirt and gravel and was muddy at the time of the incident. The parking lot was dark because two corner pole lights located at each corner end at the rear of the parking lot were not functional. There was one white mercury vapor lamp

functional; the light was located behind the open parking space to be used for the gravel train. The parking area was located west of the maintenance shop and had two wide driveways located at its north and south to provide access to the lot. There were two truck rows with a large open area between them (Figures 2, 3 and 4). The lights on the maintenance building were working, as well as one light at the front of the lot. The parking area did not have marked parking spaces or pedestrian walkways.

Figure 4. Row of trucks parked at rear of parking lot with vapor lamp and corner lights.

1. Repair and maintain the lighting at the rear of the parking lot in good working order at all times.
2. Ensure that truck drivers use their head lights when driving in the parking lot at night so that pedestrian are readily seen
3. Do not move truck from repair bay into the parking lot during periods of darkness to avoid employees on foot walking through the lot.”

- Employers should develop an interior/exterior facility inspection checklist to identify and remedy safety and health concerns, such as non-functional pole lights.

The Safety Director was unaware that the lighting was not functional in the parking lot. No night shift or truck driver had alerted him to this safety issue. To help ensure safety and health issues are addressed in a timely manner, a facility inspection checklist should be developed and include an area for corrective actions. Corrective action plans should list any problems or concerns noted during the inspection, what action is being taken to correct the problem, the person responsible for corrective action, a targeted completion date, and the date the action is completed. The facility walk-around can be completed on a monthly or quarterly basis (or more frequently as necessary) by the Safety Director, or if formed, a member(s) of the Safety Committee.

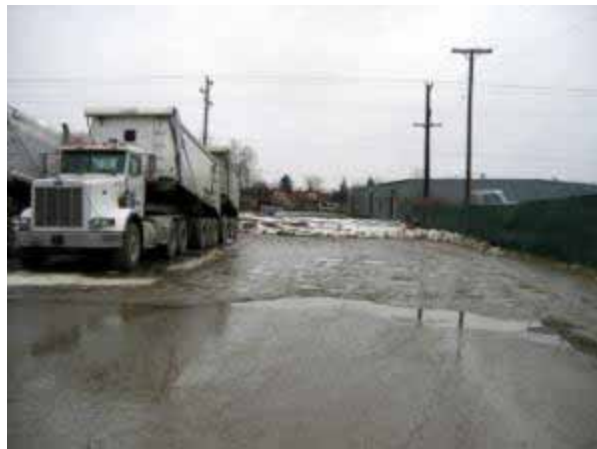
The mechanic backed the tractor trailer and dump units out of the center mechanic's bay, drove through an adjacent bay, down the north driveway of the parking area (Figure 5) and out into the rear parking lot, driving past where he

Figure 5. View from Maintenance garage at north driveway

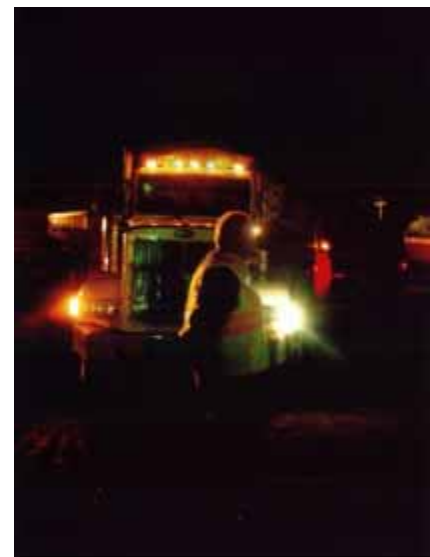
Figure 6. Deputy visibility, vapor light and amber marker lights only

The night visibility study demonstrated that the decedent would have been slightly visible in front of the vehicle with the yard lights and headlights off and the amber marker lights on (Figure 6). When the yard lights were off, but both the headlights and marker lights on, the deputy was visible in front of the vehicle (Figure 7). When all lights were on (corner yard lights, headlights and running lights), the police officer was again visible in front of the vehicle. The police findings were: a) the deputy would have been visible with the headlights and yard lights on; b) that he was difficult to see with the yard lights and headlights off; c) the vehicle was moving at the time of the crash; and d) it would have been difficult for the truck driver to see the decedent with the yard lights off and only the marker lights on.

- Employers should mandate drivers turn on the vehicle's low-beam headlights while moving through parking areas at night and during dusk through dawn hours.

Driver visibility is reduced at night and during dusk/dawn, limiting what can be seen in front and to the side of the vehicle. Ninety percent of a driver's reaction depends on vision, and vision is severely limited at night. Depth perception, color recognition, peripheral vision, and the ability to discern distance and movement are compromised in darkness. The mechanic had been working in a brightly lit area and drove the vehicle to a relatively unlit area. His eyes had to adapt to the difference in lighting from the maintenance area to the dark parking lot, potentially decreasing his ability to discern objects. The use of low-beam headlights would illuminate a small portion of the area in front of the vehicle to provide increased visibility. Additionally, headlight use also makes it easier for others to see the vehicle.

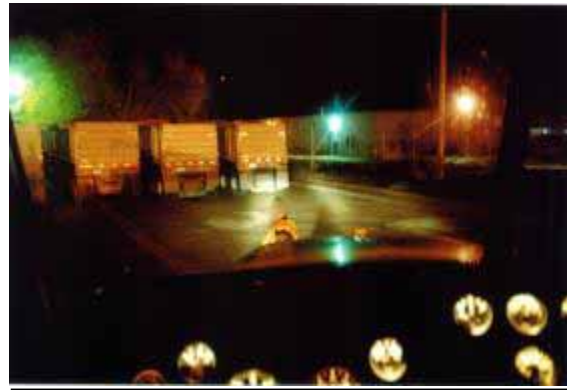
Figure 7. Deputy visibility, vapor light, headlights and amber marker lights
