INVESTIGATION REPORT

FACE 07-NJ-077

Construction Laborer Dies After Falling Through Temporary Bridge “Catch” Platform, 75 Feet To Ground

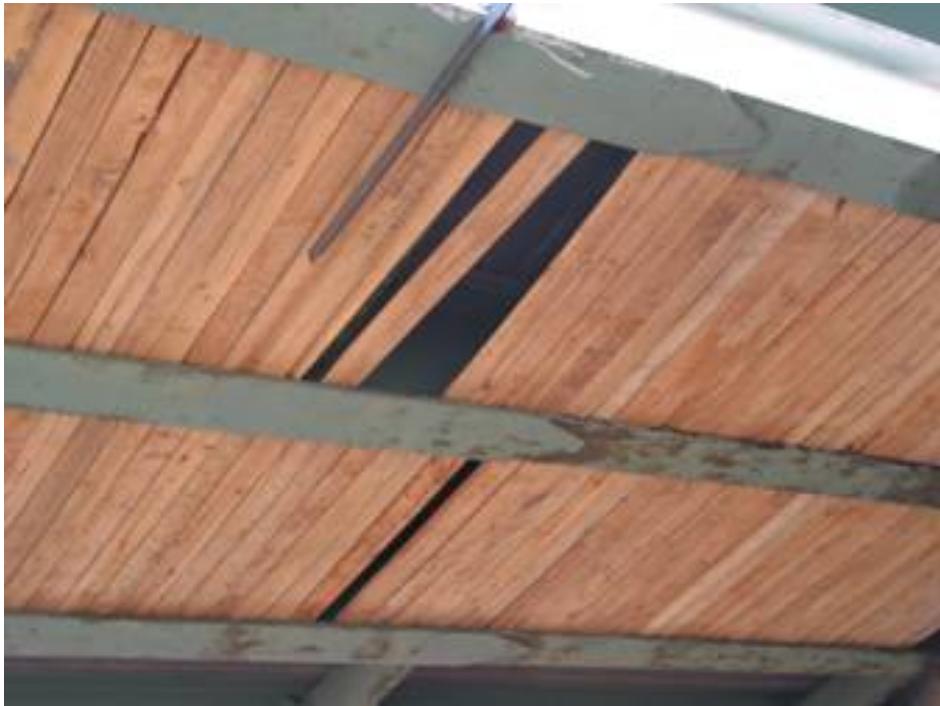
This fatal incident occurred at a large highway bridge construction project. The construction project was typical of other highway bridge projects that involved work on a bridge deck. A “catch” platform below the work area was designed to prevent any construction debris generated on site from falling to the ground below. Debris can be generated from a multitude of activities, including the breaking up of concrete or other surface material that is to be replaced or the installation of support structures and concrete for a new or expanded bridge. The “catch” platform is typically a set of wooden planks (e.g. 2' X 10') that are placed from the bottom of one I-beam to the bottom of another I-beam, with the end of the planks set to simply rest on the lip of the I-beam. The planks are typically not secured to the I-beam and it is common to observe gaps and shifting of the planks in a “catch” platform (See Figure 1).

Figure 1. Example of shifting bridge deck “catch” platform wooden planks (view from ground).

Discussion: Devices and/or designs for catch platforms to hold individual planks together to prevent shifting of the planks should be used. In this incident, although the plank that failed was only 9-³/₄" wide several planks shifted allowing the victim to fall through the bridge "catch" platform. If the planks were affixed together, this may have prevented the victim from falling through the bridge "catch" platform. This can be accomplished through several means, including nailing the edges of the wooden planks together. However, it is important to note that OSHA 29 CFR 1926.451(b)(9) prohibits the use of any material that will obscure a visual inspection of the top or bottom surface of the wood planks. Some contractors have suggested covering the entire "catch" platform with plywood, however this would eliminate the ability to visually detect and replace defective or damage wood planks. This could be a particularly problematic if the plywood alone can not support four times the weight potentially

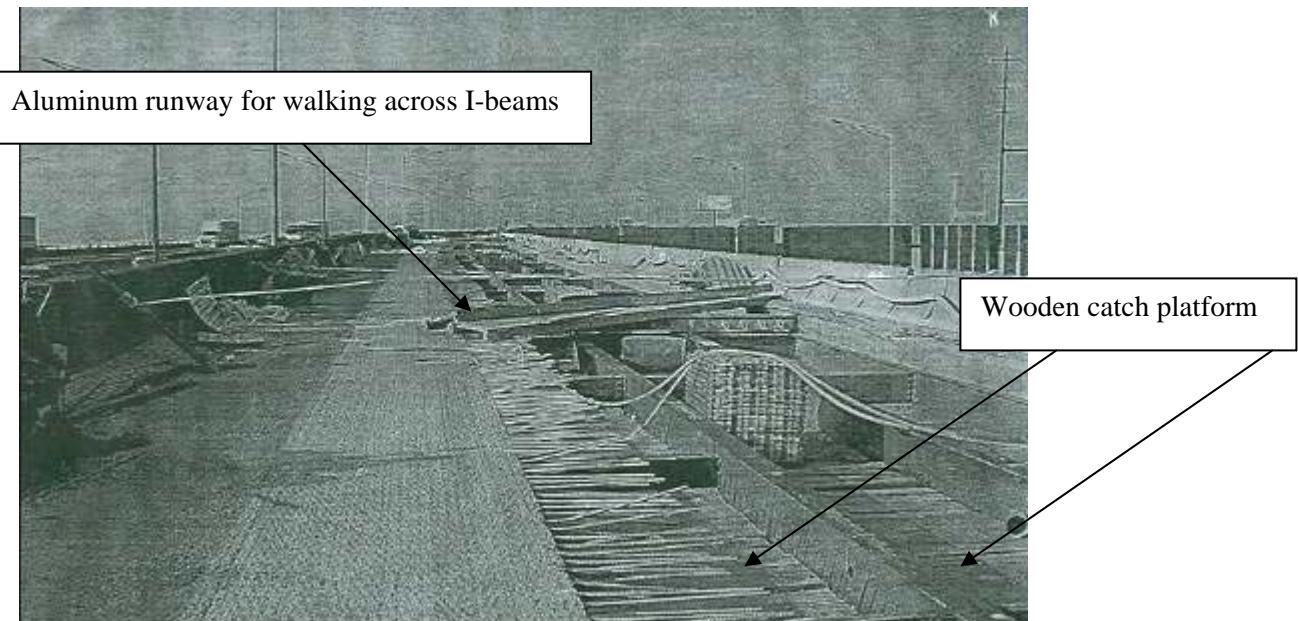
Figure 2. Bridge deck where incident occurred

The fatal incident occurred on a typical work day in 2007 shortly after the morning shift began. An OSHA Compliance Safety and Health Officer (COSHO) who had visited the work site several times since the fatal accident reported that it was not uncommon for employees to walk and work on the platform. The victim was not using any fall protection devices at the time of the incident. According to the COSHO, the victim stepped down from the I-beam onto the wooden catch platform to move a “pic” board, a metal runway used to transport concrete between work areas on the bridge. The distance from the top flange of the I-beam to the bridge “catch” surface was 16 inches. Immediately after the victim stepped down, one plank broke across its width, resulting in the employee falling partially through the platform. As the employee fell, other wooden planks making up the platform shifted because the planks were not affixed to one another, and the victim fell completely through the platform (see Figure 2, incident site).

The wooden plank that failed was a nominal 2' X 10' piece of economy-grade, white pine that was $67\frac{1}{2}$ inches long. The height and width of the failed plank was $1\frac{7}{8}$ by $9\frac{3}{4}$ inches, respectively. The plank broke with a curved split at approximately 29 to $29\frac{1}{2}$ inches from its end, near the location where the victim stepped onto it. This curved split caused the board to break into two large sections and one smaller triangular section. A failure analysis of the broken plank by OSHA revealed that the major strength reducing feature of the plank was the Slope-of-Grain (SOG), which was 1:2 (i.e., the grain along the length of the board deviated from the long axis of the plank by a distance of 1 inch for every 2 inches in length). Acceptable SOG for scaffold-grade lumber is a minimum of 1:12. The OSHA failure analysis demonstrated that the wood used in this platform was inadequate as a walking/working surface. In addition, the COSHO observed planks being reused on the bridge "catch" that had been previously removed from service due to structural concerns, and noted visibly damaged wooden planks as well as planks that had shifted, leaving open spaces in the platform.

Discussion: Wooden planks or other materials used for temporary work platforms must be designed and made of material that can support at least four times the maximum intended weight (i.e. safety factor of at least four) as per OSHA regulations (29 CFR 1926.451(a), Scaffolding). In addition, OSHA has requirements for lumber used in scaffold systems that require the use of scaffold-grade wood, as well as many other important structural requirements that can prevent failure of the temporary work platform when in use (29 CFR 1926 Subpart L, Scaffolding). In addition, there are several wood products grading agencies that have standards for acceptable wood characteristics, such as the Western Wood Products Association's requirement that scaffold grade wood have a minimum SOG of 1:16. In addition, the knot size for scaffold-grade wood is limited to very small sizes. Materials used in temporary work platforms must be inspected to assess the integrity of the material in use. For wooden planks in particular, someone trained to grade wood and other load bearing materials must identify planks that need to be replaced and assure that needed replacements are completed in a timely manner. Materials used in temporary work platforms must be maintained in a manner that preserves the structural integrity of the platform material. For example, wooden planks should not be subjected to conditions that will cause warping or cracking of the wood, which may include long-term exposure to water without the ability to dry quickly, storage underneath objects of significant weight that will eventually warp or damage the wood, or the use of the wood for other purposes such as ground traction support for heavy construction vehicles. In this case, employee interviews and the OSHA inspection suggested that the reused wood planks subjected to maltreatment over several years prior to the accident were placed in the "catch" platform.

Discussion: Prompt inspection by trained personnel must follow any employee report and if necessary corrective action taken should be taken, including the replacement of damaged or defective wooden planks. A system should be in place that will assure that defective planks are replaced and not reused. In this case, it was documented by the OSHA inspector that planks removed from service due to recognized deficiencies ended up back in use on the bridge catch platform. The work site appeared to lack a clear protocol for plank inspection and replacement and also appeared to lack a person who clearly had responsibility for the day to day platform maintenance and inspection. This type of construction work requires the presence of a competent person trained in the proper use of wood in working/walking platforms.
