**SUBJECT:** A Groundsman Working on a Tree Trimming Crew Dies When He is Dragged or Propelled onto a Wood Chipper Feed Table

**SUMMARY**  
**California FACE Report #10CA010**

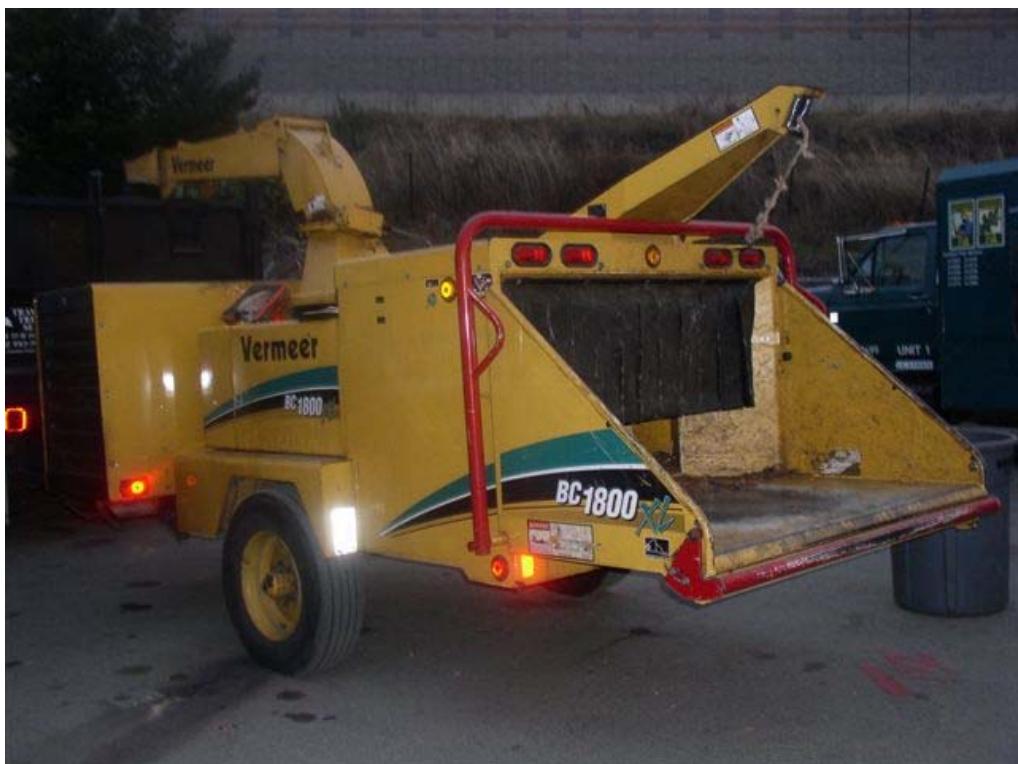
At approximately 1:30 p.m., the victim was dragging a branch from the base of a eucalyptus tree to the wood chipper which was approximately 40 feet away. As he passed another tree, the branch became entangled in the white colored climbing rope of the tree trimmer in that tree. When the victim reached the wood chipper, he fed the branches into the chipper with the climbing rope. Although this incident was not witnessed, evidence suggests that as the rope went through the wood chipper it immediately went taut. The victim was either dragged or thrown onto the chipper, striking his head. As his body landed on the feed table, it most likely struck the safety bar located on the front and shut the machine down.

**Exhibit 1. The wood chipper involved in this incident.**

**Recommendation #1: Ensure that cut tree branches are staged and free of obstacles before being fed into wood chippers.**

Discussion: In this incident, the victim dragged a tree branch that became tangled in a tree trimmer's climbing rope that was coiled at the base of the tree. Because the cut branch was large and full of foliage, it snagged the rope as it was being dragged past the tree. When the victim got to the wood chipper he most likely fed the cut branch into the wood chipper, not realizing there was a rope entangled within it. All cut branches and brush should always be inspected just prior to being fed into wood chippers to ensure that they are free of any foreign objects that might do harm to the wood chipper or cause personal injury. Staging the brush for inspection prior to starting the chipper would be the most protective procedure. As part of the chipper start-up procedure, the safety interlocks should be re-checked. Had the victim taken the time to inspect the cut branches prior to feeding them into the wood chipper, he might have noticed the entangled rope and prevented this incident from occurring.

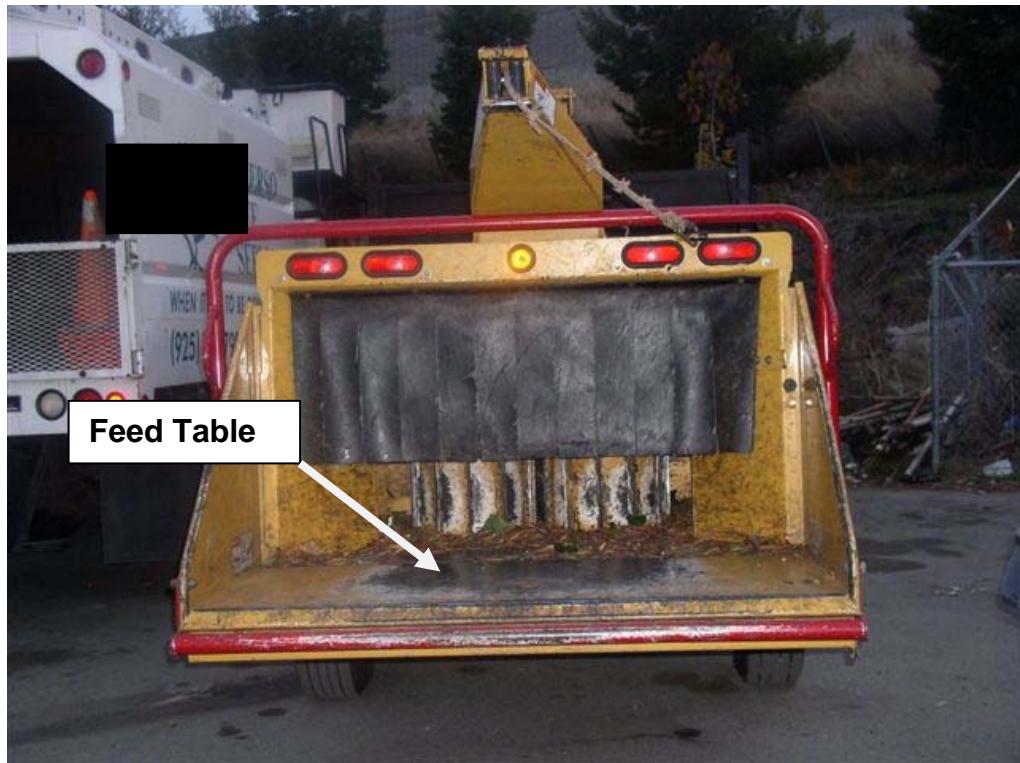
The tree trimmer, who was approximately 30 feet up in the tree, said he felt a sudden strong and fast pull on his climbing rope but his flip line prevented him from being pulled from the tree. He repositioned himself in the tree and saw the victim lying on the feed table of the wood chipper. The other two tree trimmers who were up in other trees did not witness the incident. The other two employees working on the ground were engaged in other activities at that time and also did not witness the incident. Emergency medical services were immediately called (911) and the local fire department responded. Co-workers began CPR and continued until emergency crews arrived. The victim was pronounced dead at the scene.

**Exhibit 2. The feed table where the victim landed.**

**Recommendation #2: Assign another employee as a safety watch whenever cut tree branches are being fed into wood chippers.**

Discussion: In this incident, the victim was working alone even though there were two other employees working on the ground performing similar functions. When this incident occurred, no one witnessed the event, even though they were all in close proximity. Many hazardous work assignments, such as high voltage electrical work or confined space work, mandate the use of a safety watch to be present when certain activities occur to help prevent injuries. When a wood chipper is in operation, at least one worker in addition to the operator placed in the immediate vicinity of the work area and in close proximity to the operator would be able to observe the actions of the operator as well as the material being fed into the wood chipper. In this incident, a designated safety watch stationed near the chipper may have noticed the rope entangled in the cut branches and prevented the victim from feeding the branches into the wood chipper.
