Massachusetts FACE • Occupational Fatality Report

Laborer Dies After Being Backed Over by Dump Truck at a Nighttime Highway Work Zone Construction Site - Massachusetts

Investigation: # 08-MA-028-01

Release Date: February 25, 2011

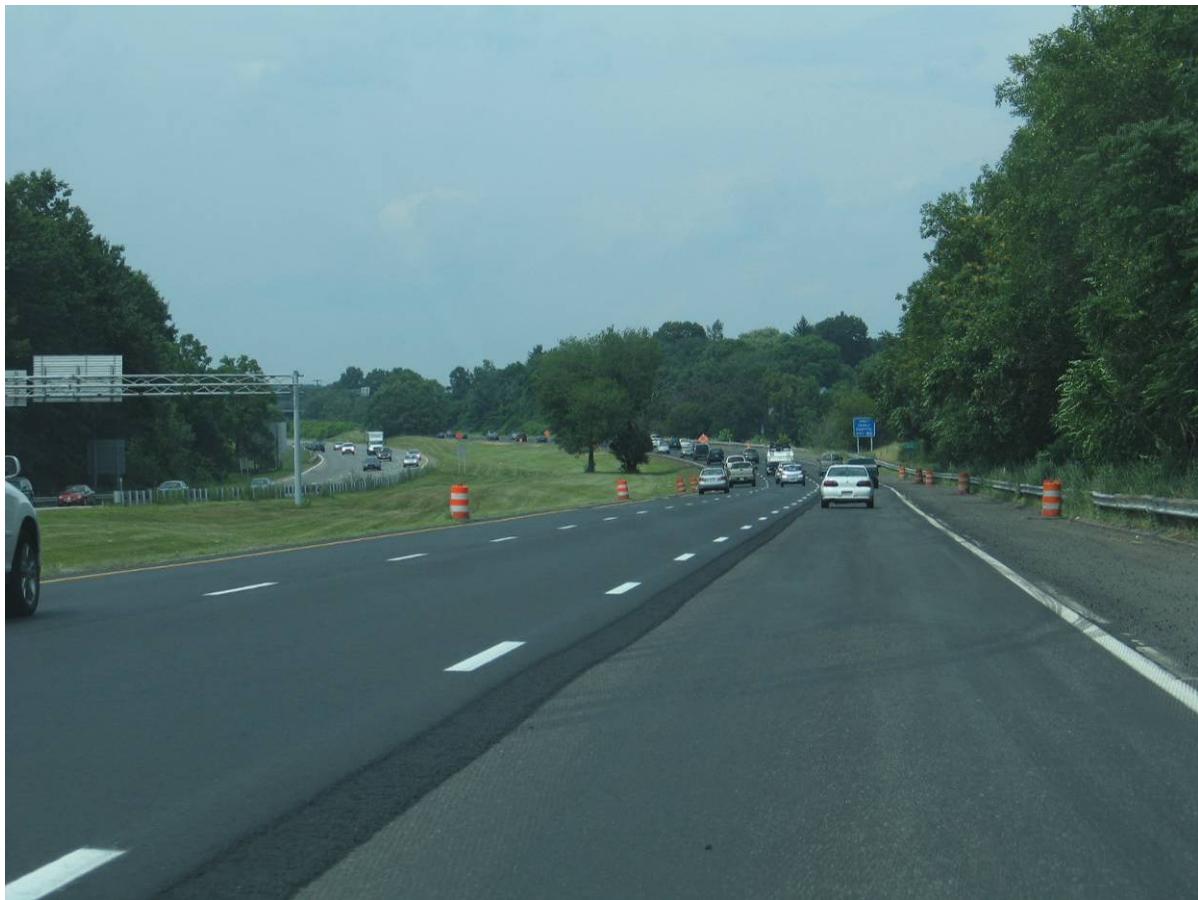
Figure 1 – Roadway where incident occurred.

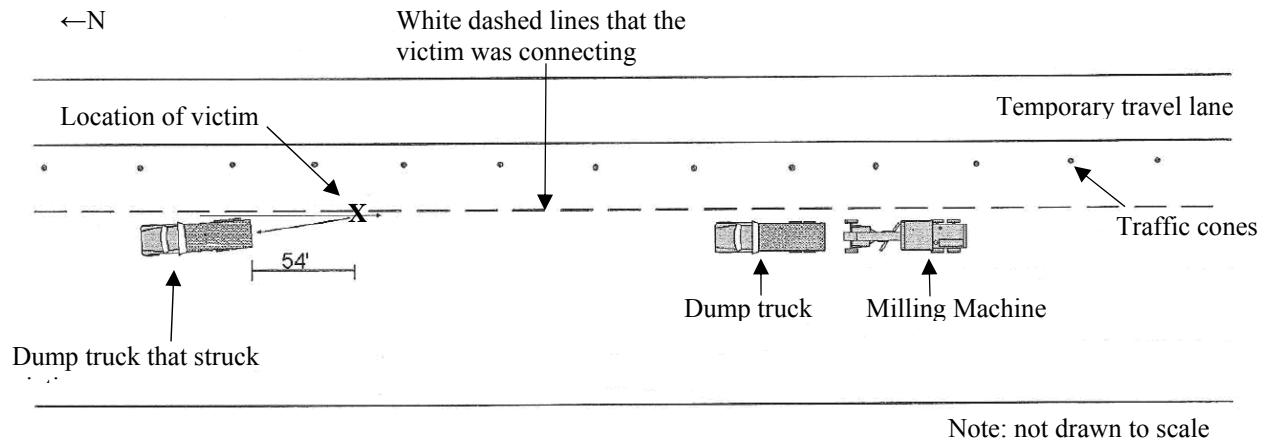
At approximately 8:00 p.m., the company's safety crew and construction superintendent, along with state troopers, arrived at the project site. The crew started setting up the work zone, which was about one mile long and included shutting down the three northbound travel lanes. The 10-foot breakdown lane and two feet of the right-hand travel lane were designated as the single travel lane for motorists to pass by the work zone. This temporary travel lane was separated from the work zone by traffic barrels. A right-hand entrance ramp merged with the single designated travel lane adjacent to the work zone. The southbound travel lanes were not affected on the night of the incident (Figure 2). The work zone set up was completed by 8:30 p.m.

Figure 2 – Diagram of the work zone.

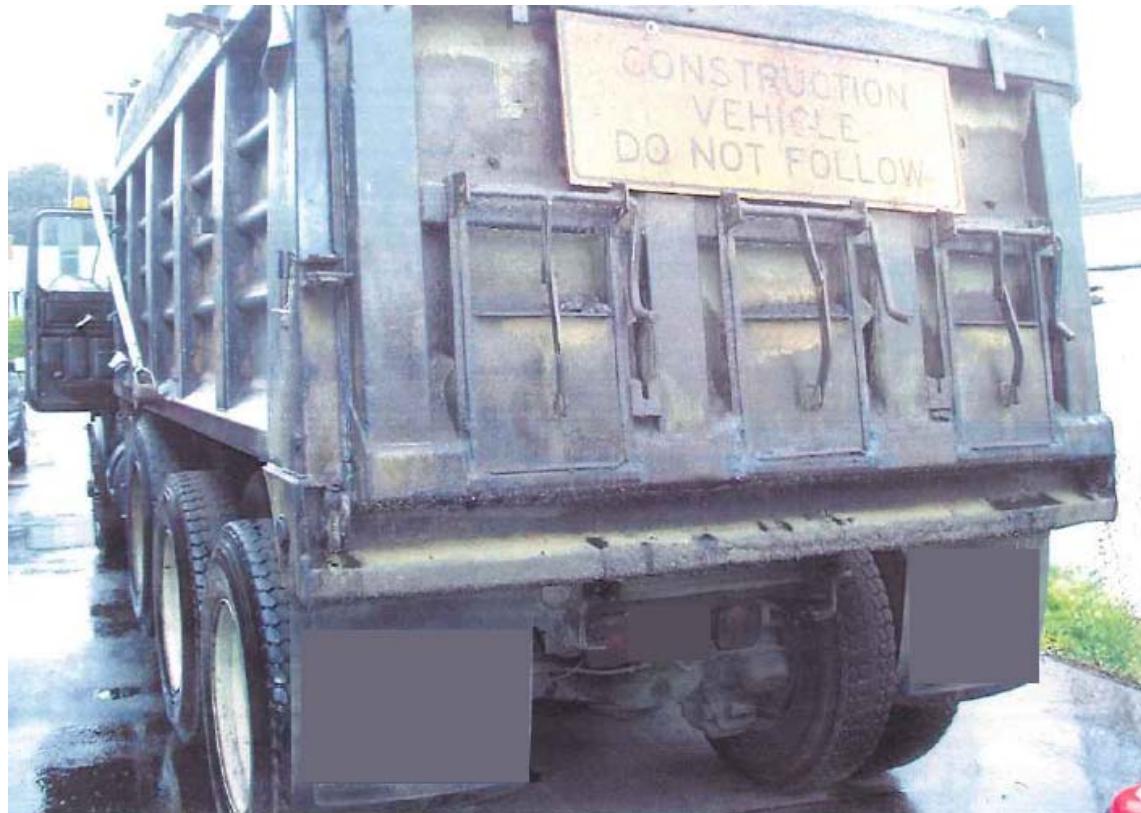
The driver of the dump truck had a passenger (non employee) present inside the cab at the time of the incident. According to federal law (49 CFR Part 392.60) unless authorized in writing by the motor carrier under whose authority the commercial motor vehicle is being operated, no driver shall transport any person on any commercial motor vehicle other than a bus.¹ After the incident the dump truck was impounded by the Department of Transportation and a full inspection of the truck was conducted. The truck appeared to be in good working order with a functioning backup alarm and backup lights.

Figure 3 – Truck involved in the incident.
