# **Land Surveyor Struck and Killed By Passenger Vehicle**

**Incident Number: 09KY079**

**Kentucky Fatality Assessment and Control Evaluation (FACE) Program**  
**Incident Number: 09KY079**  
**Release Date: January 11, 2011**  
**Subject: Land Surveyor Struck and Killed By Passenger Vehicle**

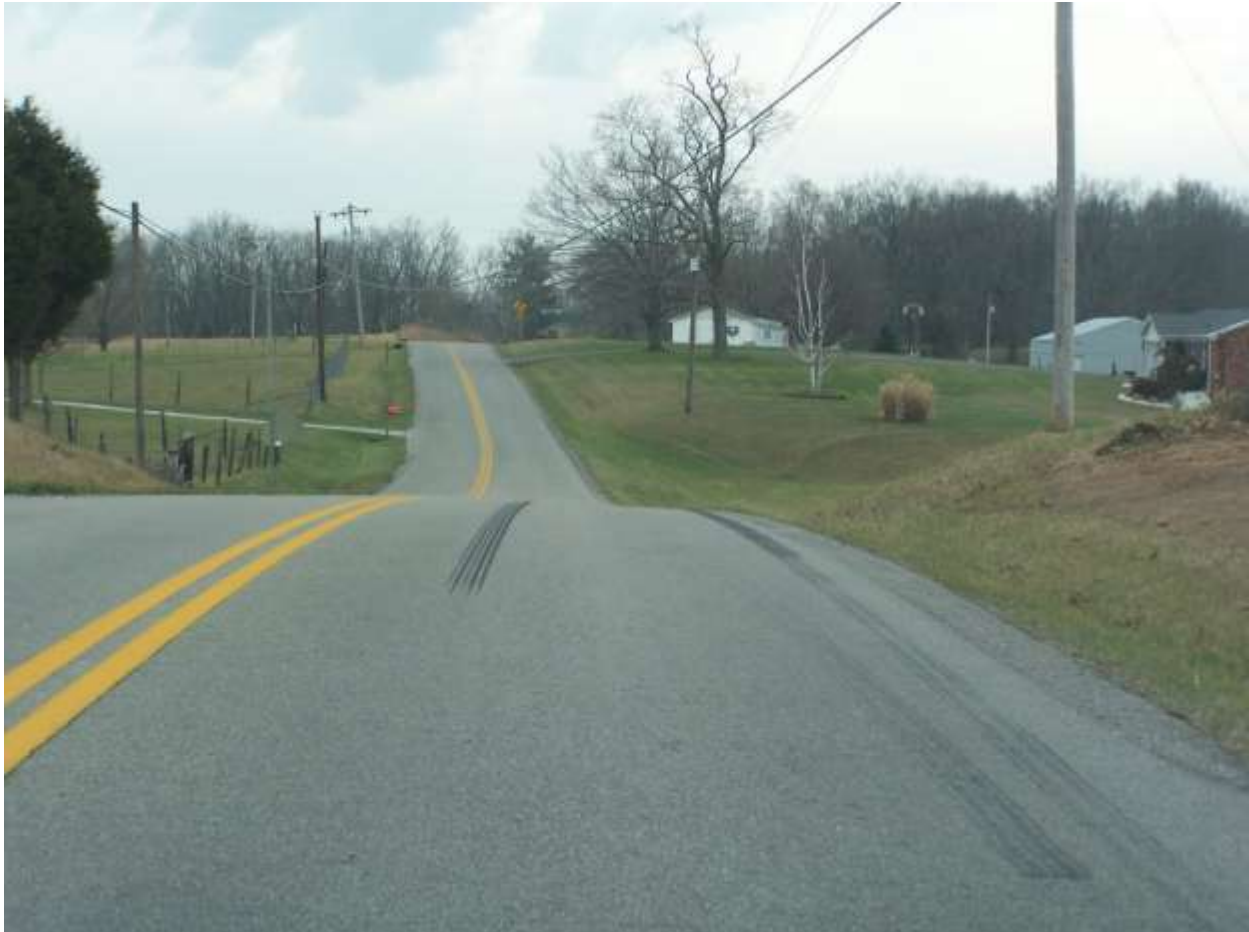
**Photograph of location where car topped hill and lost control. Picture property of KY FACE.**

The police report stated the pavement was asphalt, roadway conditions were straight and hillcrest, rural, dry, and the weather was clear. Human factors contributing to the incident were "speeding, inattention, and overcorrecting/ oversteering". Environmental factors were "view obstructed/ limited". No vehicle factors contributed to the incident. There were no obstacles in the roadway. The survey vehicle was parked in a field west of the highway.

### **Recommendation No. 1: When surveying on land near roadways, safety cones and warning signage should be erected to slow down motorists.**

The Manual of Uniform Traffic Control Devices provides guidance on where to place warning signage when working on roadways. Since the land surveyors were not surveying along the roadway, signage and/ or orange cones warning motorists of workers on the roadway was not required. However, to be prudent, signage and/ or orange cones warning motorists of workers working near roadways should be placed prior to and at the work site. Position additional signage before hills, curves, or other obstacles to warn drivers of the work site located on the blind side of the hill, curve, etc.
