NJ FACE INVESTIGATION REPORT

FACE 07-NJ-38

December 11, 2008

Cargo Handler Killed By Airplane Tail Stand Tip-Over During Transport

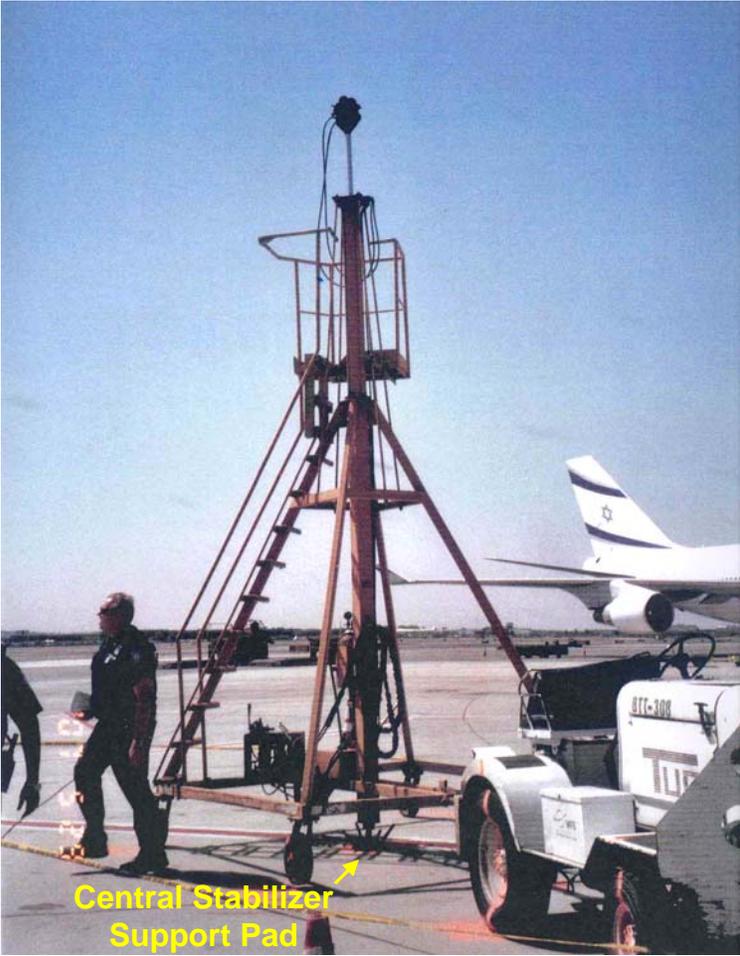
The tail stand (see Figure 1) weighed approximately 1,750 pounds and was towed to and from aircraft by a cargo tug, which is a common small vehicle used at many airports. Tail stands are necessary because 747 aircraft specifically require support of the airplane tail during loading and offloading of cargo. The cargo tug involved in this incident did not have an overhead protective cage. However, there was another cargo handling company at this airport that had overhead protective cages installed on their tugs.

Figure 1: Tail stand and cargo tug

Recommendation #1: Airport vehicular tugs should be equipped with adequate overhead protective cages to prevent injuries caused by strikes from objects falling from above.

Discussion: Protective cages serve to stop or deflect objects from above falling onto the driver, which could potentially result in injury. A great deal of the loading and unloading of cargo at this airport involves lifting or lowering heavy items from overhead storage locations. Employees interviewed during the investigation reported that falling objects are a fairly common experience at this worksite, especially because items tend to shift during flight. In addition, overhead protective cages were commonplace on tugs used by other cargo moving companies at the airport. It is believed that if the decedent was using a tug that had an overhead protective cage, the weight of the falling tail stand would have been significantly deflected and therefore may have prevented this fatality.

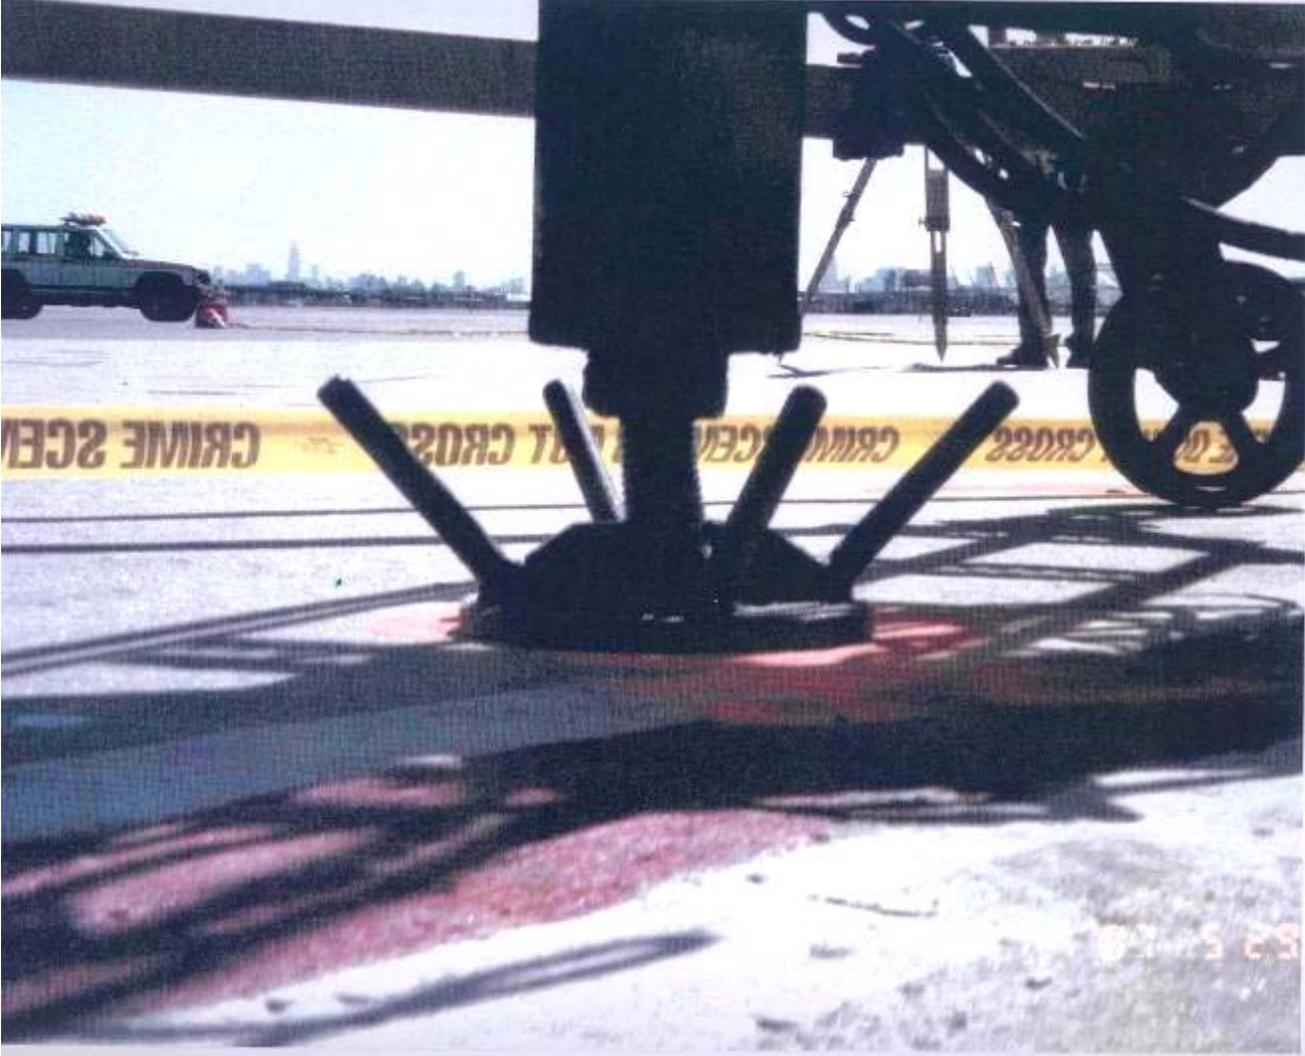
During transit, the support pad of the tail stand’s central stabilizer, which was left in the down position, caught the lip of a manhole cover that extended 5/8” above the paved surface (Figures 2 and 3). This snag of the central stabilizer support pad on the edge of the manhole cover caused the tail stand to flip forward and strike the cargo handler in the head, neck, and back before pinning him to the steering wheel of the tug. The tail stand caused massive traumatic injuries to the cargo handler, who was pronounced dead at the hospital one hour later.

Figure 2: Close-up of central stabilizer support pad in down position

Recommendation #6: Safety devices for aircraft tail stands that prevent movement of the stand unless the central stabilizer is in the correct position should be designed and integrated into the construction of the tail stand.

Discussion: Engineering controls, such as those described by this recommendation, are the most preferred method for controlling hazards. The lifting of the central stabilizer to the correct position would be required to move the tail stand if this engineering control was incorporated into the design of the tail stand. This would prevent injury because it would ensure that the operator utilized the tail stand correctly. The principal cause of this fatal accident could have been avoided by requiring the central stabilizer to be raised before the tail stand could be moved.

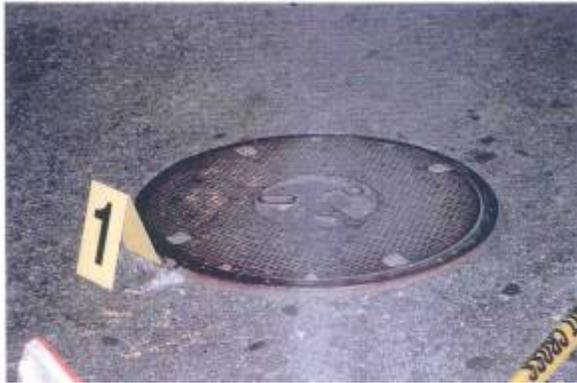
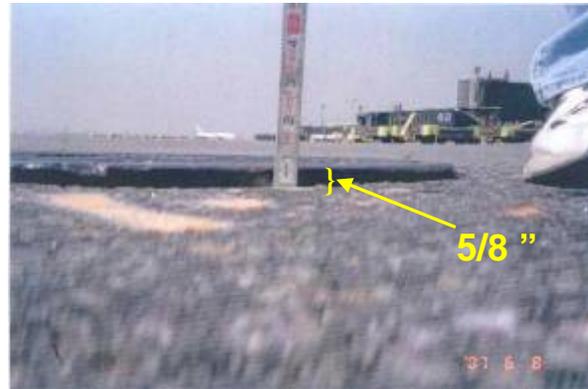
Figure 3: Manhole cover contacted by central stabilizer support pad during transport
