# **Service Technician Working Alone Dies after being Assaulted**

**Incident Number: 09KY078**

## **Kentucky Fatality Assessment and Control Evaluation (FACE) Program**

**Release Date: September 30, 2010**

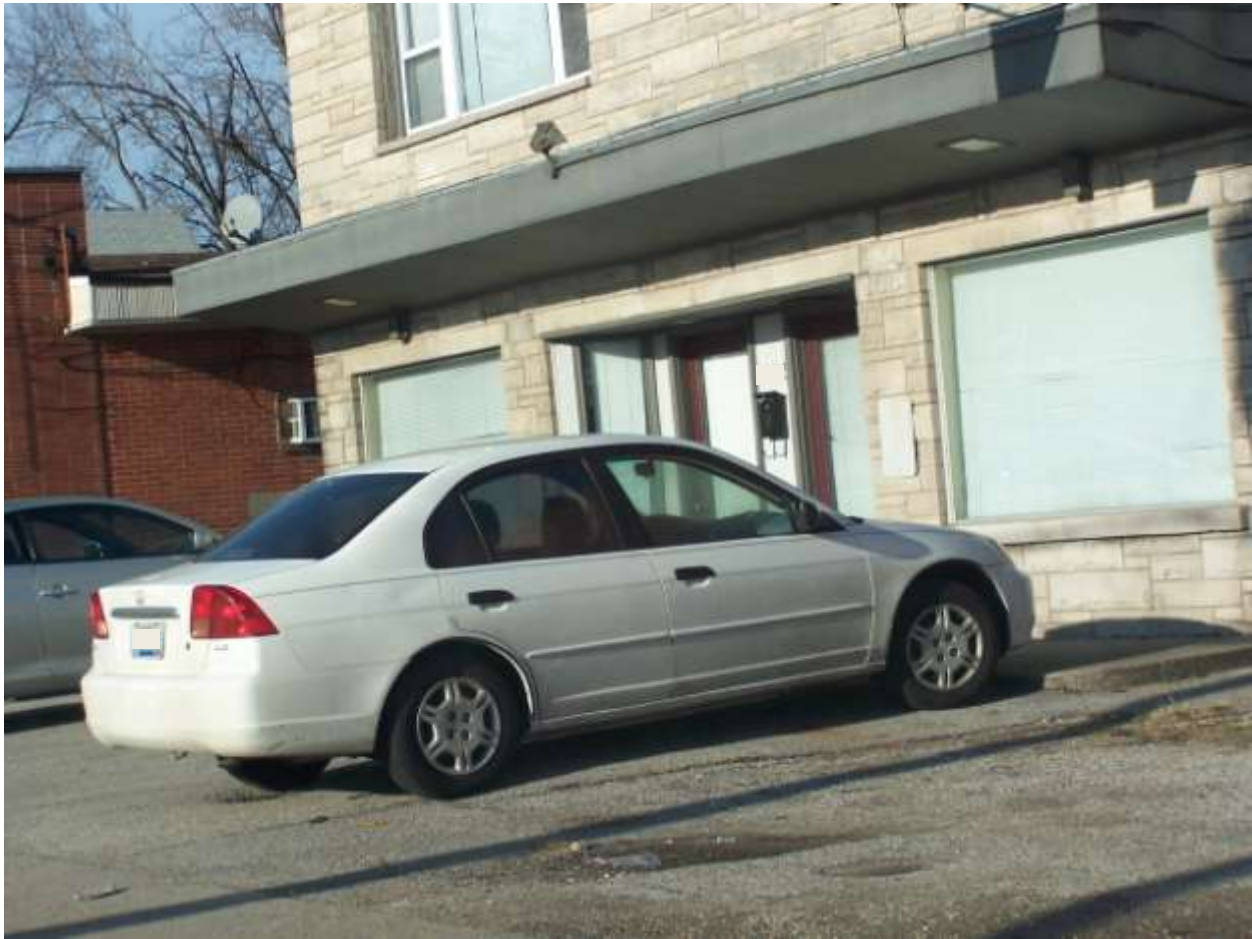
Photograph of shop. Photograph courtesy of KY FACE.

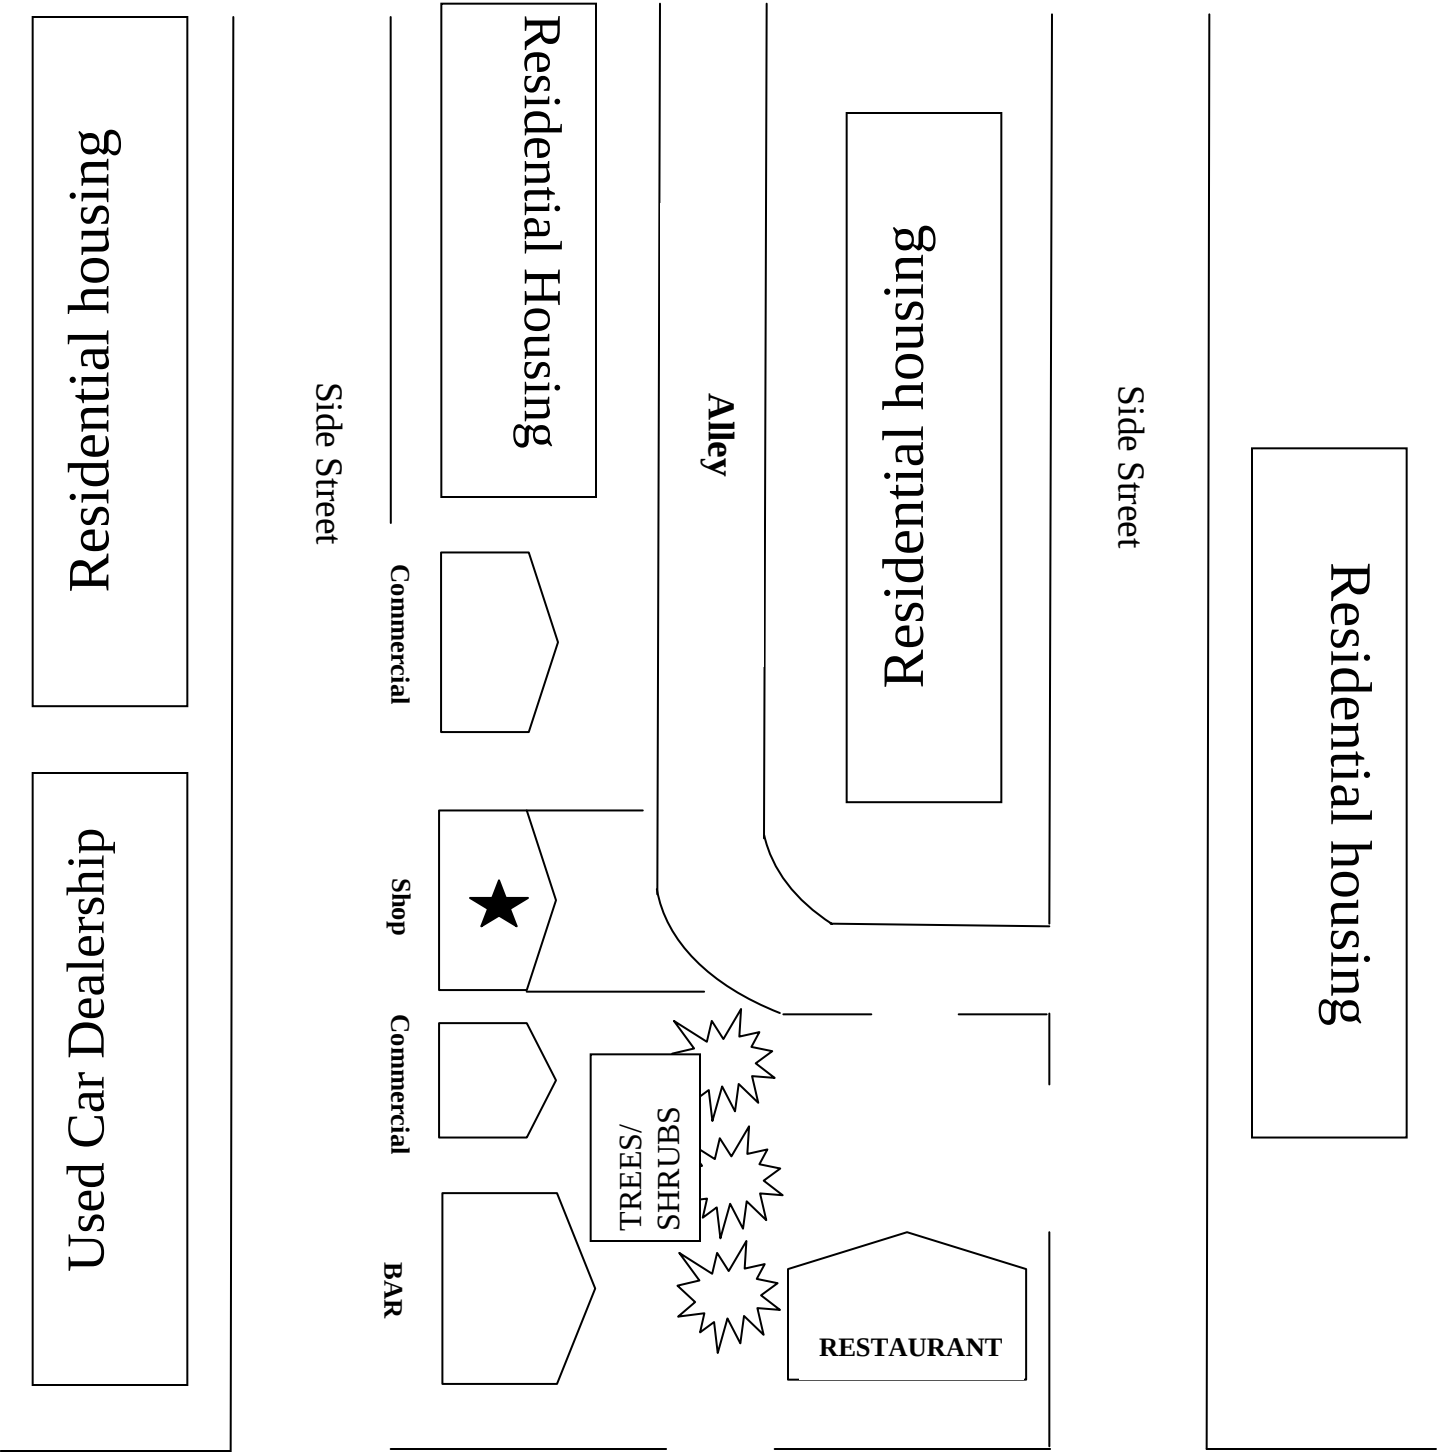
Diagram 1

The shop was the only occupant of a two story building located on a side street next to a major four lane highway in a neighborhood that was zoned residential and commercial. It was the third building north of the corner and on the east side of the street. On the southeast corner was a neighborhood bar and liquor store. Behind the business was a paved parking lot with company-restricted access where company-owned trucks were parked. The lot was enclosed, and secured by chain-link fence with privacy webbing. A gate surrounded the back lot of the shop, faced east, was secured with a chain and padlock, and opened into a curve in an alley that ran behind the shop. The alley behind the shop ran from a cross street to the north (left) of the lot, made a curve to the east, and ended at the next street (Diagram 1). To the north of the gate, another commercial building and private residences backed up to both sides of the alley; east of the gate, a fast-food establishment's parking lot had ingress/ egress to the alley. The corner bar did not have ingress/ egress to the alley.
