# MIFACE INVESTIGATION REPORT: #08MI001

## SUBJECT: Pipe Technician Killed by Coke Oven Gas Pipe Explosion

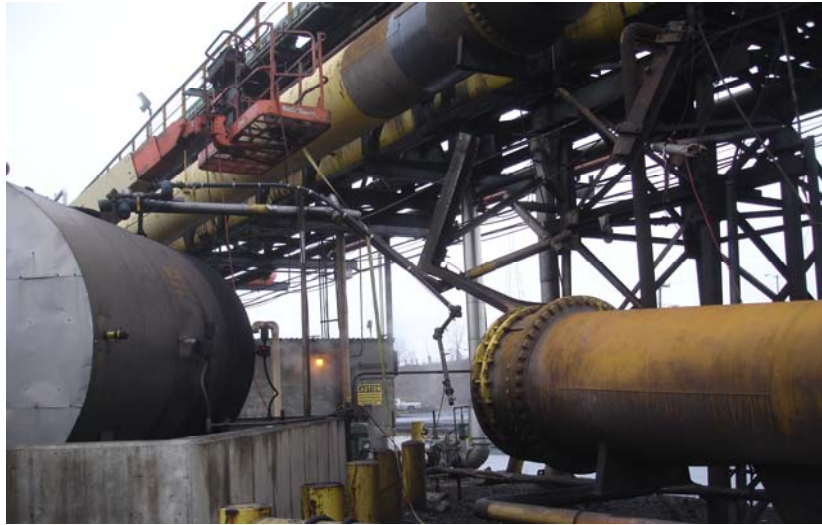
Figure 1. Incident Scene. 54-inch pipeline blown apart, area where patch repair occurred, and man lift used to elevate workers to pipeline repair area

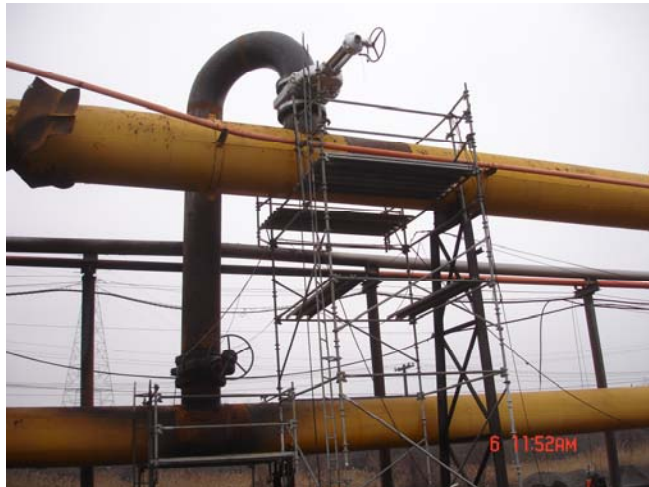
Figure 2. Example of bypass piping

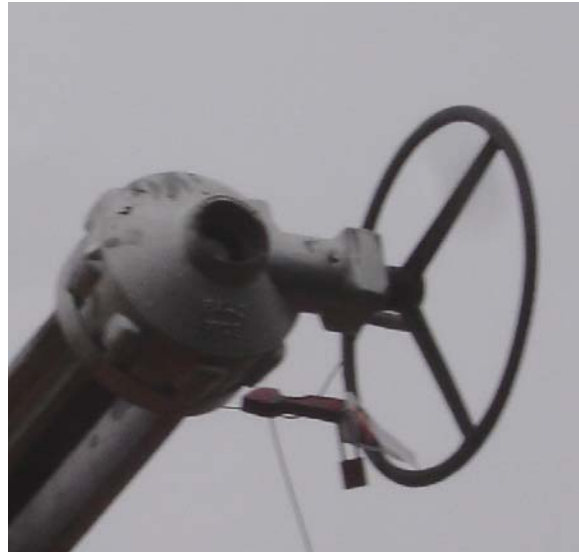
In the late afternoon on the day before the incident, the subcontractor hooked the last section and gate valve to the 54-inch dead pipeline. The four isolation/gate valves were in the closed position and only the locks of the site owner were in place (Figure 3). One of the decedent's coworkers tested the 54-inch line for flammable gas using the site owner's air monitor. Results were negative for flammable gasses. The crew supervisor installed the site owner's locks on the bypass valves at south end of the 54-inch pipe and placed the control keys for the locks in lock-

Figure 3. Site owner lock on valve

Although it is known that flammable gases must have been present in the 54-inch pipeline, the mechanism of how the gases got there is unknown. The site owner did not apply the site owner locks. The decedent's employer applied the site owner locks, whose lockbox for the keys was in one of the site owner's trailers. It appears that all pertinent valves were closed and locked out using the site owner locks. It is unknown if at some time these locks were removed and the valves opened and then shut and relocked. The decedent's employer did not place their locks on the valves to ensure the valves stayed closed. If the decedent's company had placed their locks on the valves and kept the keys in a secure area in their trailer, this would have provided an added assurance that the valves would not be opened without the knowledge of the decedent's employer's workers.

- Employers who are performing work on machines or equipment where unexpected energization, start-up or release of stored energy could occur and cause injury should always place their own lock(s) on the machinery/equipment if their workers are scheduled to be the first to perform work.

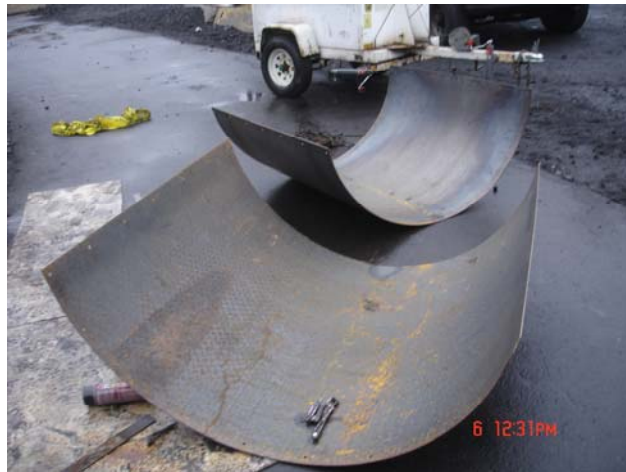
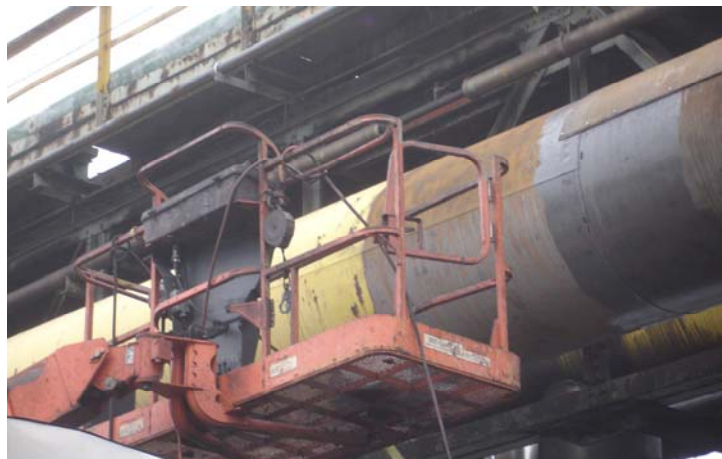
Figure 4. Gasketed steel cladding

Three gasketed steel cladding patches were to be installed on the 54-inch pipeline to cover leaks (Figures 4 and 5). The crew foreman and the ground man worked on activities while on the ground under the pipeline. The decedent and his two crewmembers on top of the pipeline were making patch repairs on the 54-inch pipeline by bolting the gasketed steel cladding to the pipe using pneumatic drilling tools. The work crew did not bleed, purge, or perform air monitoring of the 54-inch line prior to beginning the day's repair activities. The carbon monoxide (CO) monitors the crew wore on their jackets did not indicate any exposure to CO was occurring while they were performing the work. The crew completed one patch installation and then stopped for lunch at approximately 12:00 p.m.

Figure 5. Gasketed steel cladding patches and man lift

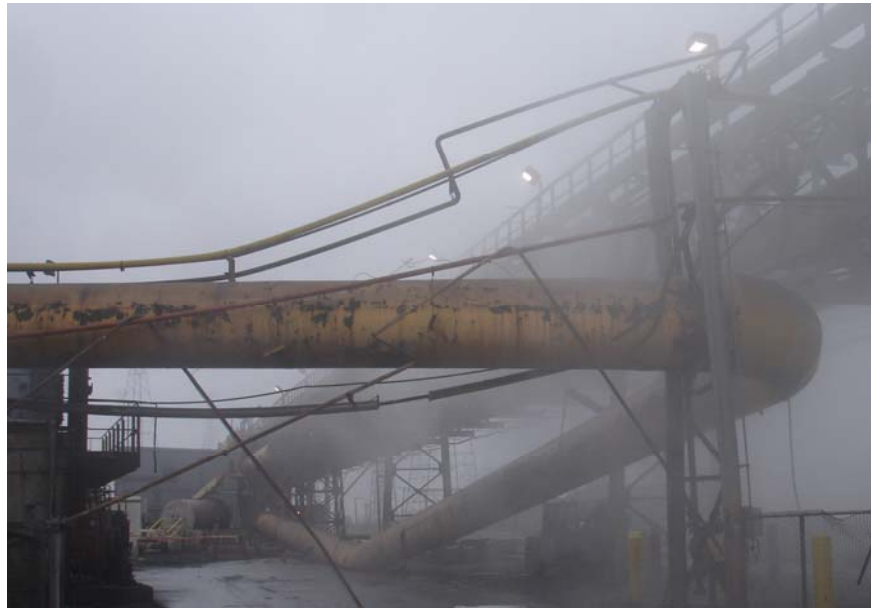
Figure 6. Incident scene shortly after explosion and fire

apart. The north piece of 54-inch pipe fell to the ground. The pressure release caused a large cloud of dust (Figure 6). A loud noise was heard by all of the crewmembers. The force of the explosion caused the decedent to be blown backwards with tremendous force, causing life-ending injuries.

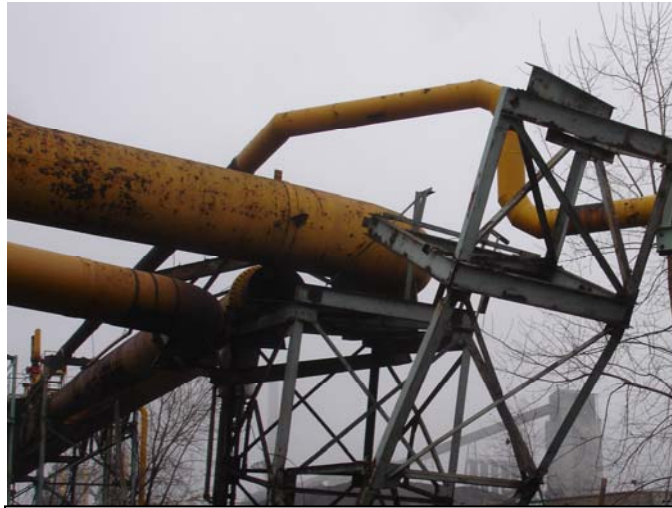
The site owner's area utilities manager walked the area after the explosion and found all four bleeder valves in the closed position. He also noted that the four main gate valves were in the closed position and were cabled and locked. The force of the explosion caused a blank to travel down the length of the 54-inch pipe and break through the end of the pipe (Figure 7). The blank fell to the ground.

Figure 7. End of pipe where blank exited
