# MIFACE Investigation Report #08MI015

## Subject: Construction Worker Dies From 69-Foot Fall Through Roof Opening

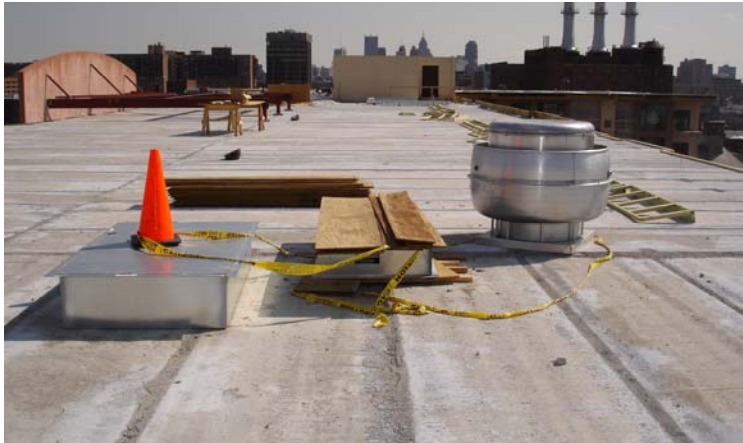
In the winter of 2008, a 19-year-old male construction worker fell from the roof of a five-story building through a 26-inch by 24-inch make-up air opening of an elevator shaft (chase) to the concrete floor of the basement. Another contractor had placed a metal roof curb measuring 72 3/4-inches long by 40 3/4-inches wide by 14-inches high over the make-up air opening, but did not secure it to the roof. There was no marking either on the roof or the roof curb indicating the open shaft below.

Figure 1. Make-up air roof curb with orange pylon, exhaust fan roof curb with plywood, looking south on roof

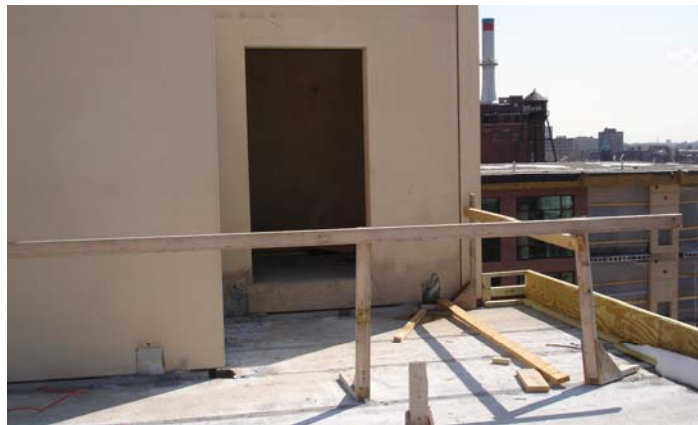
Figure 2. Guardrails at stairwell opening

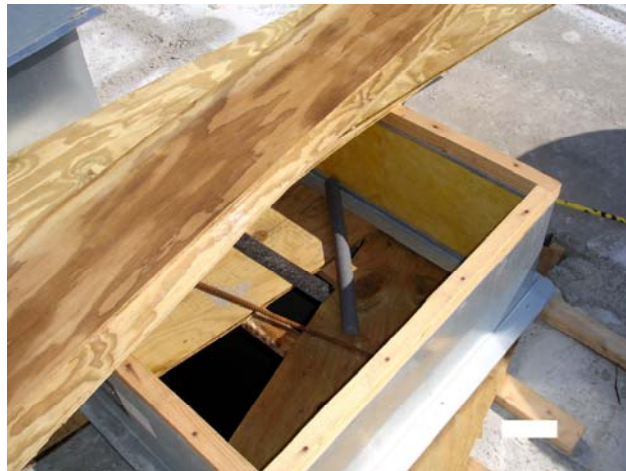
Chase A exhaust fan hole which is approximately 34 inches long by 24 inches wide has a cover created with loose 2x4 lumber supporting loose plywood. The loose exhaust fan roof curb is upon the cover.

At Chase A, Contractor C cut the exhaust fan and make-up air openings. Contractor D stated he did not secure the roof curbs at both the exhaust fan and make-up air openings. He placed the make-up air roof curb upside down to prevent the insulation from getting wet. The exhaust fan roof opening was "covered" with unsecured 2x4 lumber and plywood (Figure 4).

Figure 4. Chase A exhaust fan hole with 2x4 lumber and plywood boards as cover

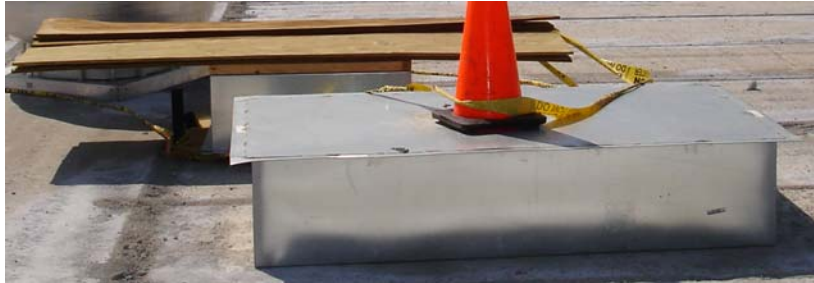
Chase A make-up air hole 26 inches long by 24 inches is covered with the make-up air roof down revealing a solid metal bottom 14 inches above the roof.

Figure 5. Close-up view of make-up air roof curb with cone, exhaust fan roof curb with plywood, looking west

It appears that the decedent was attempting to move the unsecured hood of the make-up air opening south to anchor the loose plywood sheets (Figures 5 and 7). He lifted the hood and apparently did not check under the hood before moving south in an attempt to push the hood to the plywood stack. Unbeknownst to him, the hood covered an open make-up air shaft. As he was walking, he walked directly into the open air shaft and fell five stories to the concrete floor.

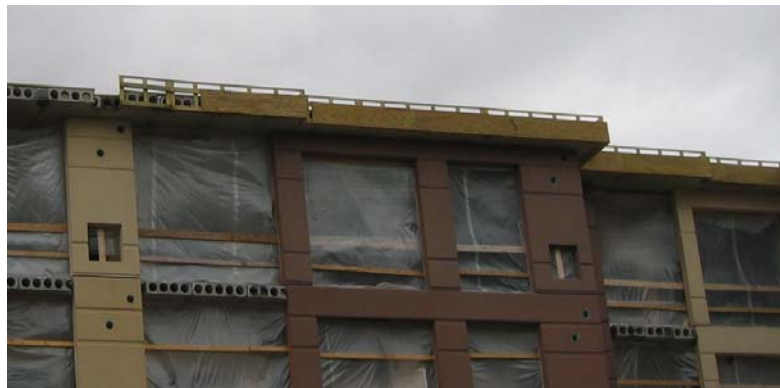
Figure 6. Example of parapet work construction

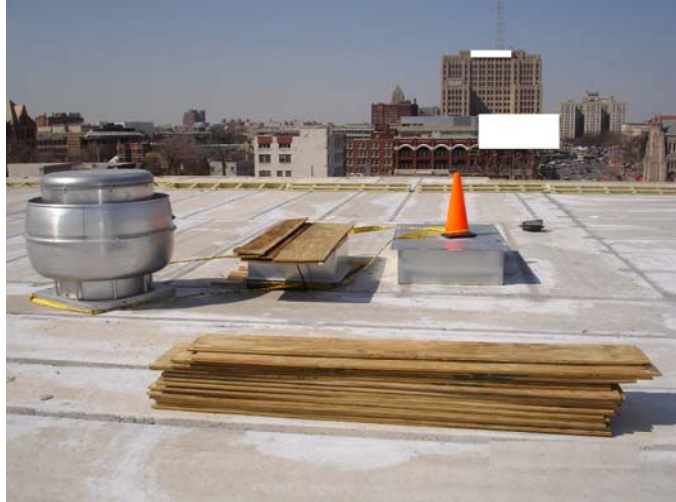
Figure 7. Make-up air roof curb with orange pylon, exhaust fan roof curb with plywood, looking north on roof

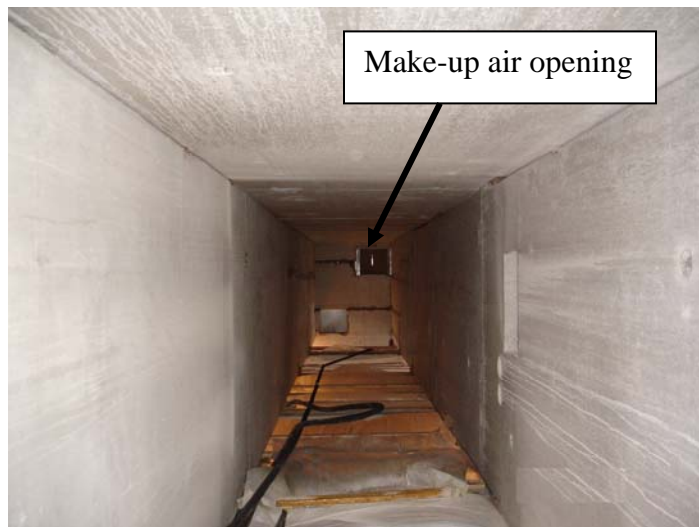
The company owner ran to the side of the roof to see if the decedent fell from the roof edge. When he did not see him, the company owner ran north toward Chase A. At the make-up air roof opening, he found the decedent's hard hat approximately two to three feet north of the opening. He looked down the opening and saw the decedent approximately 69 feet below at the bottom of shaft, which was 7 feet 11 inches long north to south by 6 feet 3 inches wide east to west. The Figure 8 shows the exhaust air opening and make-up air opening in Chase A (taken by the compliance officer while standing on the basement floor).

Figure 8. Chase A openings as seen from the basement, facing east
