Fatality Investigation Report

OR 2007-57-1

Temporary mill worker killed in fall down manlift shaft

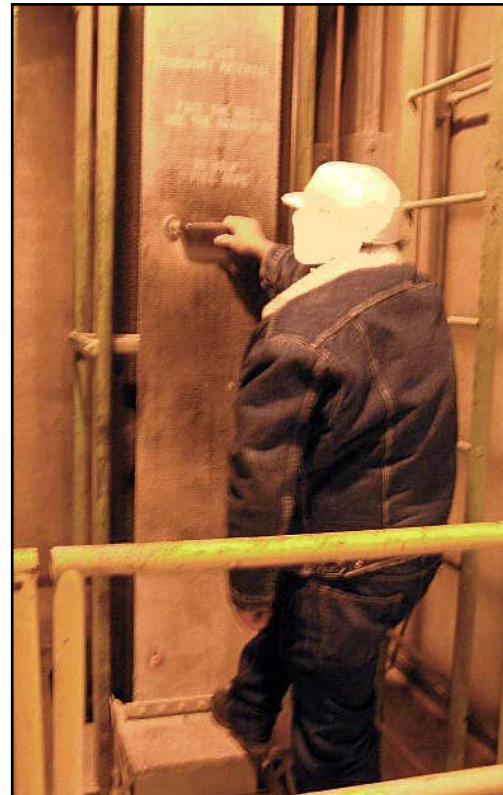
A worker at the mill demonstrates use of the manlift to ride between floors.

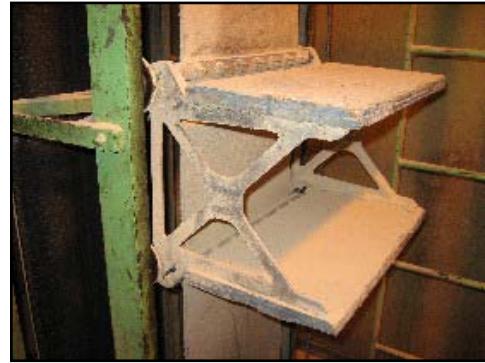
A close-up view of a platform step on the manlift shows the metal framework on the left and emergency ladder on the right.

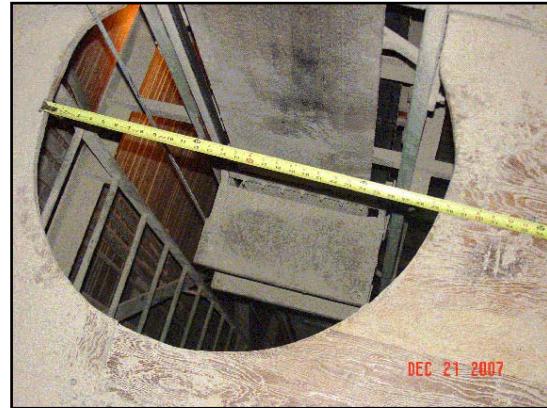
The victim fell through this manlift shaft opening. A platform step is shown on the lift belt, and the fixed ladder and stop cord at left.

1. The cleaner may have tripped on the way to the access shaft down, and fallen with his head over the hole; a descending step then struck and pulled him down the shaft. A fracture on the right side of his face above the right eye indicates he may have been knocked unconscious.
2. The cleaner may have misjudged the handhold while stepping onto the downside manlift, causing him to fall.

Recommendation #1. Workers must follow safe procedures when using a manlift.

Manlifts are for people only. Materials or equipment must not be transported on a manlift. Although the details in this event are uncertain, the broom may have contributed to the fall. The worker evidently brought the broom with him inside the gate surrounding the manlift shaft, and it could have caused a tripping hazard near the moving belt.

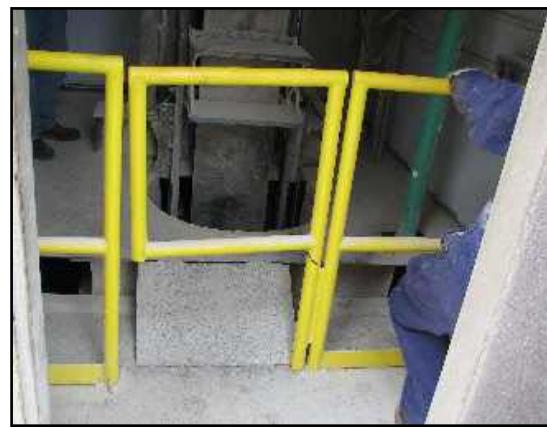
A gate guarded the manlift floor openings. At one opening, a raised plywood floor was spongy when walked upon, reducing secure footing.

Exposed bolt heads protruding one-half inch above the floor in the area of the second-floor manlift shaft presented a tripping hazard that may have been a factor in this incident. On another floor, an elevated, spongy plywood floor with a ramp to the manlift shaft also presented a tripping hazard. This incident emphasizes the importance of making sure the floor area around a manlift shaft is flat and solid, and clear of obstructions.

Recommendation #5. Employers must ensure landing surfaces for manlifts are clear and provide safe footing.
