# MIFACE INVESTIGATION REPORT: #08MI003

## SUBJECT: Steel Mill Supervisor Pulled From Catwalk by Contact with Belt Conveyor

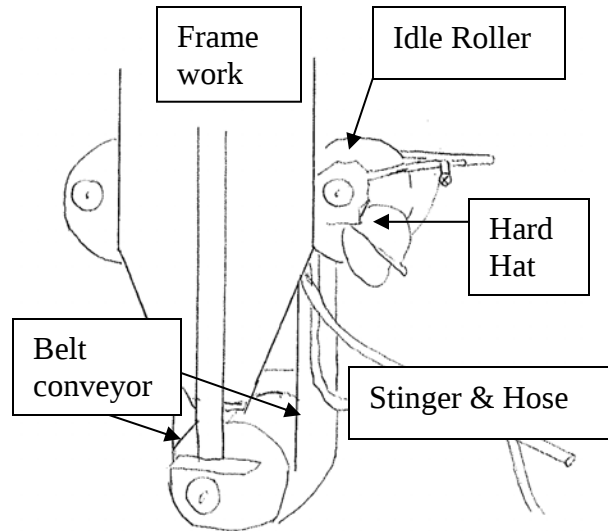
Drawing 1. Belt conveyor drawing illustrating resting point of decedent's hard hat and location of stinger/air hose

decedent had fallen and was lying face down. The air hose and stinger was found between the conveyor belt and the tension roller at the topside of the tension roller. The stinger was bent around the roller and several feet of hose was looped under the conveyor belt north of the roller. The air hose shut-off valve was bent. The decedent's hardhat was caught between the east edge of the idle roller and support frame with his helmet liner and respirator hanging from the hard hat.

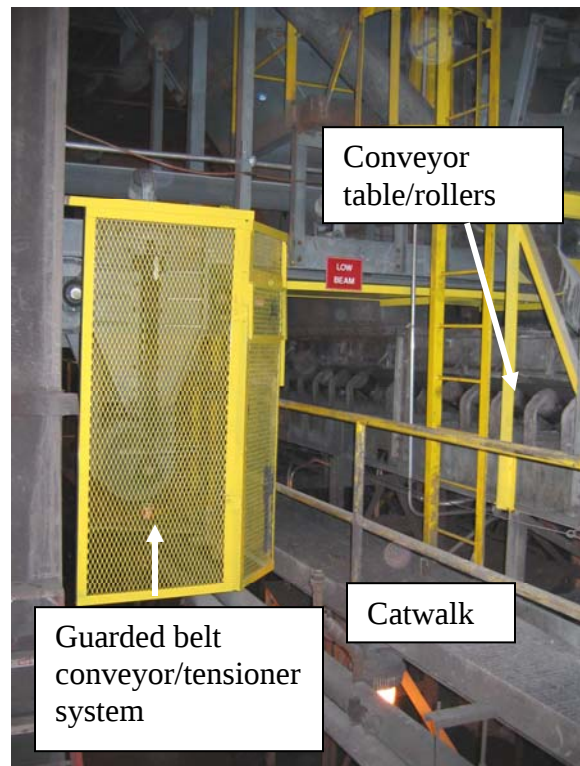
Figure 1. Overview of work area

above the charger room floor. Access to this conveyor was provided by stairs leading to a catwalk that ran parallel to the conveyor table/rollers. The catwalk was approximately 132 inches above the floor. The catwalk had a standard 42-inch barrier (Figure 1). The belt conveyor into which the decedent was pulled was 22 inches wide. This conveyor first traveled parallel to the catwalk and then turned and traveled in a perpendicular direction above the catwalk. At the location where the catwalk passed under the belt conveyor, a warning sign identified a low beam approximately 66 inches above the catwalk. At the low beam area, the tensioner for the belt conveyor turned downward from above the catwalk. The tensioner system was 25 inches from the catwalk rail (Figure 2). At the time of the incident, the belt conveyor and tensioner system was unguarded.

Machine guarding is required by MIOSHA General Industry Safety and Health Safety Standard, Part 14, Conveyors, Rule 1442 (2): *A nip point at a pulley shall be guarded by an enclosure or barrier constructed to prevent access by an employee's body members or loose clothing.* After the incident, the employer had installed a fixed metal guard to shield the area and prevent employee contact with the conveyor belt/tensioner system (Figures 1

and 2). The guard was designed and installed so an employee could not reach behind it and get caught in the in-running nip point.

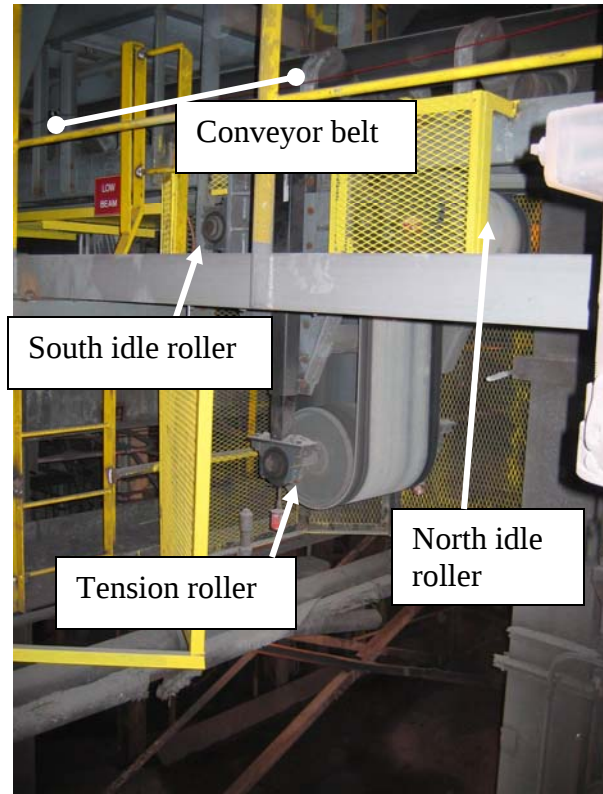
Figure 2. Conveyor belt tensioner system and catwalk work area

There were two idle rollers above and on each side of the tension roller. The north idle roller was involved in the incident. The tension roller was located at the bottom point between the two idle rollers. The tension roller was adjustable for the amount of slack created when the conveyor belt stretched.

The incident was unwitnessed. It appeared that as the decedent passed under the low beam and conveyor belt with the stinger/air hose unit on his shoulder, the air supply hose and/or stinger were caught in the conveyor belt/tensioner north idle roller. The movement of the belt caused the hose and stinger to be pulled between the conveyor belt and idle roller. Unable to react quickly enough, the decedent was also pulled from the catwalk and struck the structural support of the tensioner system. The decedent struck the support with sufficient force to wedge his hardhat between the tension roller and support framework before his body dropped over the railing to the floor below.

- Employers should provide guards on conveyor belts at all in-running nip points where employees may be at risk of coming into contact with moving/rotating parts.

Although not required to be shut down and locked out, the fatal incident could have been prevented if the unguarded conveyor/tensioner system had been shut down and locked out prior to beginning the cleaning operation. Because of the ever-present danger of entanglement when working near unguarded moving machinery components, employers should continually strive to protect employees by providing machine guarding in the areas where work is actually performed. The decedent, while cleaning the conveyor table/rollers with the 10-foot stinger apparently contacted the adjacent belt conveyor, which had no guarding to prevent contact with the conveyor's belt/tensioner system. The in-running nip point formed by the belt tensioner system was just 25 inches away from the catwalk that was designed to provide access to both Conveyor A and Conveyor B. As the stinger/air hose became entangled, he was unable to release the stinger before he was pulled into the conveyor system. A guard that prevented inadvertent contact with the moving conveyor belt would have prevented the decedent from coming into direct contact with the adjacent conveyor's belt. An interlock to interrupt power to the conveyor when the guard is disabled would provide additional safety.

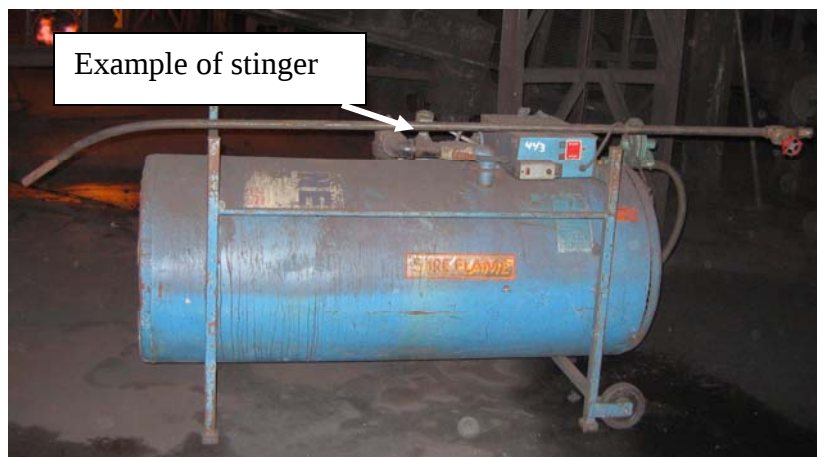
Figure 3. Tornado heater with example of stinger resting on top

it would not be necessary to turn off the belt conveyor because the crew would not be near the tensioner. The building supervisor accompanied the crew to the area where the conveyor and catwalk were to be cleaned of coke rocks and debris. The building supervisor then shut off the conveyor table to be cleaned but left the belt conveyor operational. Because of the time of year, the tornado heaters being used to heat the building were contributing to the noise level in the building (Figure 3).
