Massachusetts FACE Occupational Fatality Report

Laborer Struck by Skid-steer Loader While Exiting from a Tarp-enclosed Area on a Construction Site - Massachusetts

Investigation: # 07-MA-019-01

Release Date: July 28, 2008

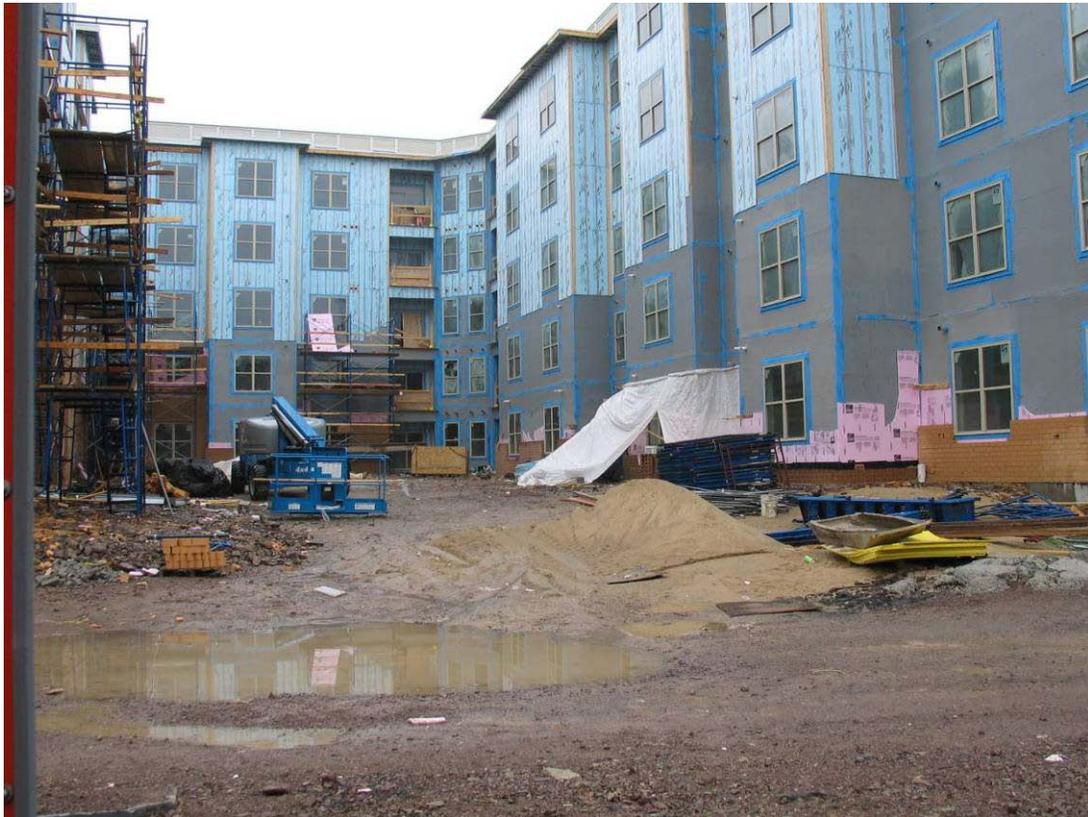
At the time of the incident, the company had approximately 14 people on-site and was performing brickwork on the exterior facade of a building (Figure 1). The victim's main job was to mix and supply mortar to the masons. These tasks involved the use of a large mechanical mixer to mix the mortar and the use of a wheelbarrow to transport the mortar to the masons' location.

The incident occurred a few minutes after 8:00 a.m. on a Monday morning. The weather conditions at the time of the incident consisted of temperatures around 40°F with an average wind speed of 16 miles per hour and no precipitation. The incident location was next to a building that was nearing completion. One section of tubular welded scaffolding was set up against the building and was enclosed by two blue tarps. The scaffold was being used as a supporting structure for the tarps that were set up to protect the work area and the workers from the environmental elements (Figure 1). There was no designated entrance or exit location to the tarp-enclosed area. Entering or exiting this area required the lifting of the bottom of the tarp and crouching down to get underneath the tarp.

At the time of the incident, the victim was exiting the tarp-enclosed area with the wheelbarrow to fill the wheelbarrow with mortar. The mortar mixing machine was located approximately 20 feet to the west of the tarp-enclosed area. The victim was crouched down close to the ground lifting up the bottom of the tarp while backing out from underneath the tarp-enclosed area and pulling the wheelbarrow with him at the same time. The victim, in the crouched position, was struck and run over by the skid-steer loader as it passed parallel to the tarp-enclosed area.

**Figure 1 – Similar location of the incident.
The tarp attached to the building without the scaffolding support.**

Recommendation #1: Employers should ensure that tarp-enclosed areas have designated entrance/exit openings for workers.

Discussion: In this case, the victim and other co-workers would enter and exit the tarp-enclosed area multiple times during the day. This entailed the workers crouching down to lift up the bottom of the tarp and then crawling out. Inexpensive entrance/exit openings that still provide protection from the environment can easily be installed in tarps. One type of opening is the chamber type design. This typically consists of a vertical slit in the tarp with three foot wide strips of tarp material attached to the top of either side of the tarp covering the slit. Another option that could be used is a heavy duty tarp zipper. These zippers are self adhesive and can be installed vertically.

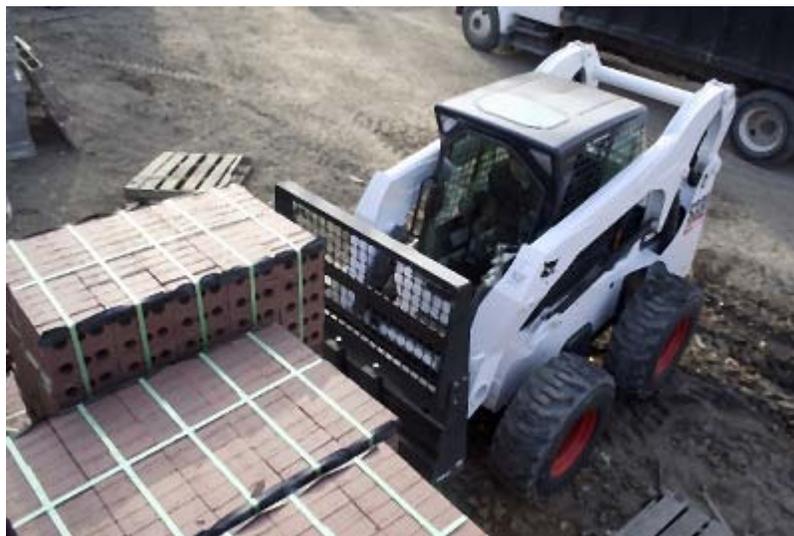
The masonry company reported that they had two large pieces of equipment on-site at the time of the incident, a lull and a skid-steer. The lull was a rented piece of equipment, and the skid-steer loader, the equipment that was involved in the incident, was owned by the masonry company. The skid-steer loader, manufactured in 2004, is powered by a diesel engine and has rubber tires (Figure 2). Without attachments, the skid-steer loader is approximately ten feet long, six feet wide and over six feet high (to the top of the cab). The cab of the skid-steer loader completely encloses the seated operator. At the time of the incident, the fork attachment was being used on the skid-steer loader to transport bricks and blocks on pallets to the different areas of the construction site.

Prior to the incident, the victim was inside the tarp-enclosed area and a co-worker was operating the company's skid-steer loader in the forward direction. The co-worker was driving the skid-steer loader parallel to the tarp-enclosed area to load a pallet of bricks onto the skid-steer loader's forks. The pallet of bricks was located approximately 50 feet north of where the incident occurred. The skid-steer loader's forks were in a lowered position and did not have a load on them at the time of the incident.

Figure 2 – Skid-steer loader similar to the one involved in the incident.

Recommendation #5: Employers should ensure that employees operating skid-steer loaders have the required state-issued hoisting license.

Recommendation #6: Employers should provide employees training on the operation of skid-steer loaders and other equipment.
