Utility Construction Supervisor Killed When Struck by a Pickup Truck at a Work Zone in Washington State

FATALITY INVESTIGATION REPORT

Investigation: # 02WA03401
SHARP Report: # 52-13-2005

Release Date: July 29, 2005

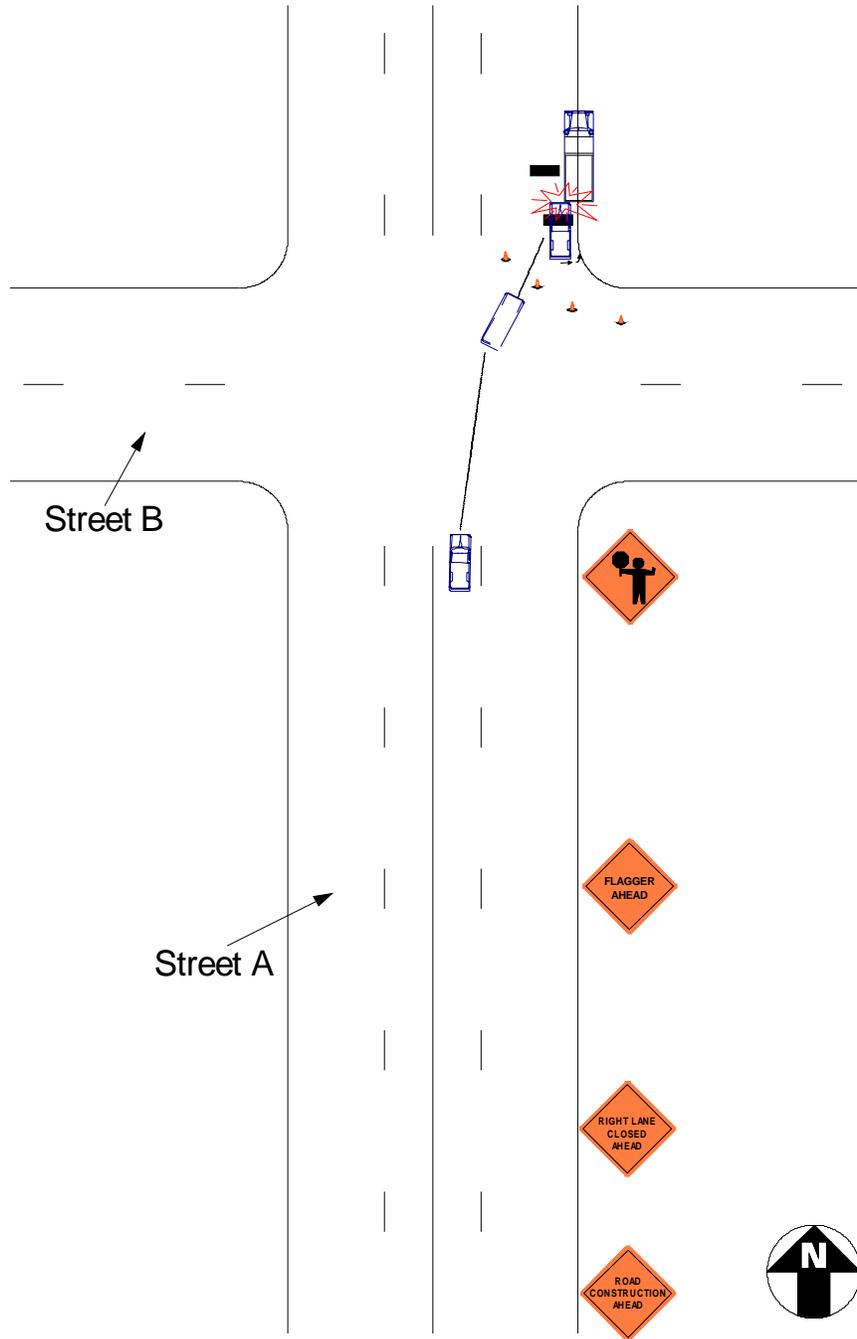
The work zone occupied the parking lane of both street (A) and (B) at the northeast corner of the intersection between the two streets. The work zone impacted the motorists traveling west on street (B) and those traveling on the inside lane heading north on street (A). Please refer to figure 1 and photo 1 for views of the incident area.

No existing line was found that could be used, so the crew had to run a new line and dig out a section of pavement. They cut out a section of asphalt that extended from the curb at the corner of streets (A) and (B). The work crew then excavated the cut-out area to expose the natural gas line main, running along street (B), and were in the process of making the natural gas connection at the time of the incident (see figure 1).

The excavator dug a narrow trench extending from the side walk curb into the parking area along street "A". The trench was about 2 ½ to 3 feet deep, about 8 to 10 feet long and about 4 feet wide. Their crew's dump truck was parked just north of the trench, straddling part of the parking lane and the sidewalk along street "A" (see photos and figure 1).

The fire station was located only a couple of hundred feet from the work zone. The fire engine was stopped on street (A) facing south (see figure 1) waiting on oncoming traffic in order to make a left turn in order to cross the north bound lanes and head into the fire station. They saw the red pick-up strike the supervisor who was in the trench and also saw the co-worker who was standing near the trench go flying in the air.

Figure 1. Diagram of the incident area, streets and layout of the work zone.

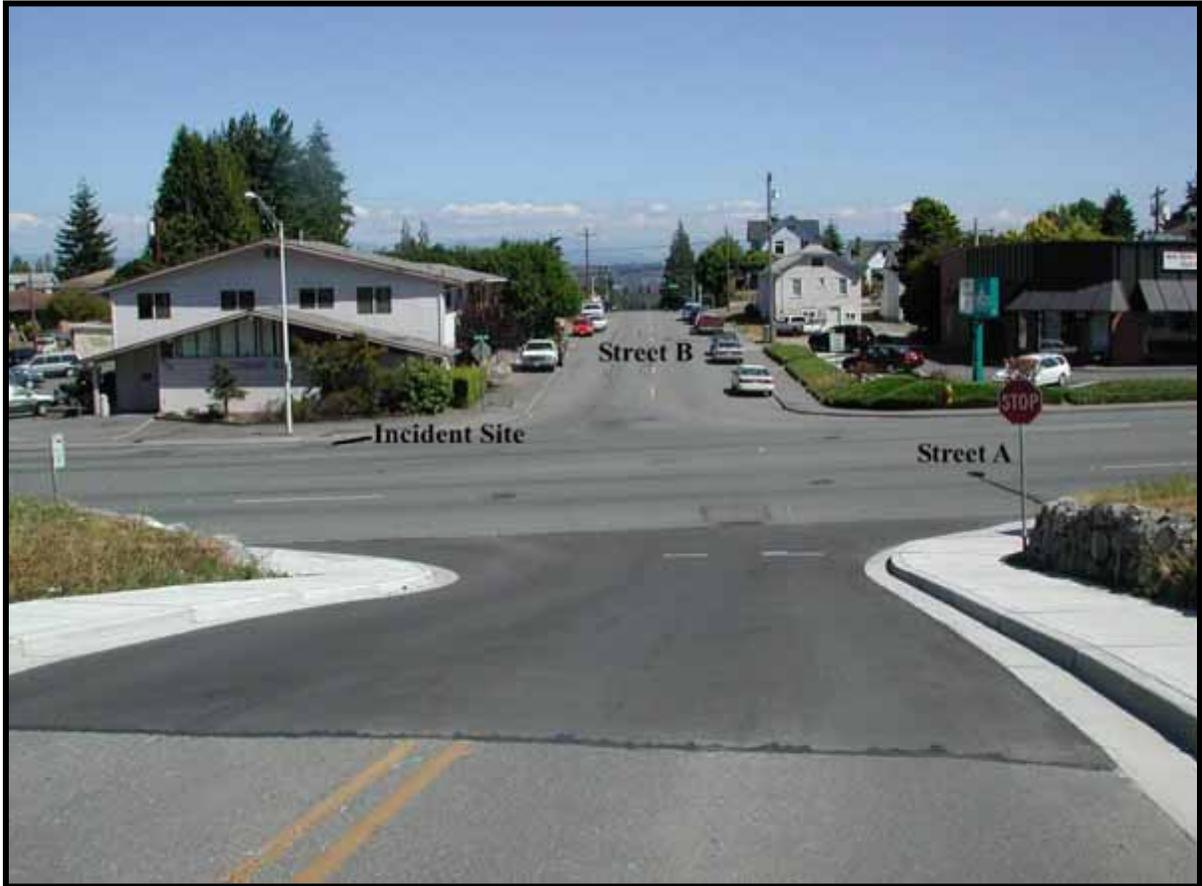
Photo 1: Shows the work zone incident site after completion of the job, and streets (A) and (B) in relation to the incident site (looking east).

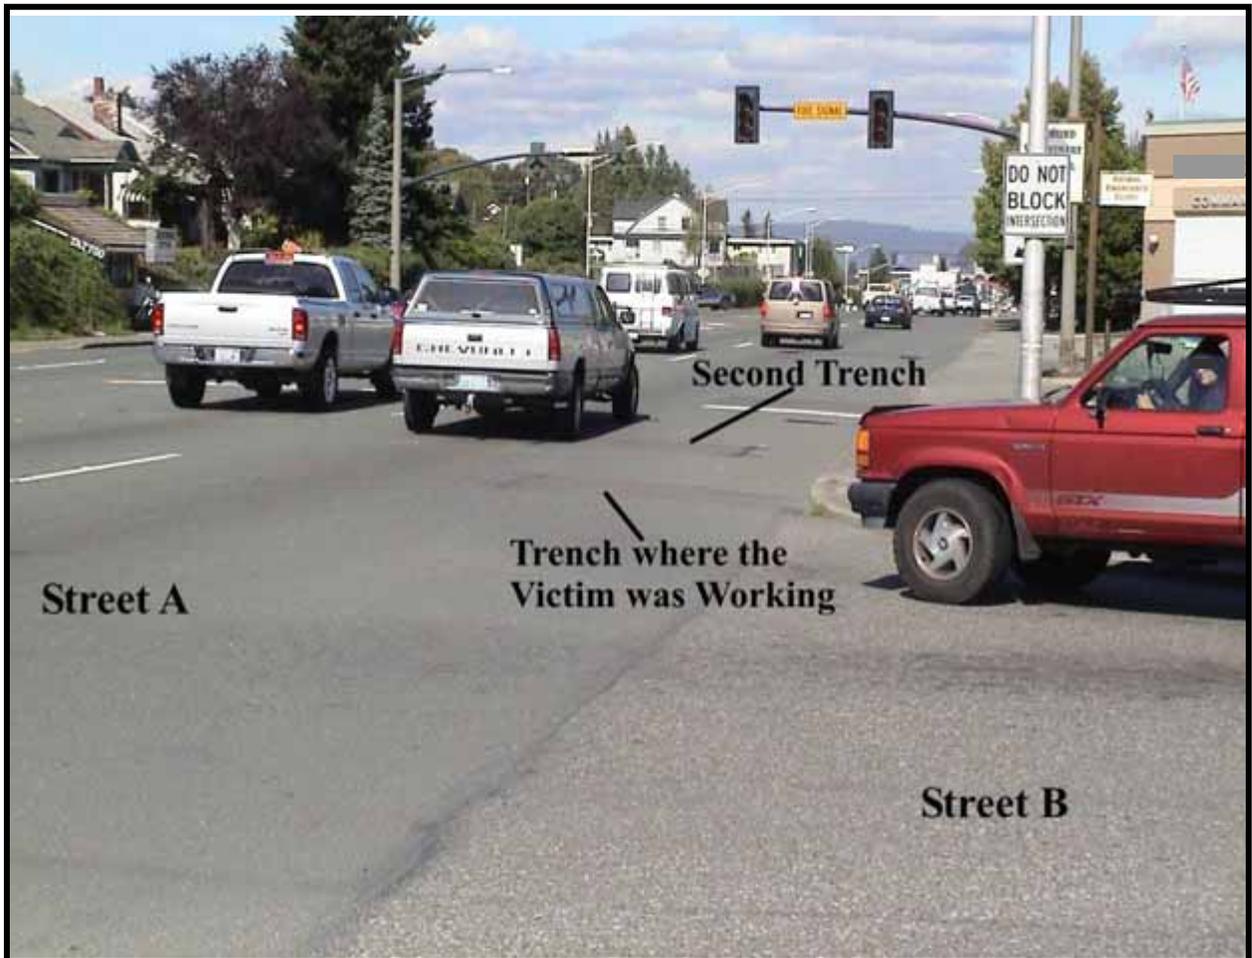
Photo 2: Shows the work zone incident site after project completion, and the intersection of streets (A) and (B) Near the work zone. The photo also shows the close proximity to traffic. The area in front of the trench and the area where the red pick-up truck is located were coned off to traffic (looking north).

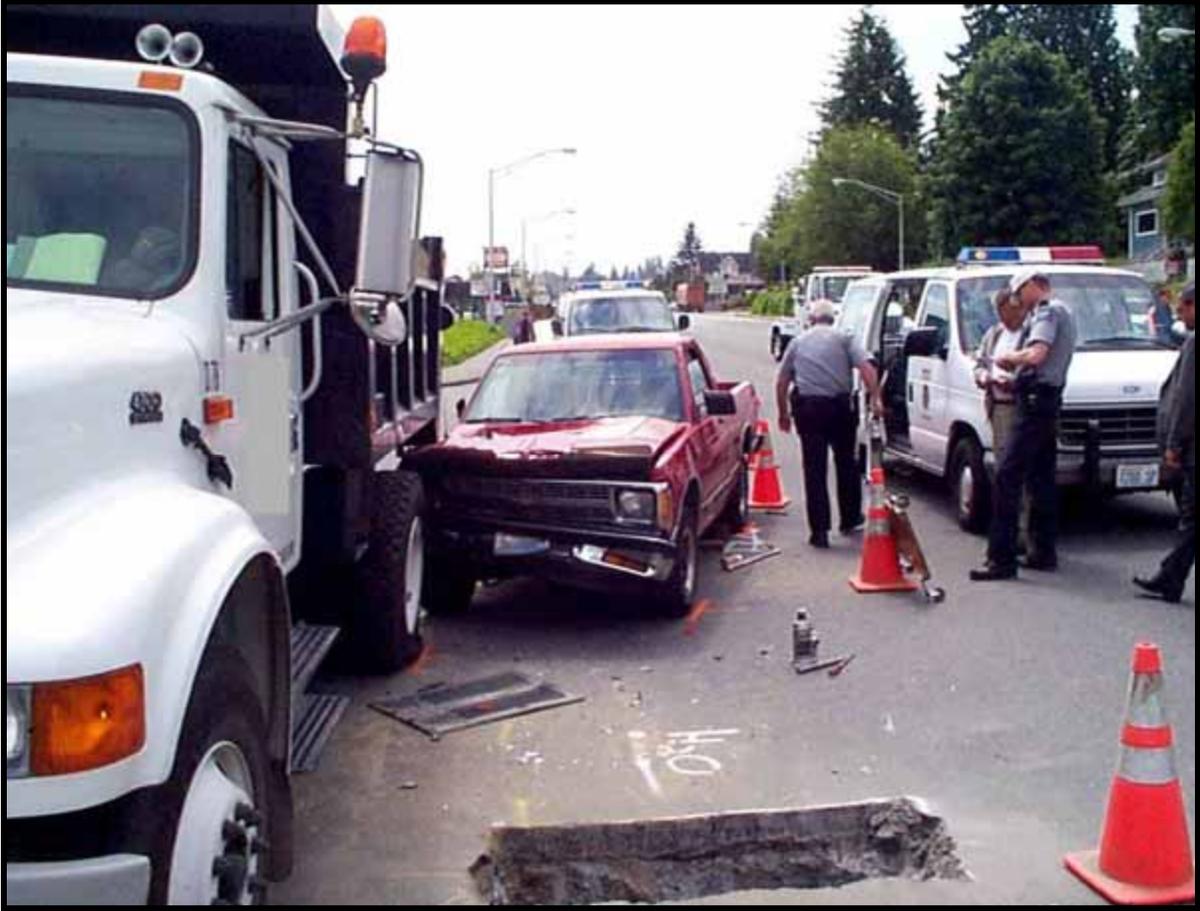
Photo 3: Shows the work zone incident site and the second trench. The trench that the workers were in is under the red pick-up truck (looking south along street A).

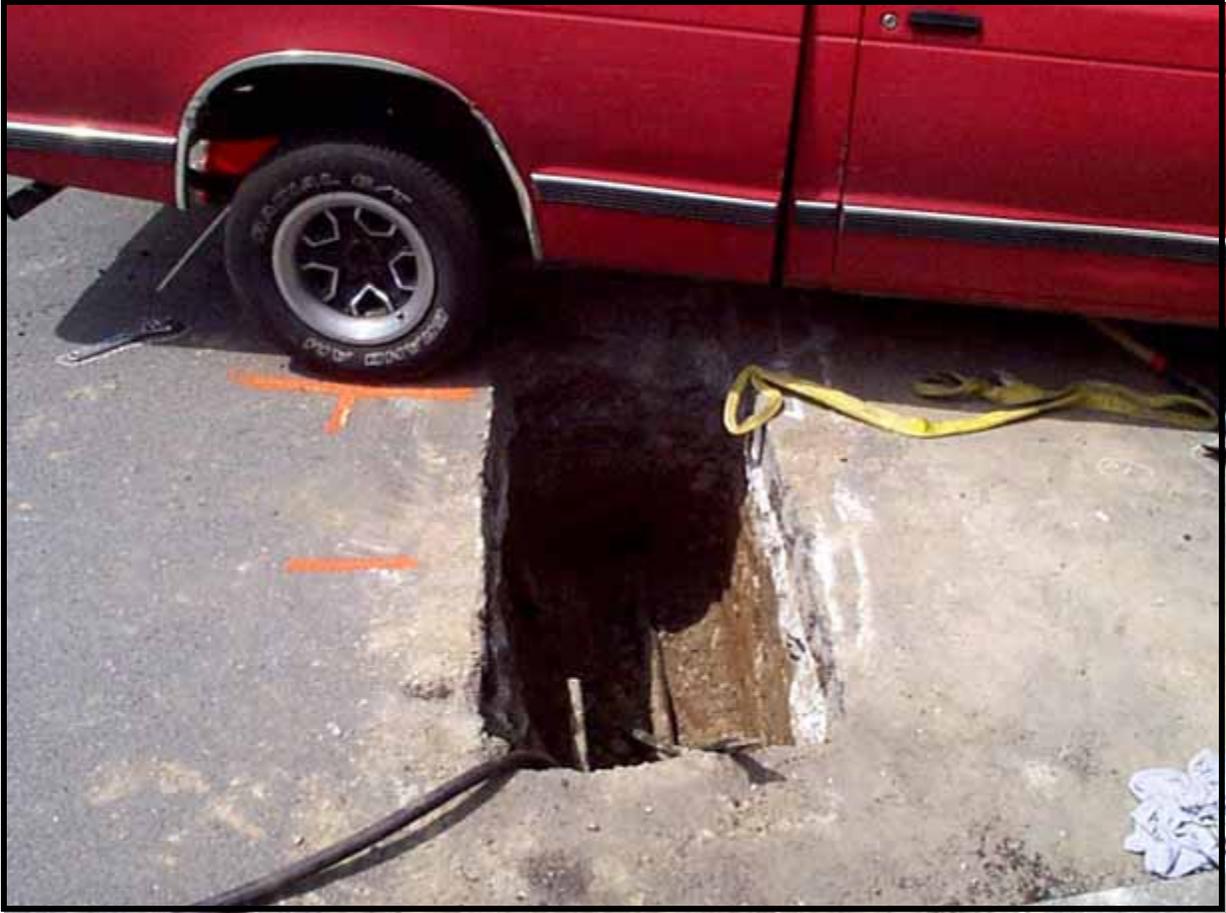
Photo 4: Shows the incident site, with the pick-up truck and the utility trench located along street (A) (looking west).
