# Temporary Construction Worker Dies After Falling from a Scaffold Plank in Washington State

## FATALITY INVESTIGATION REPORT

Investigation: # 02WA01901  
SHARP Report: # 52-16-2007

Release Date: June 25, 2007

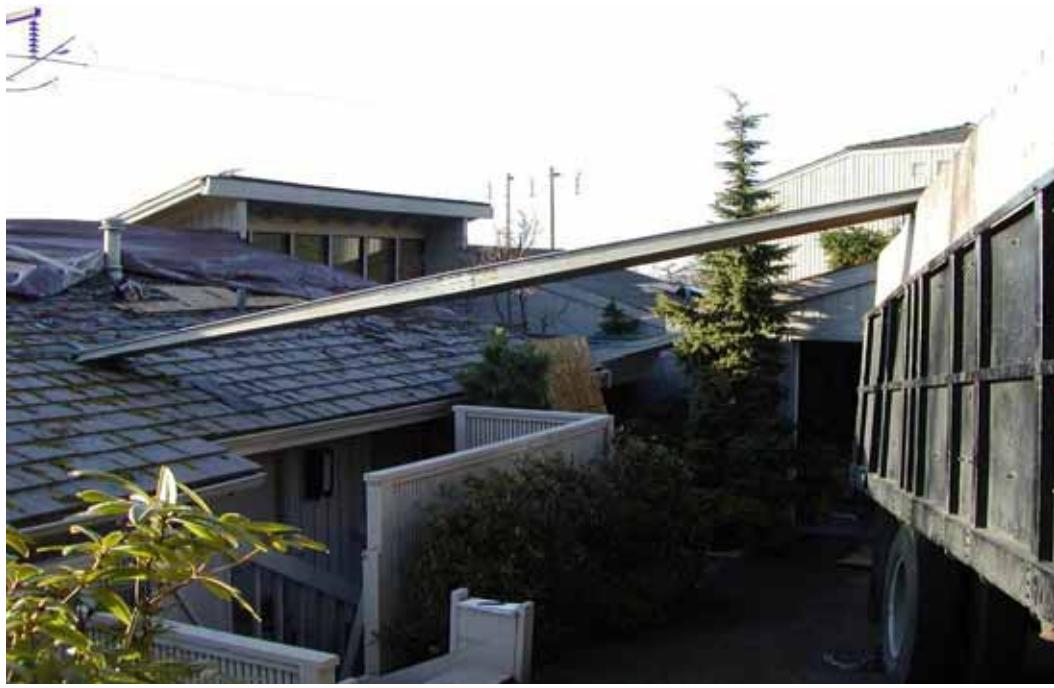
estimated that the plank was at an approximate 12° angle going up from the roof to the truck. The roofing contractor stated that he set up the walking-surface because he could not park the truck close enough for the workers to throw the debris into the truck from the roof.

The upward angle was created partially due to the topography of the property and the relationship of the elevated driveway to the residence located on a hillside. The angle of the plank was also dictated by the length of the plank. Because of the length of the plank, it had to be positioned lower on the roof in order for it to reach the side of the dump truck. This forced the plank to be positioned in an upward angle from the roof to the truck. (see photo 1).

The plank was used to facilitate moving the roof tear-off debris from the roof to the dump truck. The problem with this setup was that they used a narrow, unguarded scaffold plank to travel and carry debris from the roof to the dump truck, exposing the worker to a fall hazard during each trip. The manufacturer of the ladder-jack scaffold plank had not intended it to be used as a ramp, but had designed it to be a part of a ladder-jack scaffold system. The use of the scaffold plank as a walking surface/ramp in this case probably contributed in the death of the temporary laborer. This was the wrong tool for the job. An appropriate ramp would be designed with proper guardrails, walking width, weight-bearing capacity, and method of securement.

**Photo 1:** The job site after the incident, showing the plank from the roof to the edge of the truck bed.

To prevent deaths and serious injuries due to falls from elevation, employers/contractors should use a variety of preventive measures to help ensure the safety of their workers. In this incident a small bucket loader could have been rented by the roofer and positioned so that the bucket extended to the edge of the roof to collect debris removed from the roof tear-off. Then when the bucket was full it could dump the contents into the back of the dump truck. In some instances, with the right topography and access to the building, the roofing contractor could use a chute extending from the roof into the debris truck. The workers would then dump the roof debris directly down the chute into the truck.

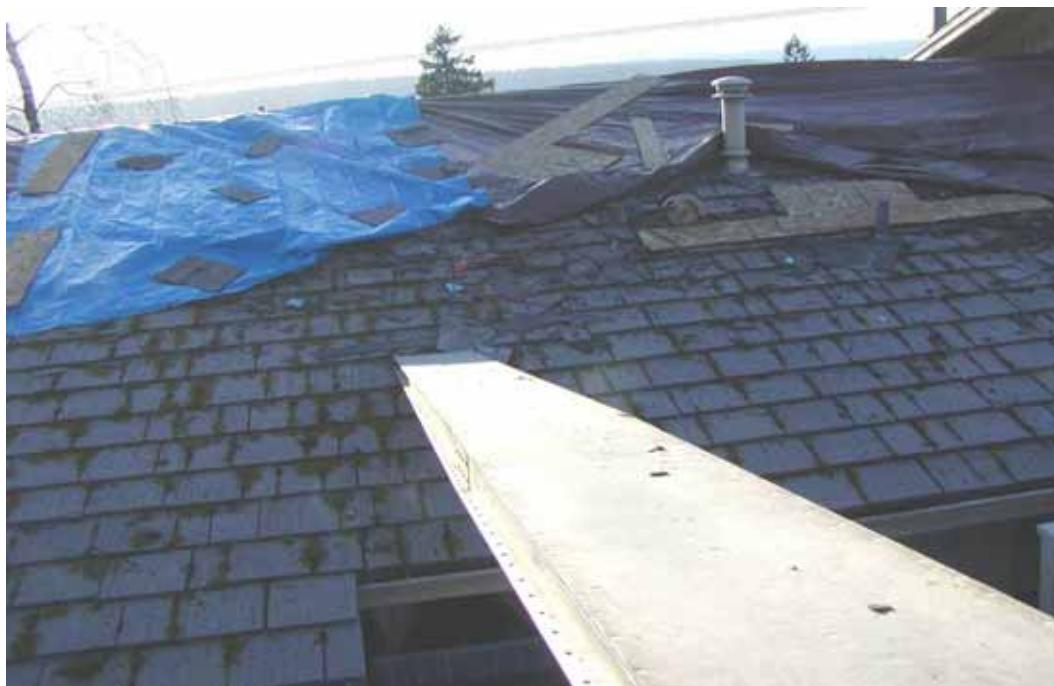
**Photo 2:** A view of the plank and roof at the incident site from the truck bed.

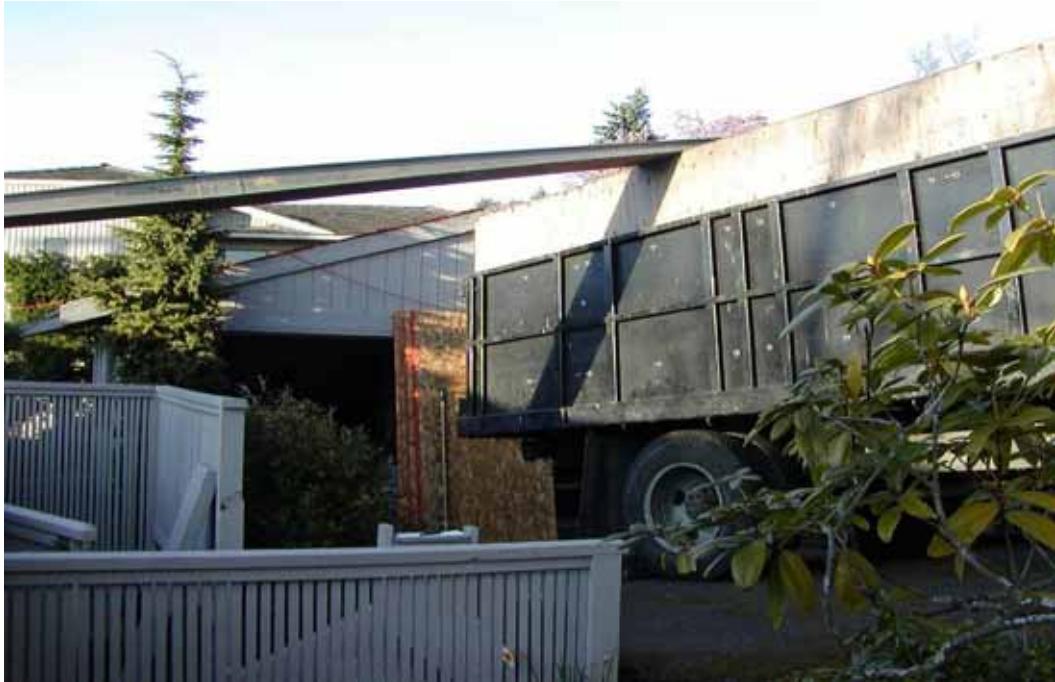
**Photo 3:** A view of the ramp and truck involved in the incident from the ground.

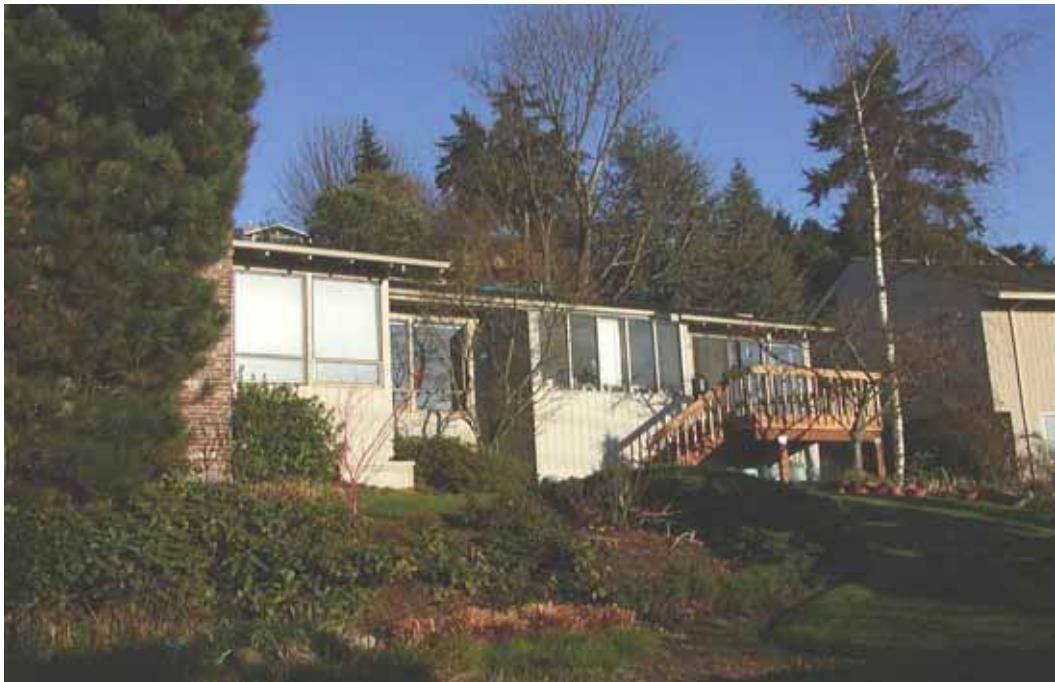
**Photo 4:** A view of the residence where the incident occurred from below, on the opposite side of the house from the truck and plank.
