Maintenance Worker Killed When Struck by a Vehicle Along a Highway in Washington State

FATALITY INVESTIGATION REPORT

Investigation: # 02WA04801
SHARP Report: # 52-15-2006

Release Date: October 23, 2006

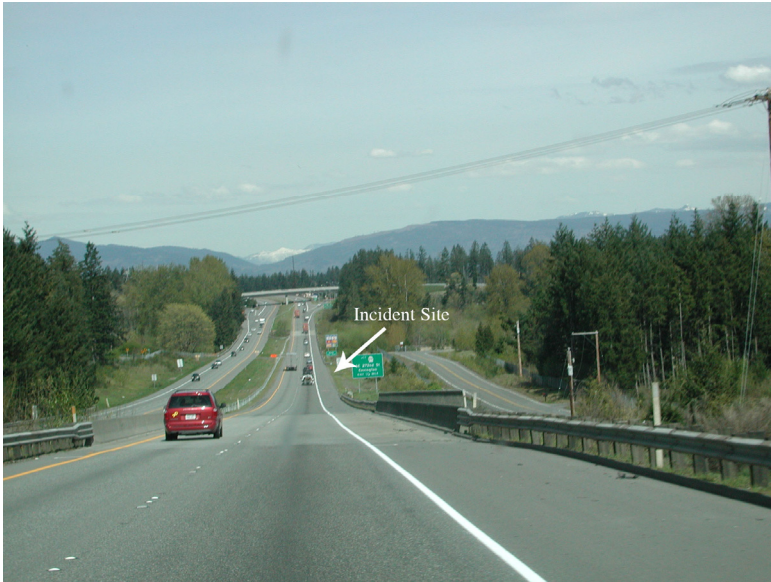
Photo 1: The view traveling down the highway east toward the incident site. The incident occurred at the bottom of the hill on the right shoulder.

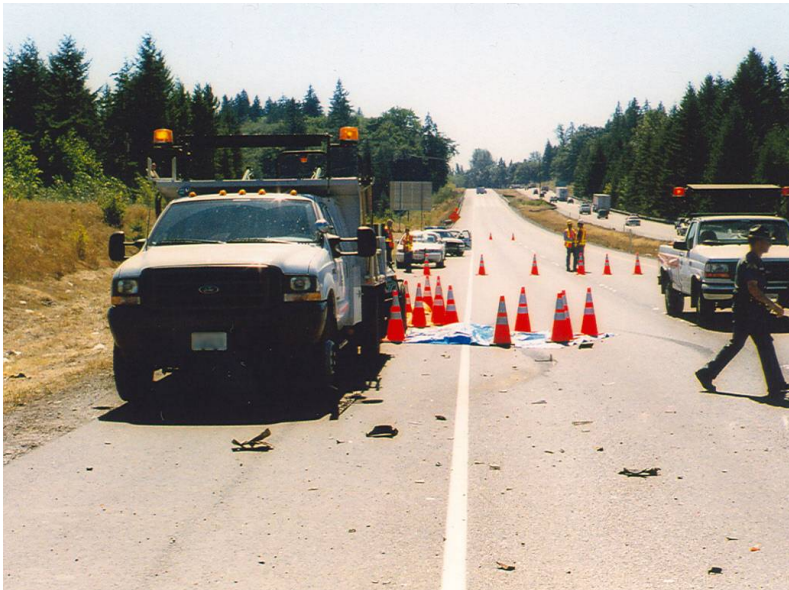
Photo 2: The incident scene after emergency response, facing west, looking up the hill toward on-coming traffic.

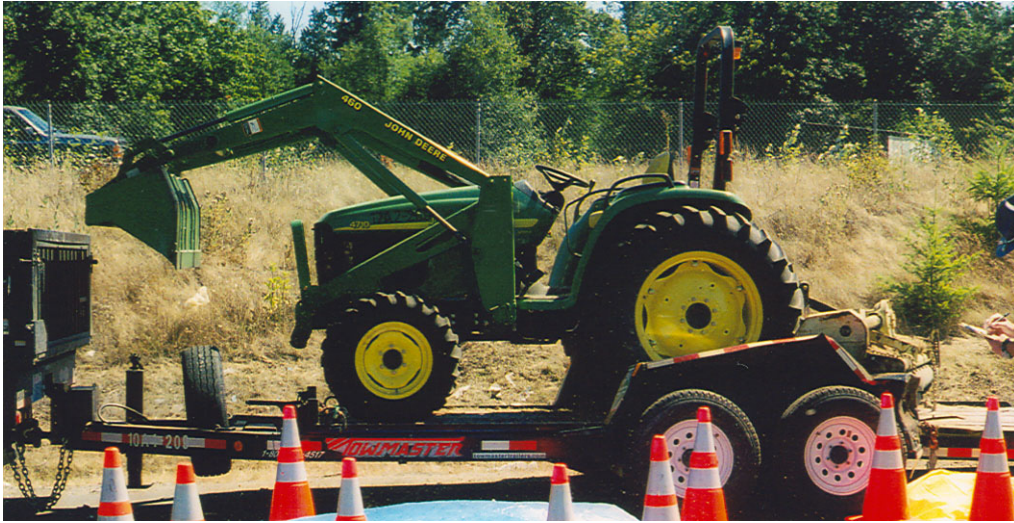
Photo 3: This photograph shows the tractor and mower attachment that were in the process of being tied-down to the trailer when the incident occurred.

- **Recommendation #1: Re-engineer the equipment load-binder/safety chain system on the trailer so that workers are able to secure equipment without having to stand near the traffic-side of the trailer.**

It is recommended that the load-binder/safety chain system be reviewed in order to look at the possibility of the system being re-designed or installation of a new system to help minimize worker exposure to traffic while loading equipment along roadways. The employer should check with the utility trailer manufacturer or distributor to see what equipment securing devices are available for upgrade or changes that can be made to upgrade the system.

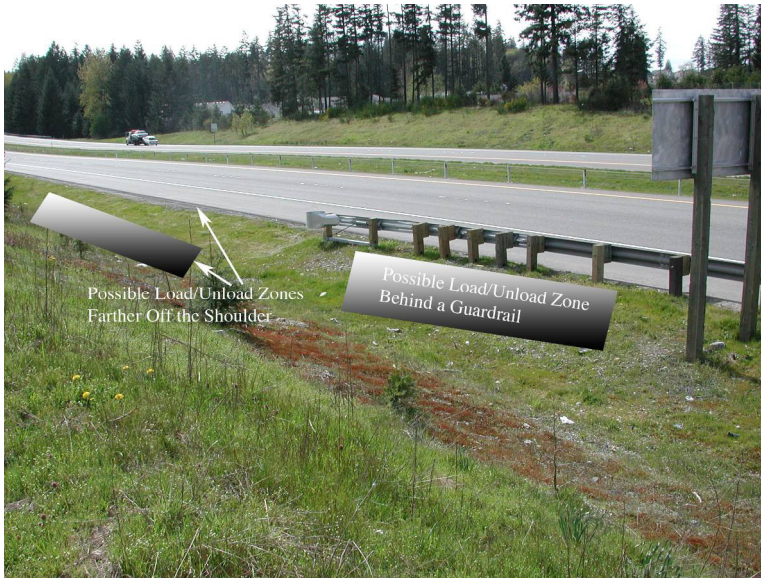
Their truck and trailer were parked primarily off on the asphalt shoulder of the highway. Part of the passenger-side trailer wheels, were on the grassy edge of the shoulder. The grassy area was level, and firm, with light vegetation which transitioned into the asphalt shoulder with no significant drop off. The area was easily able to support the weight of the truck and trailer plus that of the tractor/mower without any issues. (See photo 4)

Photo 4: This figure shows several additional options, just beyond the site of the incident, for parking a trailer to load/unload that might provide better protection than the shoulder.

If there are existing guard rails and/or crash cushions and there is adequate and reasonably level terrain to safely park vehicles, take a look at the ability to be able to park and locate the vehicle/trailer behind these existing devices to provide protection for loading and unloading equipment. If there are no guardrails, or crash cushions available in the area, then take a look at some of the natural topography of the work area that can provide a degree of protection for the workers on foot. Though perhaps not as effective as engineered guardrails, sometimes the natural topography can provide adequate protection when other protection modes are not available.

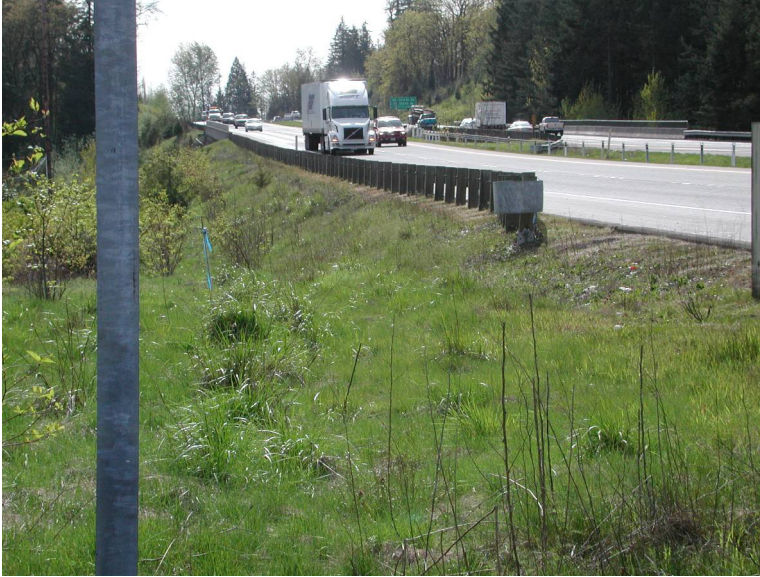
Photo 5: This photograph shows another possible site at the bottom of the hill, just before the incident site, where a trailer might be able to load/unload if feasible. This site would give good protection, behind a guardrail.
