Massachusetts FACE • Occupational Fatality Report

Forklift Operator Crushed Between Forklift Cage and Mast while Loading Waste Paper into a Trailer - Massachusetts

Investigation: # 08-MA-019-01

Release Date: March 16, 2010 (revised June 2010)

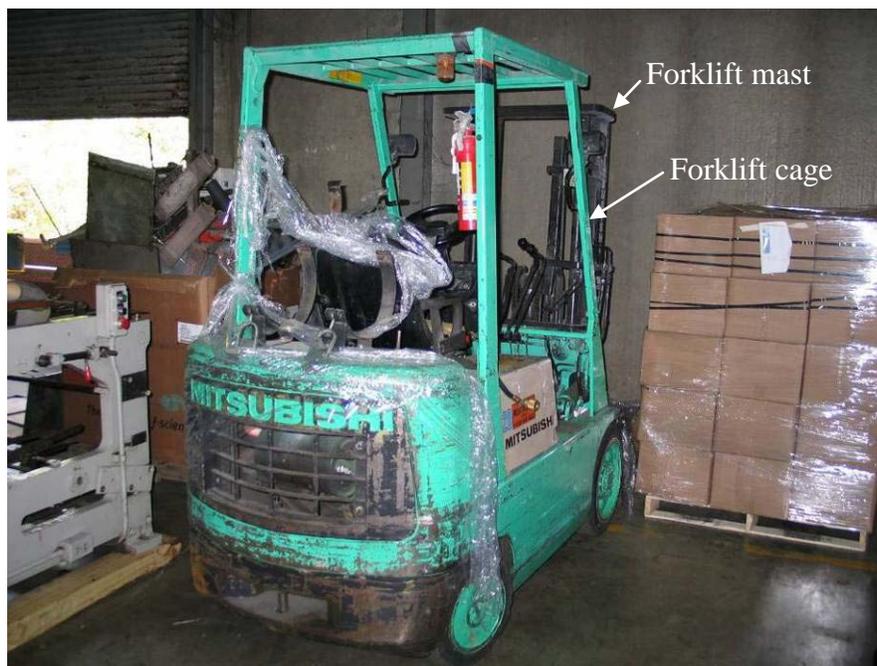
The company owns multiple fork trucks, including sit-down forklifts, standing forklifts, and walkers, but the forklift involved in the incident was not owned by the company. This forklift was owned by one of the company's vendors, a waste paper company (Figure #1). The company has a contract with this waste paper vendor which includes having a trailer located at the company's loading dock and a sit down forklift onsite to load the trailer. The vendor's forklift was used only by the envelope company employees, including the victim. The forklift was used to collect waste paper throughout the facility. Once collected, the waste paper was either baled or stacked onto wooden pallets and stored by the loading dock area. The forklift was also used to load the paper bales and pallets into the vendor's trailer stationed at the loading dock. Once the trailer was full, the waste paper vendor traveled to the company location, picked up the loaded trailer and dropped off an empty trailer.

The vendor's forklift was a sit-down propane powered forklift. The forklift was manufactured in 1987 and has been located at the company since 2001 (Figure #1). The forklift is equipped with a cage around the operator's area and two lights attached to the two pillars that make up the front of the cage. Three control levers are located to the right of the forklift's steering wheel (Figure #2). These levers are used to adjust the forklift tines and mast. The lever closest to the steering wheel raises and lowers the tines. The middle lever, when pulled down, tilts the mast back towards the forklift's cage, which in turn angles the far end of the tines up. When the middle lever is pushed forward it tilts the forklift mast forward away from the forklift cage and angles the far end of the tines back towards the ground. The lever furthest to the right of the steering wheel shifts the tines from side to side.

Figure 1 – Forklift involved in the incident.

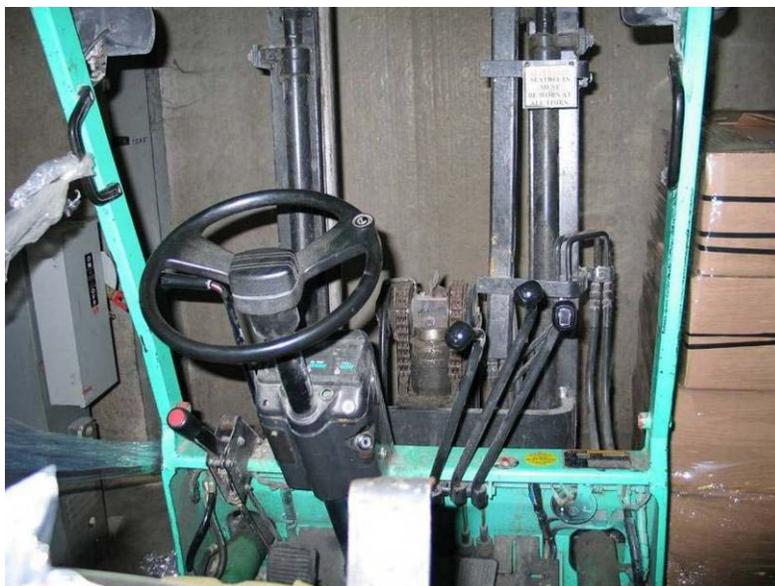
From this point forward it is unclear if the victim was trying to fix the problem or if he was attempting to get a better look at why the pallet was hung up. While the forklift was running and the tines were still raised approximately six feet, the victim engaged the forklift's emergency brake and exited the forklift operator's area. Evidence indicates that the victim then climbed up onto the exterior of the forklift between the forklift mast and the forklift cage and placed at least one of his feet on the forklift's dash board (Figure #5a and 5b). His foot came in contact with and engaged the forklift's middle control lever, pushing it in the downward direction. This caused the forklift mast to tilt back towards the forklift cage, crushing the victim between the mast and the cage.

Discussion: In this case, the forklift was running while the victim was standing partially on the dashboard and reaching between the forklift's upright mast and the operator's cage to see what the raised load was caught on. While he was standing on the dashboard, his foot had engaged the lever that controls the tilting of the mast, causing the mast to tilt back towards the operator's cage, crushing him.

Figure 2 – Forklift's controls.

1. A guard at the front of the operator's cage designed so a worker could not contact the forklift controls while in the area between the cage and mast. The guard should be designed so that it does not impair the operator's vision and prevents objects from falling back into the operator's area.
2. A safety interlock, requiring forklift operators to engage two controls before moving the forks and mast.
3. A pressure interlock within the operator's seat that would engage by locking the forklift controls in place when the operator is no longer seated, or a sensor device attached to the forklift's seatbelt that when the seatbelt is disconnected the forklift's power shuts off.

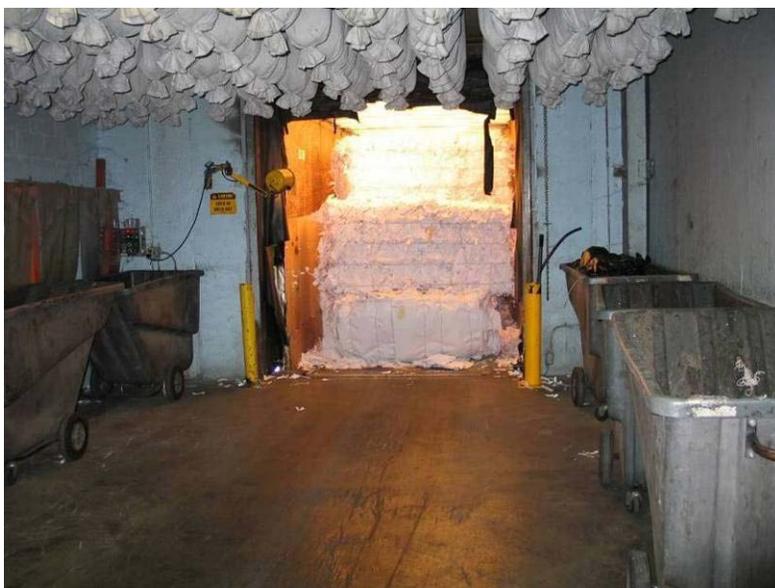
Figure 3 – Incident location with a tractor trailer loaded with paper bales not on pallets.

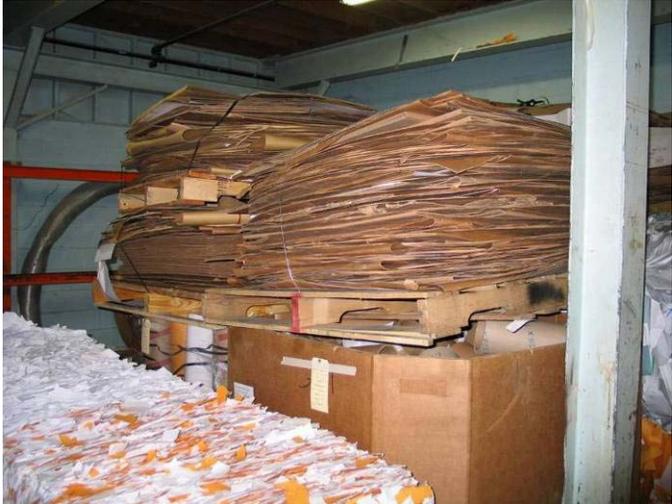
Figure 4 – Similar loaded pallet to the one being moved during the incident.

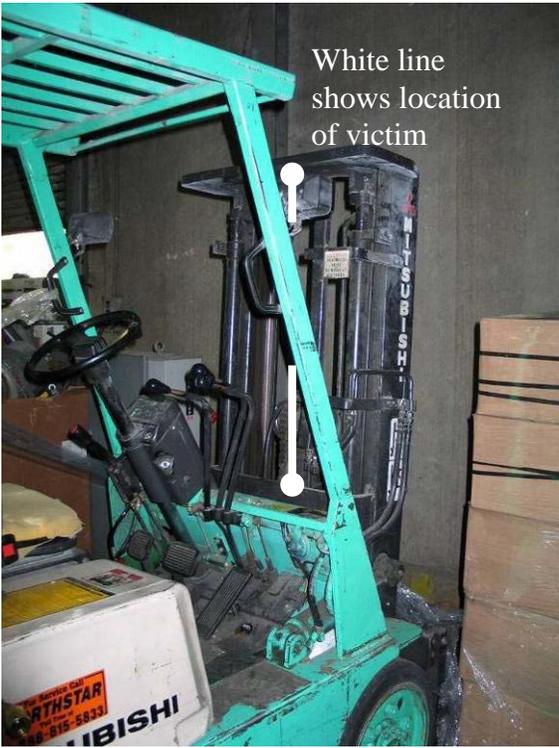
Figure 5a – Forklift's cage and mast.

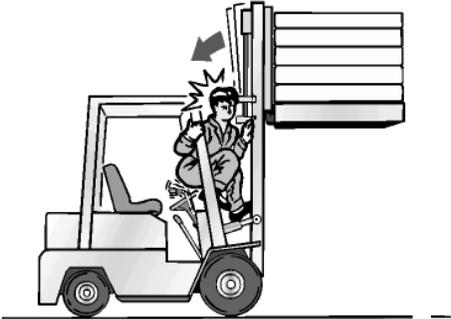
Figure 5b – Diagram of hazard.

Recommendation #1: Employers should ensure that forklift operators never position themselves or any part of their bodies between the forklift operator's cage and the upright of the mast while the forklift is running.
