Massachusetts FACE • Occupational Fatality Report

Municipal Laborer Dies after being Struck by a Motor Vehicle while Closing a Water Gate Valve – Massachusetts

Investigation: # 09-MA-031-01
Release Date: June 16, 2010

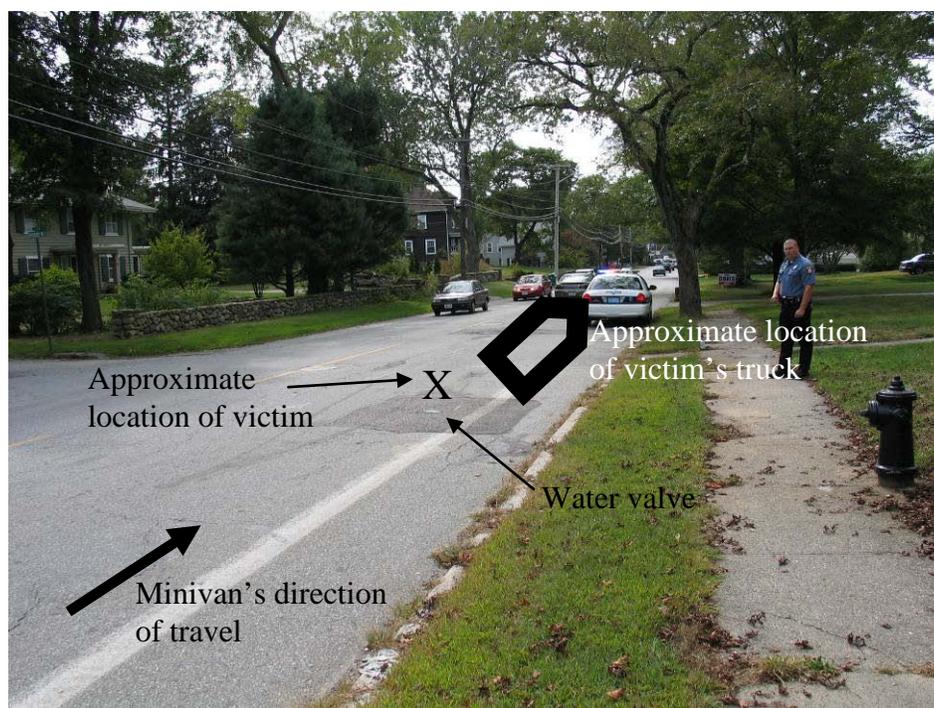
The morning of the incident, a water main located under a major roadway in the city broke at around 5:30 a.m. The victim, who was on the city's overtime list for such events, was called into work after the break occurred. At the water main break location a police detail was provided and a work zone was set up. The victim and a co-worker were at the water main break location and then were assigned to close a water gate valve to control the flow of water. They left the work zone area and traveled approximately 900 feet to the east, where the water gate valve was located (Figure #1).

When the victim and the co-worker arrived at the incident site, they positioned the ½ ton work pickup truck approximately four feet beyond the gate valve lid, facing west in the westbound lane. This is the same direction as the traffic flow in that lane. The truck's hazard lights were on as well as the yellow beacon located on the roof of the truck's cab. There were no other traffic control devices being used at the incident location at the time of the incident. Both the victim and the co-worker were wearing ANSI Class II green vests at the time of the incident.

Figure 1 – Incident location.

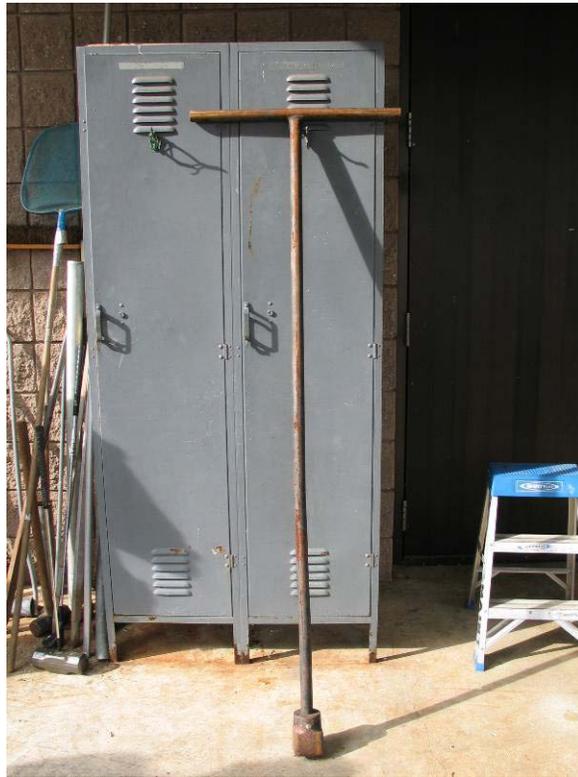
The gate valve is encased in a steel valve box and has a steel pipe that runs from the valve box up to the street level. This steel pipe provides access to the gate valve. At the street level there is a lid that covers the steel pipe. To open and close the water gate valve, a valve wrench is used. The valve wrench used during this incident has a pipe base that is approximately nine feet long with a perpendicular section of pipe at one end that is used as a handle. The other end of the wrench has a key that fits onto the gate valve (Figure #2). Using the handle the valve wrench is turned to open or close the water gate valve.

Figure 2 – Similar valve wrench to the one being used.

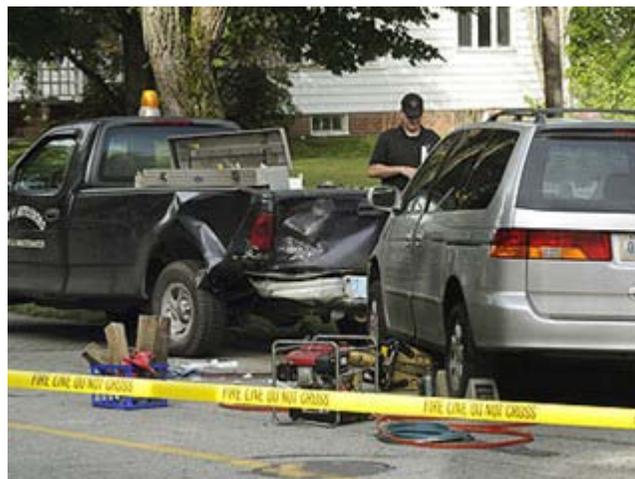
While walking in a circular motion to close the gate valve, the victim might have had his back to oncoming traffic as a minivan traveling west in the westbound travel lane approached. The minivan struck the victim, pushing him into the work pickup truck and pushing the pickup truck forward. The minivan then bounced backwards and then forwards, stopping partially on top of the victim. Reportedly, the minivan driver did not apply the minivan's breaks prior to the crash. The co-worker heard the noise of the crash and turned to see the victim trapped underneath the minivan (Figure #3). The co-worker went to the victim then placed a call to Emergency Medical Services (EMS) and to other co-workers. Within minutes EMS and the local police arrived at the incident location and the victim was freed and transported to a local hospital where he was pronounced dead. Since the incident, the municipality has instituted additional work zone safety measures, including providing comprehensive work zone training for city employees and a cooperative agreement between the water department and police department which calls for police officers to control traffic when water department employees are accessing water valves located in roadways.

Figure 3 – Scene after the incident.

At the time of the incident, the pickup truck was located beyond the victim facing west in the westbound travel lane. The truck's location did not provide the victim protection from the approaching motorists traveling in this westbound lane. In this case, the pickup truck could have been located between the victim and the approaching traffic by parking it before the gate valve lid with the truck's wheels turned to the left. Having the truck in this location with the wheels turned to the left would provide protection to the workers on foot in the event that the truck was struck from behind by an approaching motorist. If struck from behind, the truck would move towards the left, away from the workers in the roadway and sidewalk, and in front of the vehicle that struck it, blocking that vehicle from continuing forward towards the workers.
