Massachusetts FACE • Occupational Fatality Report

Municipal Forestry Foreman Drowns while on Emergency Duty during an Ice Storm - Massachusetts

Investigation: # 08-MA-054-01
Release Date: June 11, 2010

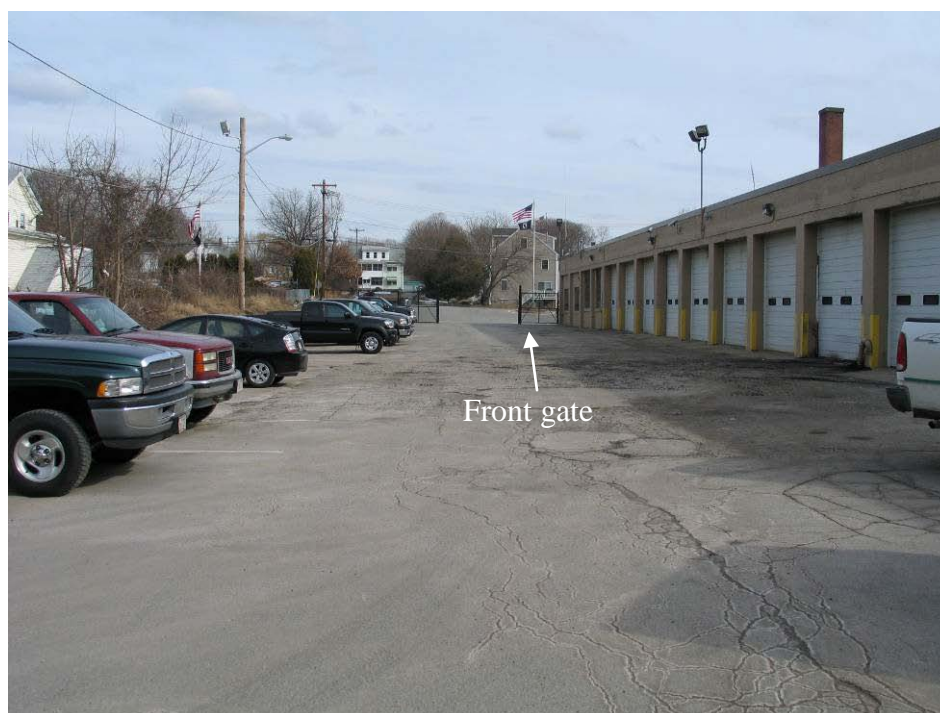
Figure 1 – Department's parking lot.

The department of public work's building consists of office and garage space. The driveway / parking area in front of the department's garage overhead doors is sectioned off by front and rear chain link gates (Figures 1, 2 and 5). The front gate is open during week day business hours and typically closed and locked during non business hours (Figure 1). The rear gate, which leads to the driveway of a neighboring club, is typically always open and unlocked (Figure 2).

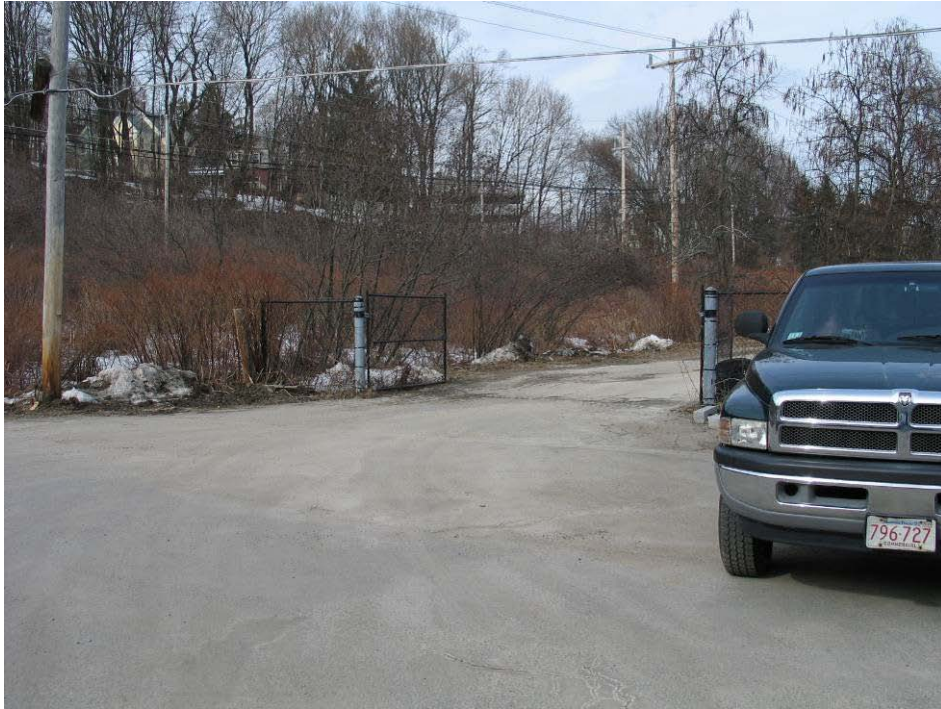
Figure 2 – Department's parking lot rear gate.

The rear parking lot gate connects the department's parking lot to the parking lot of a neighboring private club. Reportedly, this rear parking lot gate was always open and routinely used by employees, especially when the main gate was closed after business hours. Given the potential for pedestrian traffic at the private club, use of the rear gate should be avoided. The rear gate should be closed and to the extent possible the front gate should be used for parking lot access.

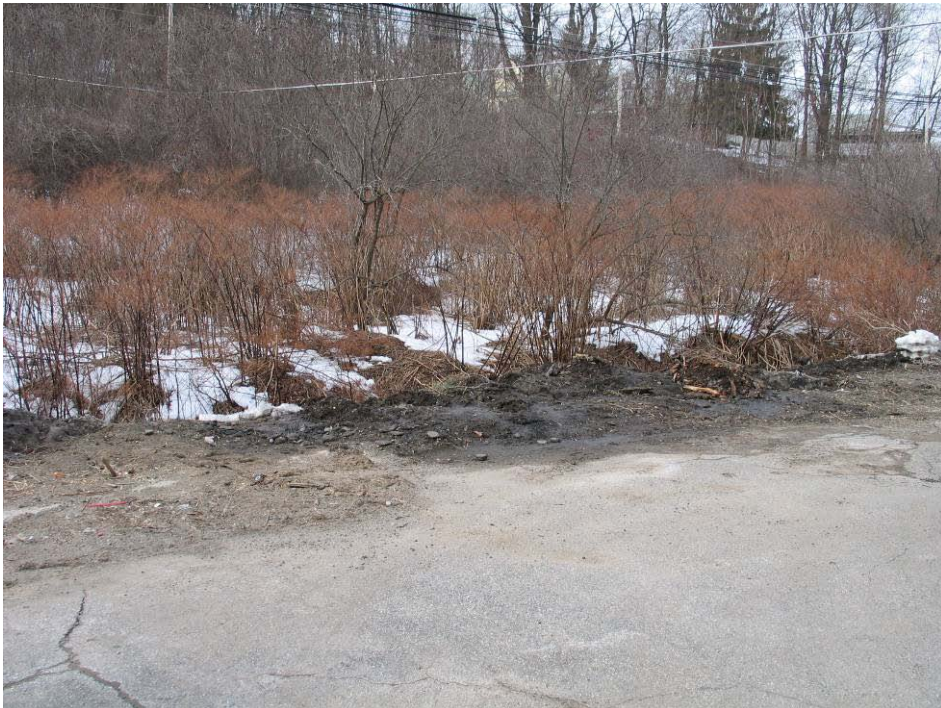
Figure 3 – Parking lot edge.

A stream is located behind the property and is part of a rainwater runoff collection system. The stream runs parallel to the rear edge of the parking lot, next to the rear gate (Figure 3 and 5). At the rear edge of the parking lot is a steep embankment that leads straight down approximately eight feet to the stream (Figure 4). The stream, which runs through mostly wooded areas, eventually empties into a reservoir. During normal conditions, such as the day of the site visit, the stream's water depth is approximately ten inches (Figure 4). During the morning of the incident, due to the heavy rains and frozen ground, the stream was approximately eight feet deep and was flowing quickly. It was reported that the stream had been at flood stage level.

Discussion: In this case, if a physical barrier, such as a guardrail, was installed at the unprotected edge of the embankment leading to the stream, it would have prevented the vehicle from entering the stream at the time of the incident. A barrier at this location would not only protect the city workers who routinely access the parking lot and building, it would also protect the general public who has access to the building site. Any barriers being installed should be in compliance with applicable codes, guidelines and consensus standards.

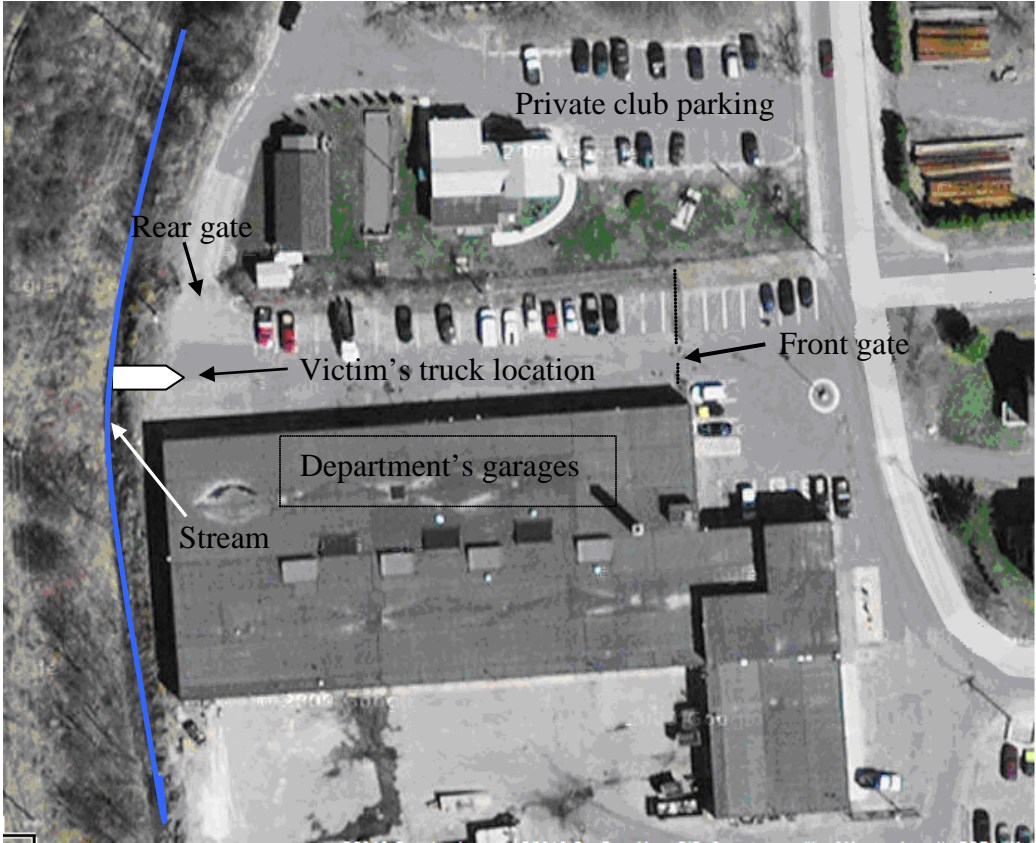
Figure 5 – Aerial view of incident location.

recording again, the video footage is dark due to the parking lot lights being out and the victim's pickup truck is now backed down the steep embankment into the stream (Figure 5).
