**SUBJECT:** A Welder Dies When the Scissor Lift He was Operating Tips Over

**SUMMARY**  
**California FACE Report #09CA008**

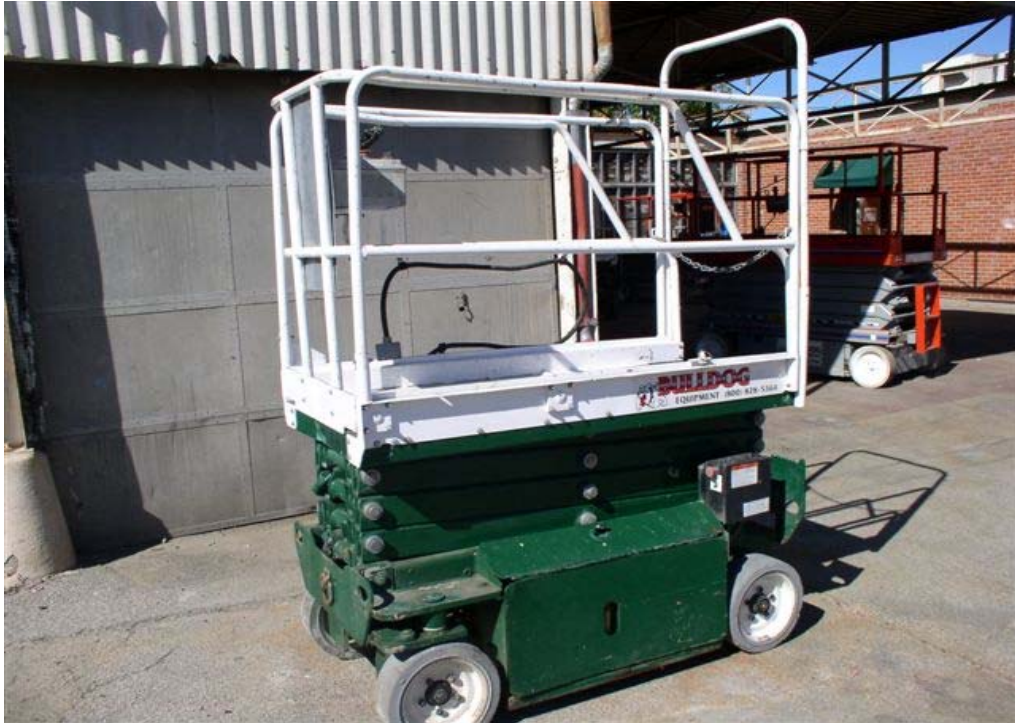
The machine involved in the incident was an electric self-propelled Condor scissor lift (model V1833XL) that was rented by another contractor on the work site. The scissor lift had a maximum platform height of 18 feet. The operating controls for the scissor lift were inside the work platform which measured 30 inches wide and 60 inches long. These controls allowed the operator to lift and lower the platform as well as move the entire lift forward and backward. There was no limit switch to prevent movement when the work platform was extended. There was no operating manual accompanying the scissor lift, but placards were attached inside the work platform detailing operational and safety instructions.

**Exhibit 1. The scissor lift involved in the incident.**

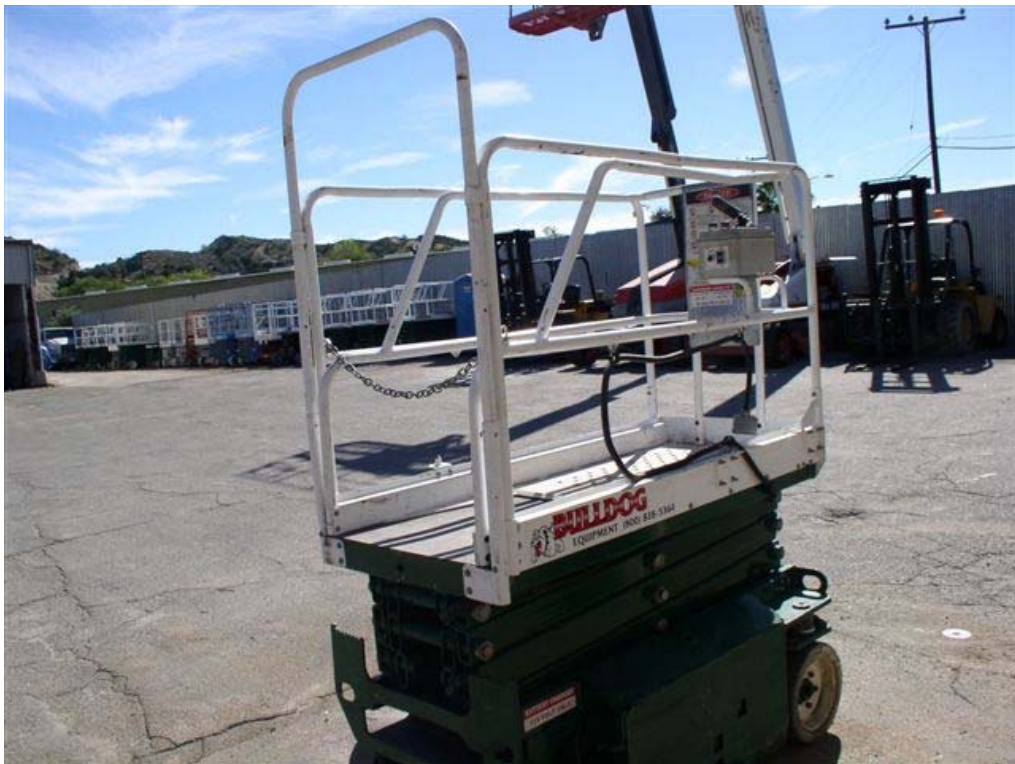
**Exhibit 2. Alternate view of the scissor lift involved in the incident.**

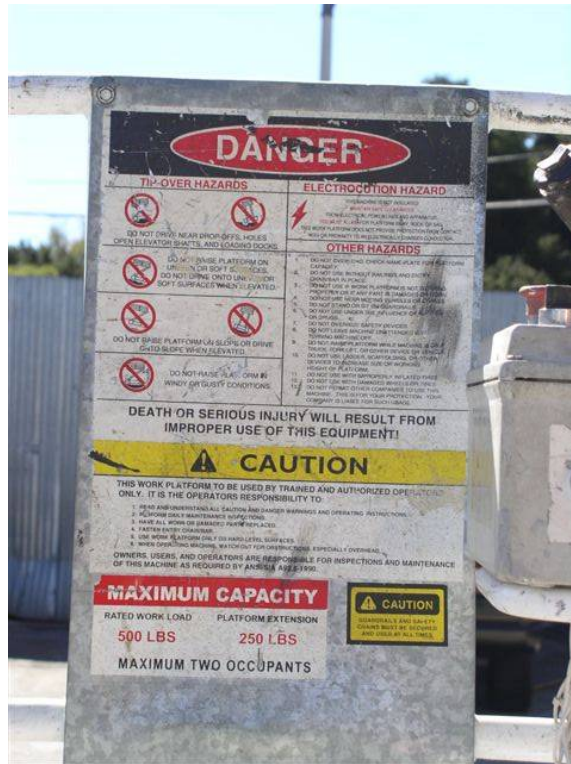
Exhibit 3. The placard attached to the scissor lift listing hazards associated with operation.

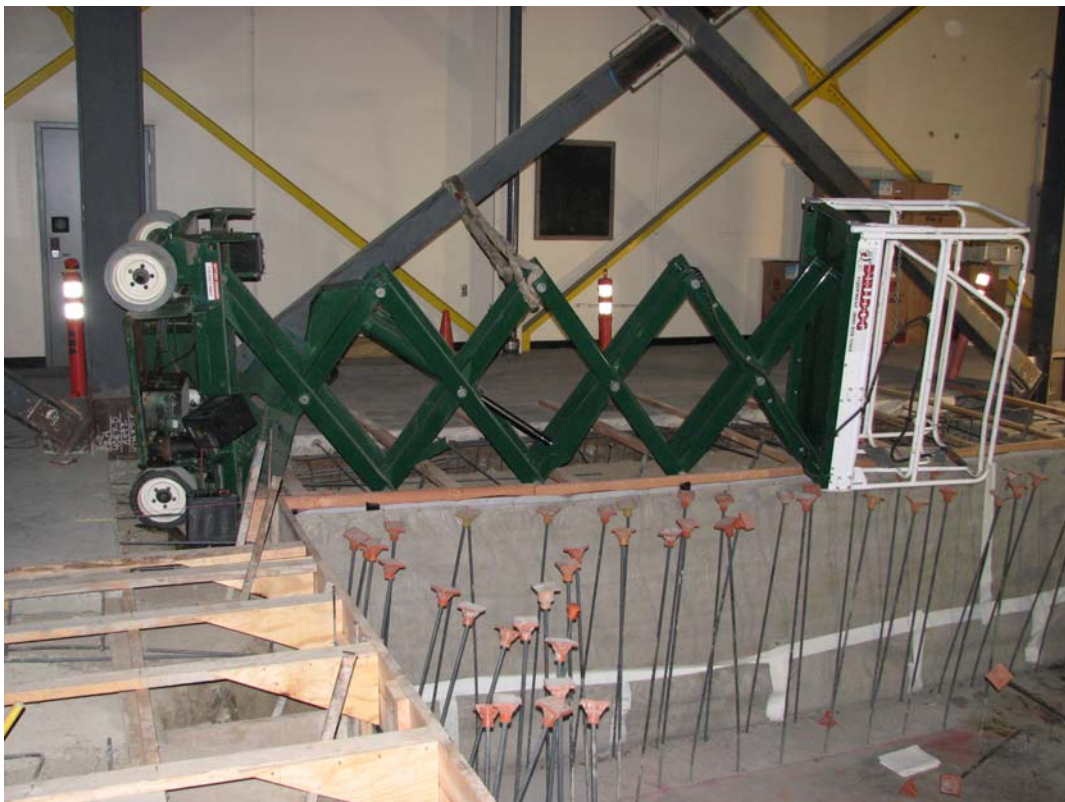
level and straight. According to the general contractor, the distance from the steel beam to the edge of the depression of the pit was approximately 30 inches. The only barrier between the scissor lift and the depression of the pit was an orange cone on the concrete floor.

While in an elevated position, the victim moved the scissor lift forward to access his work. This movement caused the two front wheels of the scissor lift to roll into the depression of the pit. This momentum caused the entire scissor lift to topple forward onto the depression alongside the pit. The victim was ejected from the work platform headfirst, hit the opposite wall of the pit, and then fell to the pit floor. Several co-workers in the area ran to assist the victim. The paramedics and fire department responded within minutes and pronounced the victim dead at the scene.

Exhibit 4. The incident scene.

**Recommendation #1: Employees perform a thorough hazard assessment and implement effective controls prior to using aerial lifts.**

**Recommendation #2: Employees not move scissor lifts forward or backwards while in the raised position.**

**Recommendation #3: Manufacturers should install safety interlocks that prohibit scissor lift travel while the platform is raised.**
