# STATE OF NEW YORK DEPARTMENT OF HEALTH

## FATALITY ASSESSMENT AND CONTROL EVALUATION

### Mechanic Killed when Aerial Work Platform Collapses Case Report: 07NY080

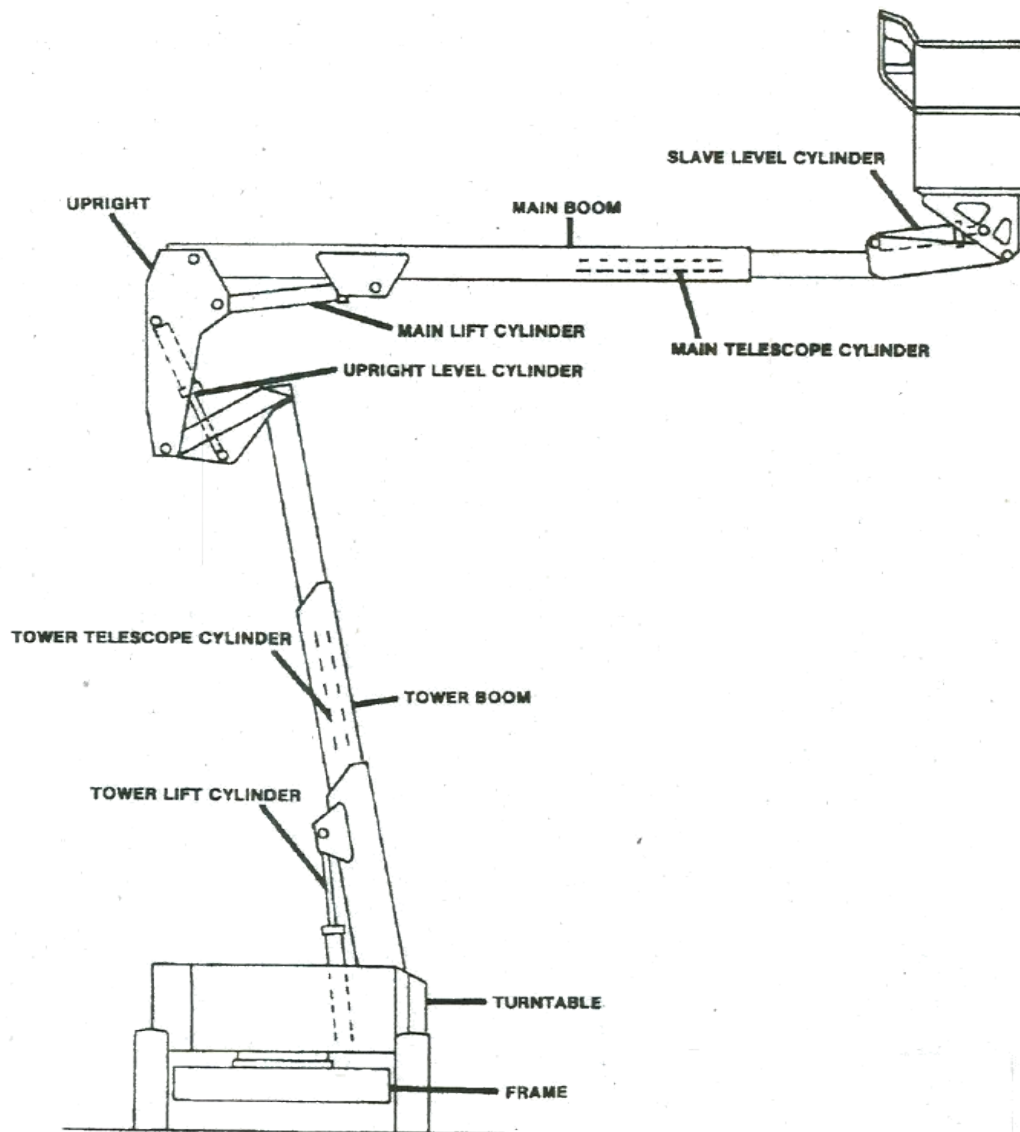
*Figure 1. The schematic of the boom-supported aerial work platform.*

The collapse of the aerial work platform was determined to be caused by a failure of the upright level cylinder (Figure 1): the rod of the cylinder had broken away from the cylinder barrel (Photo 3). After the incident, a mechanic who specialized in the model and make of the aerial work platform examined the failed cylinder. The mechanic concluded that the rod assembly of the cylinder had been modified and the modification directly caused the failure of the cylinder.

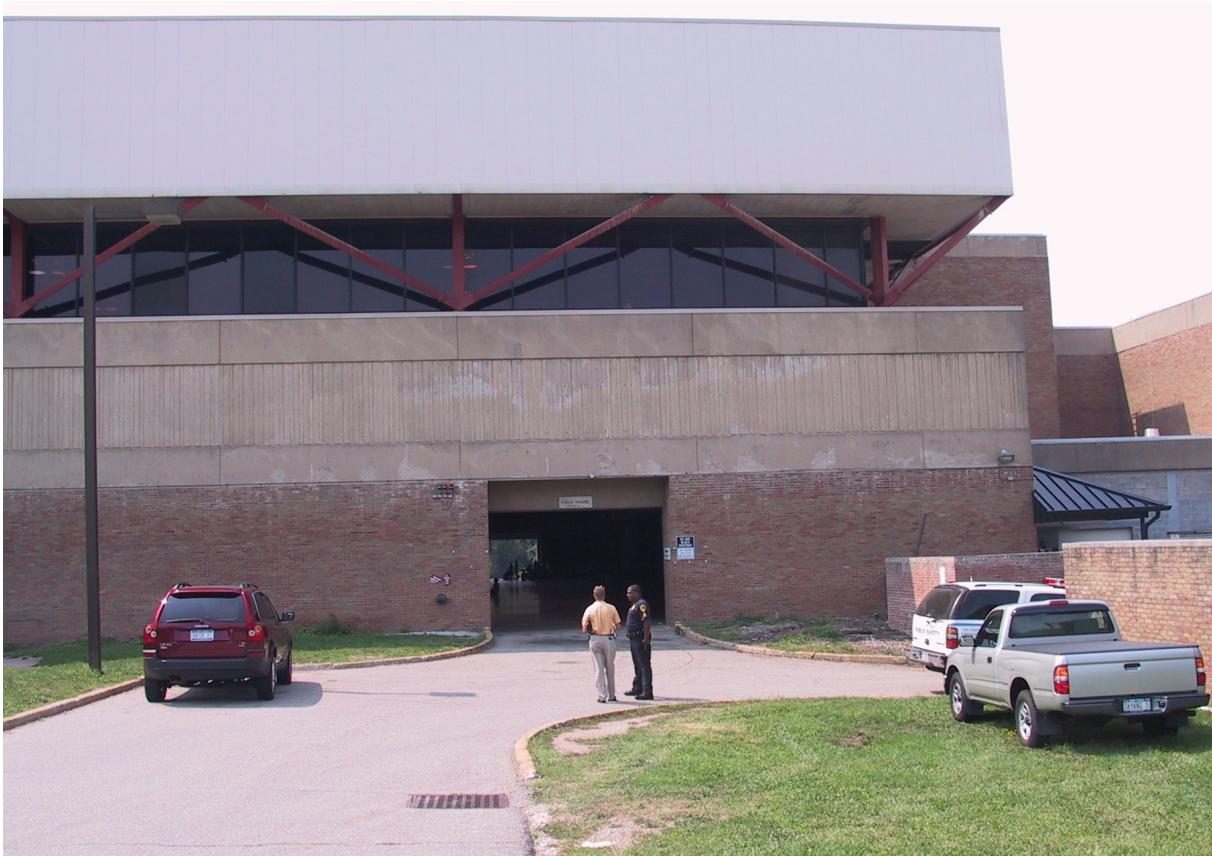
*Photo 1. The Field House entrance where the aerial work platform was parked during the incident.*

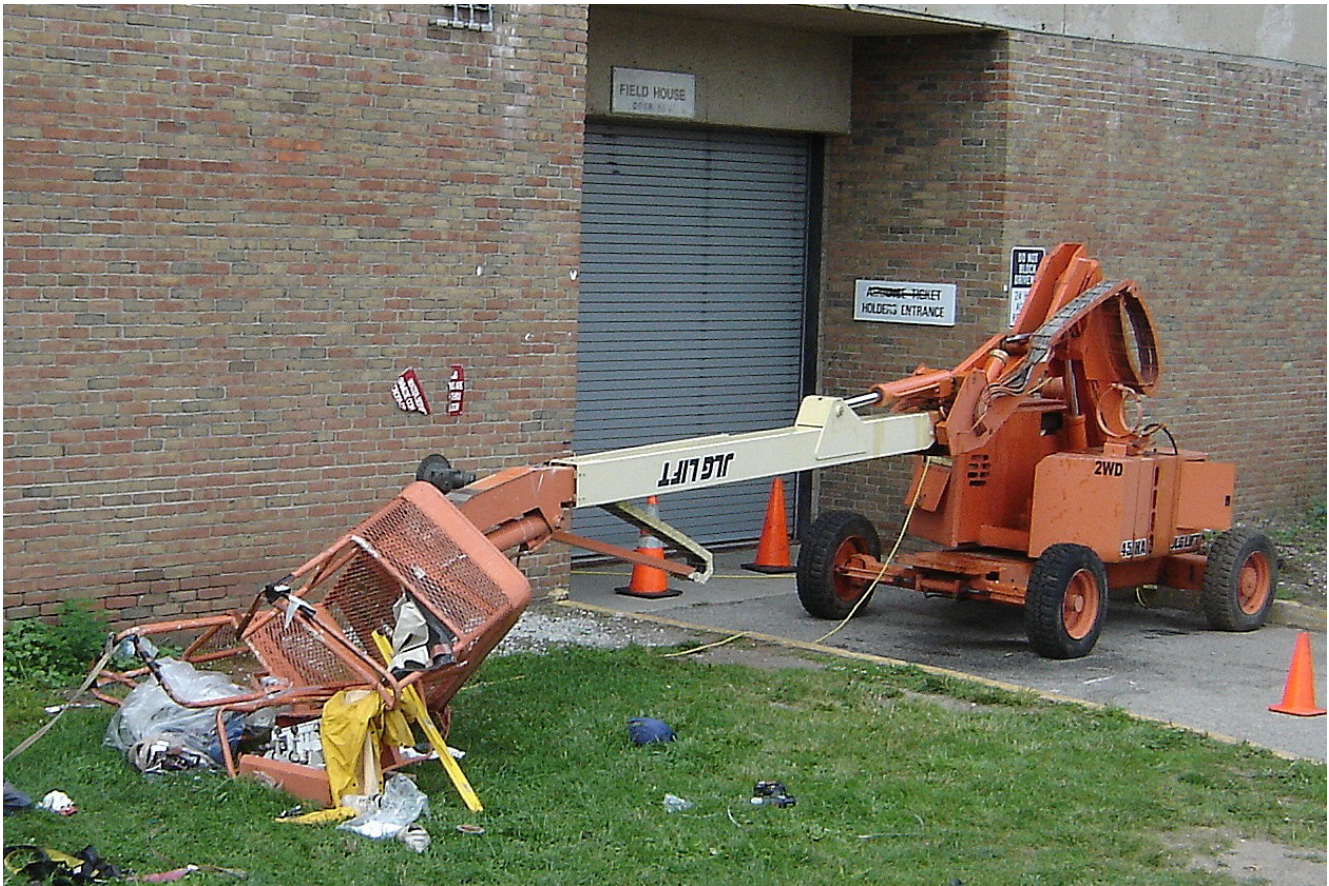
At approximately 11:40 am, the lift basket fell to the ground and landed on the grassy surface (Photo 2). A camp student heard the crashing noise; he came outside and saw the collapsed aerial work platform. The victim was inside the basket and the co-worker was on the grass in front of the basket. Campus security was notified immediately and paramedics arrived within minutes. Both workers were transported to a hospital where the victim died an hour later. The co-worker had serious injuries and survived. Based on measurements taken at the incident site, it was estimated that the victim and the co-worker fell approximately 40 feet.

*Photo 2. The aerial work platform collapsed during the incident and the lift basket crashed to the ground and landed on the grassy surface by the Field House (Photo courtesy of OSHA).*

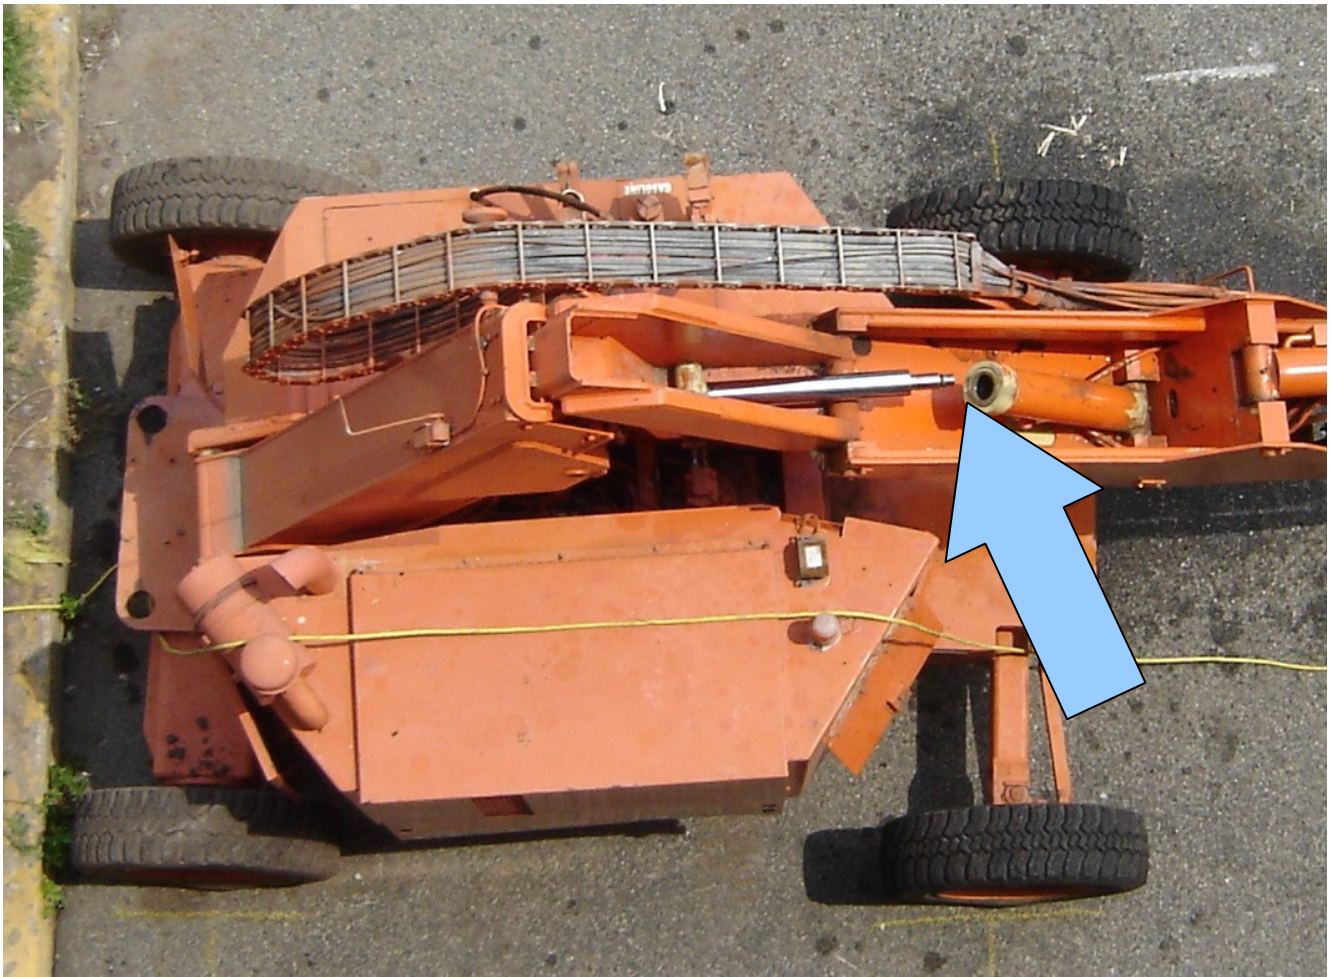
*Photo 3. Top view of the collapsed aerial work platform with the rod completely separated from the upright level cylinder (Photo courtesy of OSHA)*

**Recommendation #1:** *Owners of aerial work platforms should prohibit unauthorized modifications or alterations of the machines.*

**Discussion:** Modification or alteration of aerial work platform parts or components may compromise the integrity of the machine and cause serious or fatal injuries. The serious and potentially life threatening consequences of unauthorized modification of aerial work platform parts or structure should be clearly communicated to all employees, including both operators and maintenance staff.

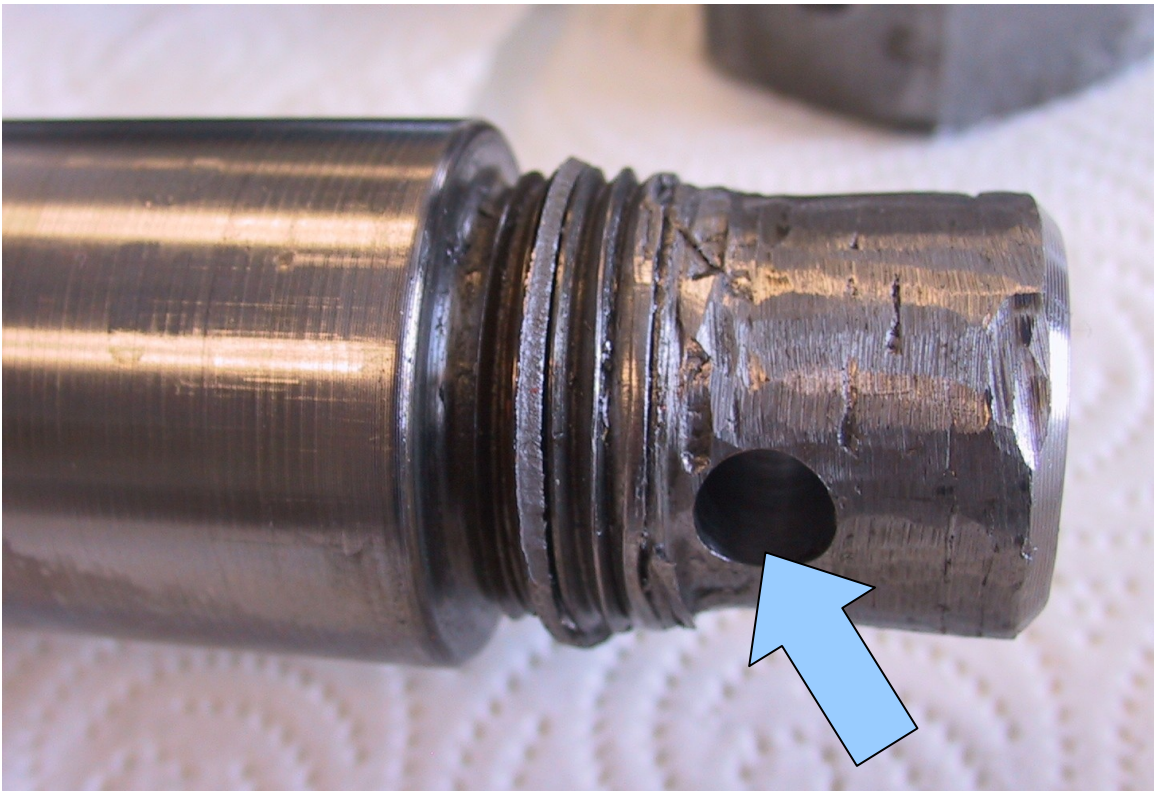
The original rod assembly of the cylinder had a threaded end. The piston was secured to the rod by a hex nut that screwed into the threaded end. The hex nut had a set screw to secure it to the rod. The investigation found that the thread of the rod assembly of the failed cylinder was ground off. A hole was drilled through the hex nut and the rod (Photo 4 and Photo 5). A bolt had been inserted through the hex nut and the rod and it was fastened with a nut. The bolt broke into three pieces (Photo 6) during the incident and caused the cylinder to fail.

*Photo 4. The thread of the failed cylinder rod was ground off and a hole had been drilled through the rod.*

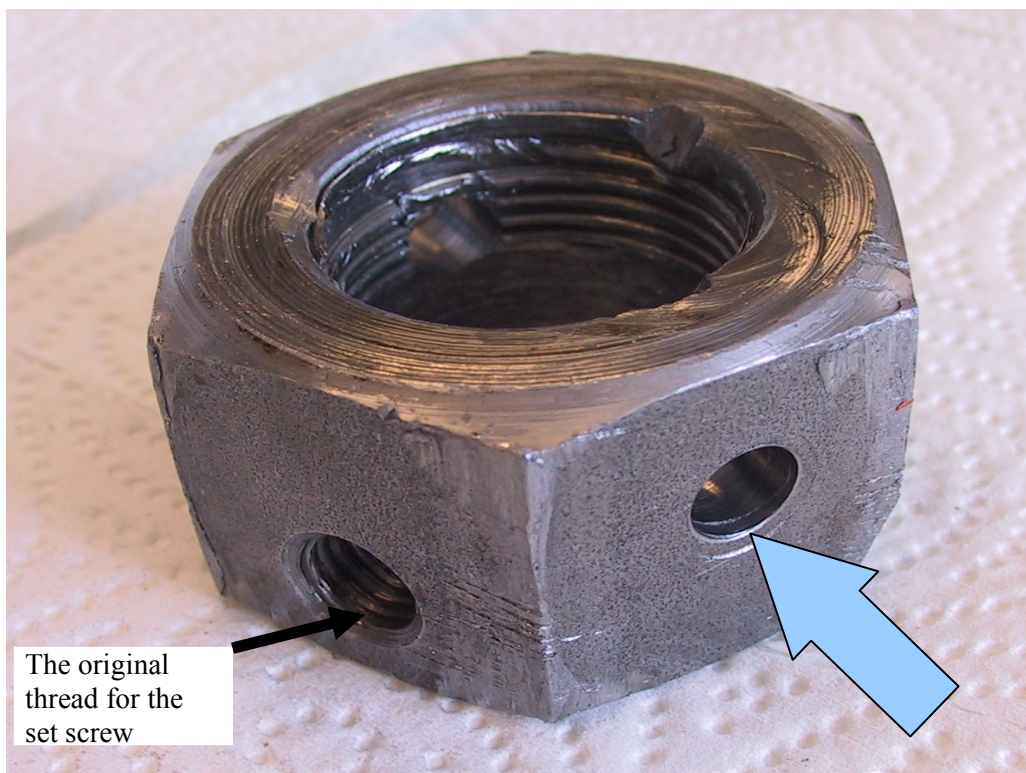
*Photo 5. The hex nut was drilled through so that a bolt can be inserted to hold the rod and the nut together.*

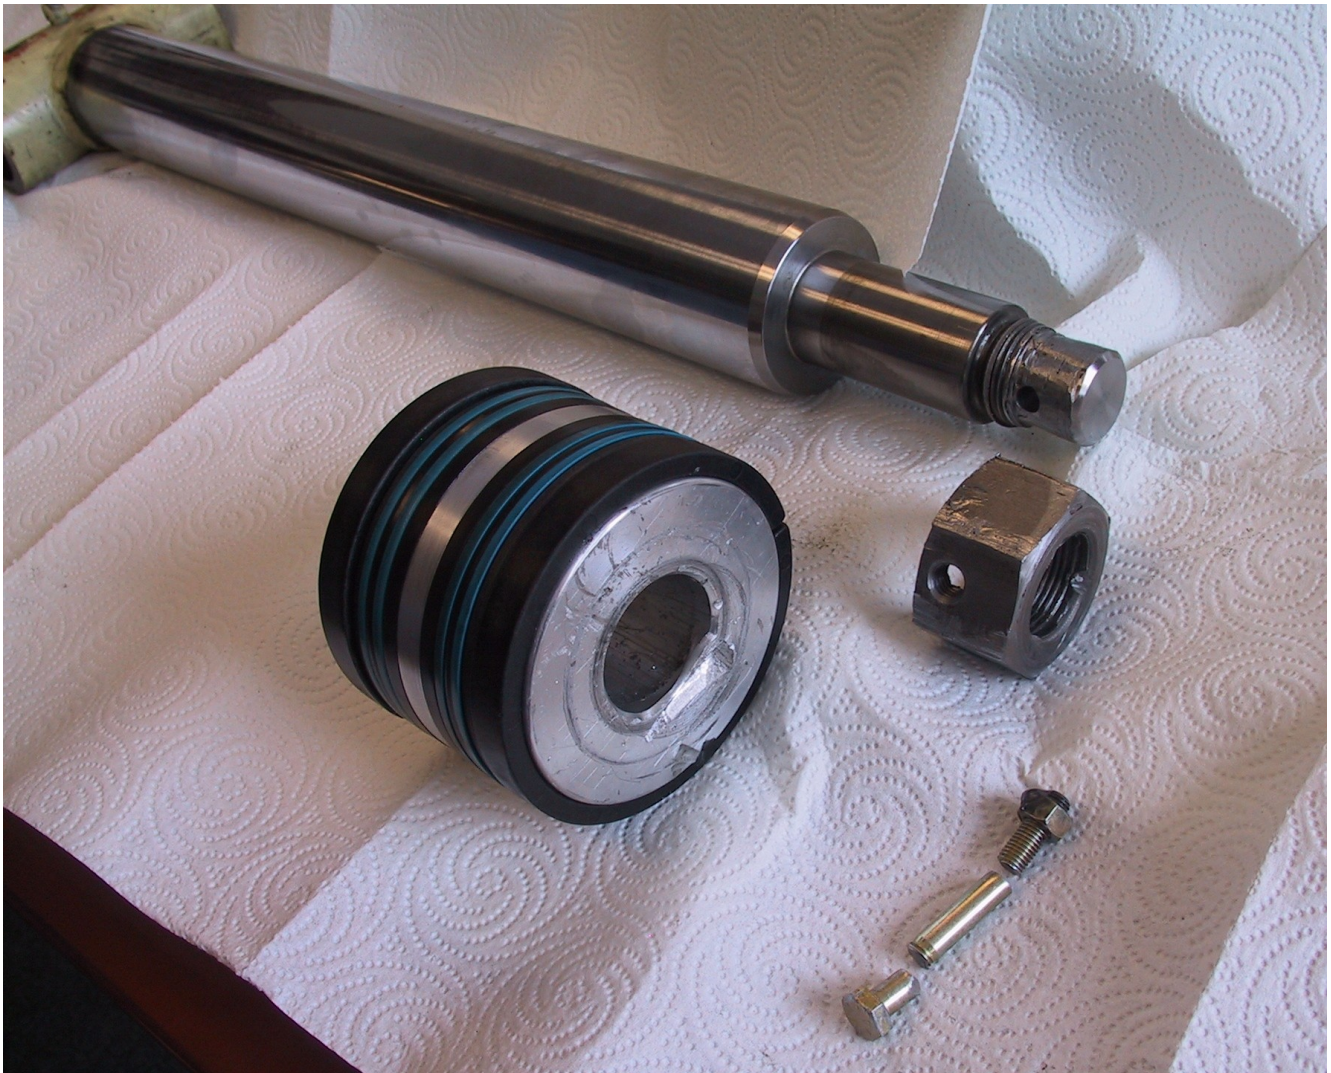
*Photo 6. A bolt had been inserted through the hex nut and the rod and it was fastened with a nut. The bolt broke into three pieces during the incident and caused the cylinder to fail.*
