MIFACE INVESTIGATION REPORT: #08MI135

SUBJECT: Farmer Drowned While Removing Stop Logs From Water Level Control Structure

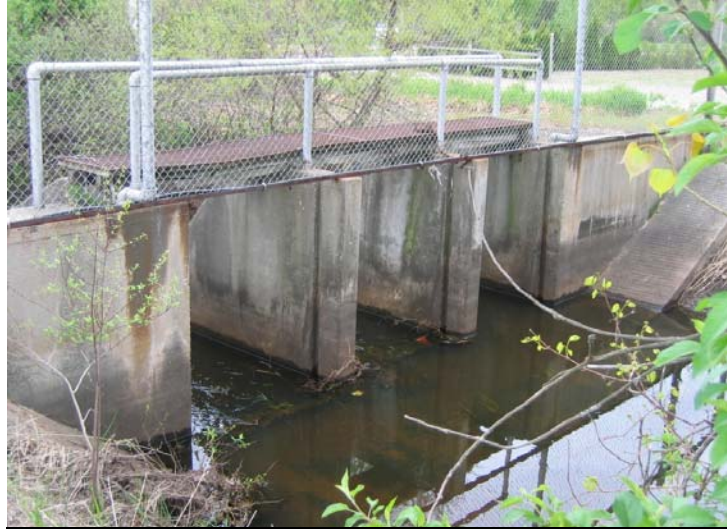
In June 2008, a 76-year-old male farmer, who was a member of a volunteer cooperative drowned, as he was removing wood stop logs from the drain's water level control structure to relieve a high upstream water level (Figure 1). The structure had three sections six feet wide. Each section had at its base, one 12-inch wide wooden stop log that was turned on its edge. Stacked on top of the 12-inch stop log were four 8-inch wide stop logs, also turned on their edge. The five stop logs were held in place by a channel in

Figure 1. Upstream side of water level control structure looking east

- The drain commissioner should ensure that a standard operating procedure to add/remove stop logs for each of the county's water control structures is developed and implemented. This procedure should prohibit individuals from entering the drain to remove the stop logs.

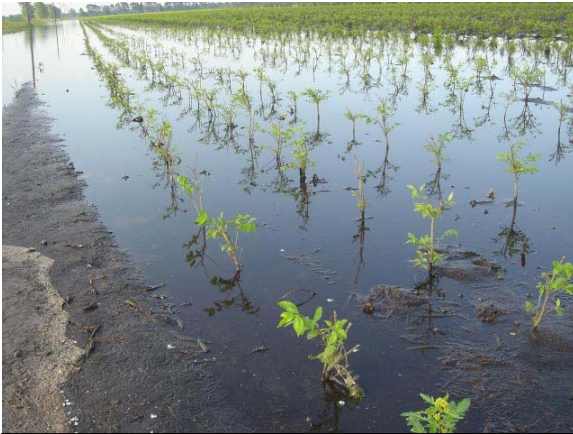
Figure 2. Example of water levels in field drainage ditch and field upstream of drain

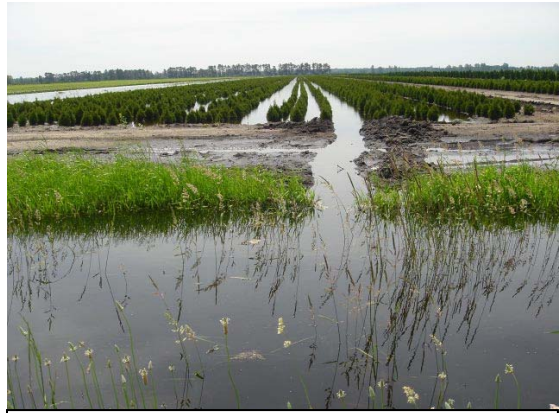
Figure 3. Example of water in fields upstream of drain and height of water in drain

Because of the soil characteristics and the amount of precipitation, the soil became saturated and caused water run off to field drainage ditches and the county drain. The amount of water overwhelmed both field drainage ditches and the county drain, causing field flooding upstream of the water level control structure (Figures 2 and 3). On the day of the incident, the decedent did not contact other cooperative members to assist him in removing the stop logs. The decedent drove to the water level control structure site. After parking his truck, he removed his boots and donned chest waders. He did not wear a life preserver.

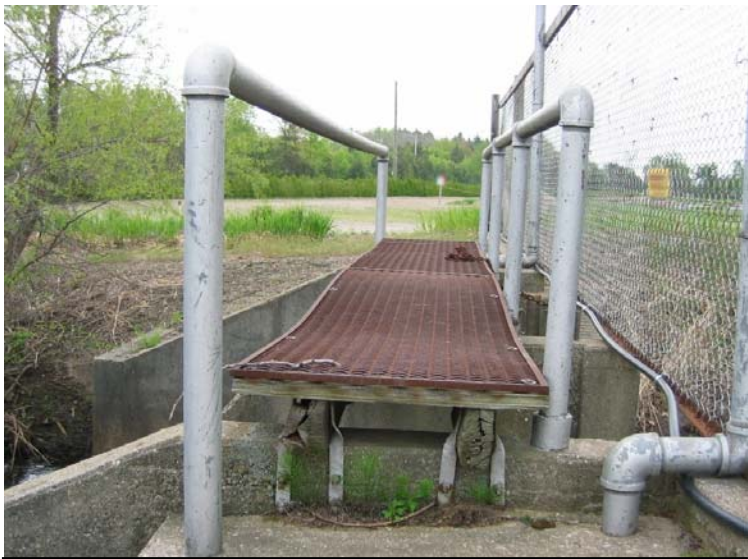
Figure 4. Water level control structure's wood and expanded metal walkway, handrails, and fence, looking south

The water level control structure was constructed of a 31-inch wide expanded metal walkway that was attached to a deteriorating wood platform. The walkway/wood platform was secured to two abutment concrete walls and two piers spaced six feet apart. Two metal handrails were located on each long side of the walkway. The 4-inch diameter east handrail was secured only to the north and south concrete abutment. The 3-inch diameter west handrail (upstream side of the structure) was secured to the north and south concrete abutments and had support pipes to the two middle concrete piers (Figures 1, 4 and 6). The top of the rails were 31 inches from the walking surface of the walkway. No midrails were present. A fence was approximately 18 inches from the west handrail. All of the concrete support structures had a channel into which the stop logs were inserted to regulate water levels in the drain (Figure 5). Five

Although the cooperative members were volunteers and not employed by the drain commissioner, the 31-inch high guardrails installed at the incident structure did not meet either the exemption of 36 inches if installed prior to August 28, 1973 nor the MIOSHA standard (42 inches) for height. The barrier also did not have the required intermediate rail.

- The drain commissioner should review all area water level control structure walkway handrails to ensure compliance with MIOSHA Safety Standard, Part 2 – Floor and Wall Openings, Stairways and Skylights.

MIFACE recommends that the drain commissioner conduct a survey of all water level control structures in the county to assess compliance with MIOSHA standards for guardrails and make necessary modifications.

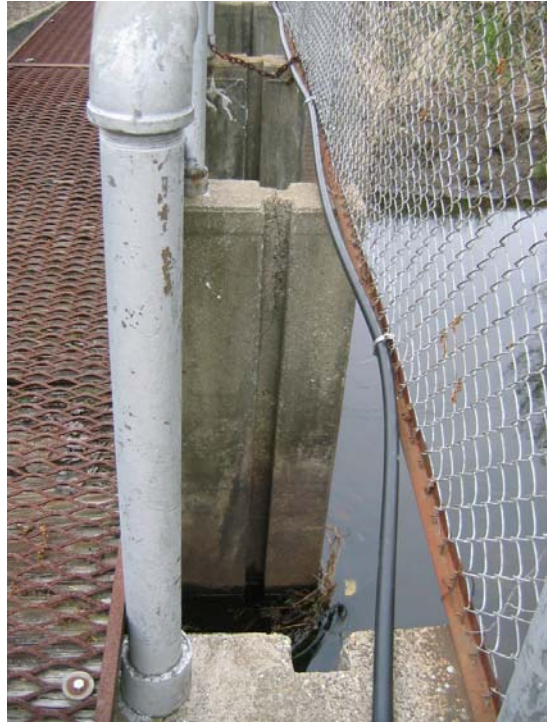
Figure 5. Channels holding stop logs

lumber stop logs, each turned on their edge, were placed within the channels of each of the three sections of the structure. Each section had at its base one 12-inch wide stop log. Placed on top of the 12-inch wide stop log were four 8-inch wide stop logs. At the time of the incident, all three sections of the structure contained the full complement of stop logs. The stop log height from the base of the bottom stop log to top of the topmost stop log was 44 inches.

This water level control structure was the only structure in the county that did not have eye bolts screwed into the stop logs to assist the volunteers when adding or removing the stop logs. Volunteers use tools to be inserted into the eyebolts so stop logs could be handled on the walkway instead of standing at the base of the water line.

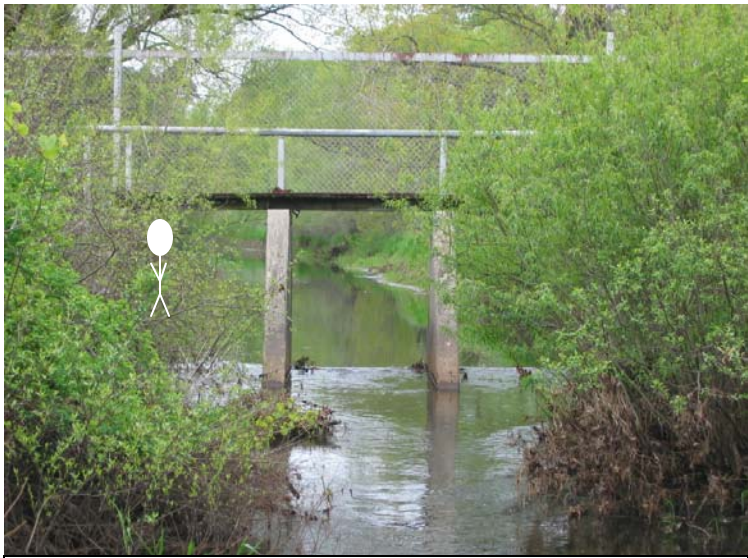
Figure 6. Downstream side of the water level control structure, looking west, showing decedent's location under the structure

As he was lifting the stop log, water flowing under it may have entered into his chest waders. As he removed the stop log from the channel, he may have slipped on the concrete sill of the structure and/or knocked over by the force of the water rushing over the top of the remaining stop logs. He was found approximately 40 feet downstream, caught by low hanging tree branches. He was partially submerged in the water and holding the stop log he had removed. His waders were full of water.

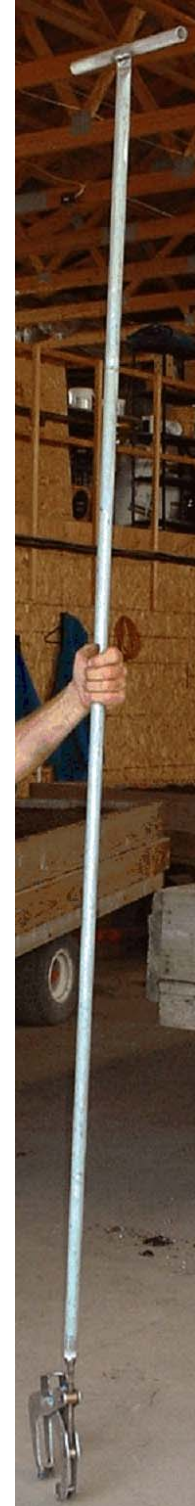
Figure 7. Tool developed to add/remove stop logs

A local farmer developed a tool to permit the addition and removal of the stop logs while standing on the structure's walkway. The user turns the handle, causing the tool shaft to twist, which opens and closes the 10-inch clamp at its base.
