# MIFACE INVESTIGATION REPORT: #08MI037

## SUBJECT: Lineman Electrocuted When He Contacted 7,200-volt Power Line

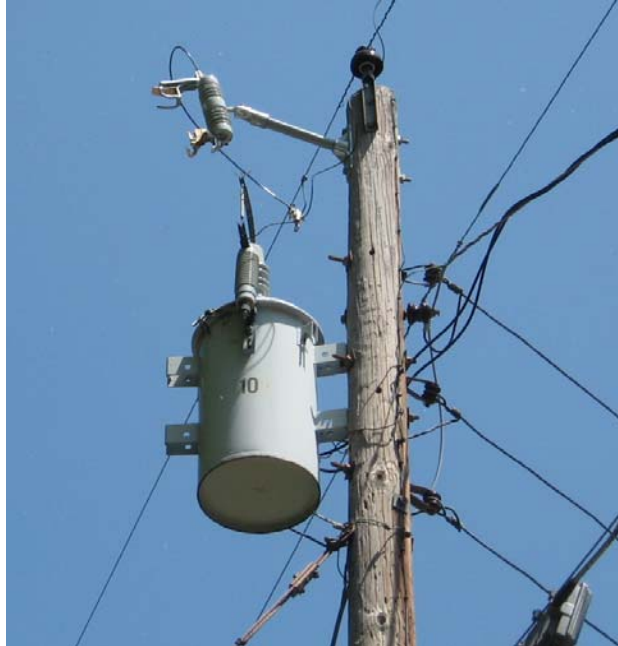
Figure 1. Transformer/can arrester involved in incident, looking north

There were not any on-site safety inspections being performed while the employees were performing switch upgrades on the power line. The employee not wearing his high voltage gloves was removing bolts from the energized can arrester that was fastened to the side of the transformer on pole when he was electrocuted.

The employee, not wearing his high voltage gloves, was removing bolts from the 7200-volt energized can arrestor that was fastened to the side of the transformer on pole when he was electrocuted.

- Employers should ensure that linemen follow established safe work procedures to de-energize, ground, and verify the work area is de-energized through testing prior to beginning maintenance and repair operations on power lines.

- Employers should ensure that linemen use all appropriate protective equipment, including insulated tools, before attempting any work on power lines with energized circuits.

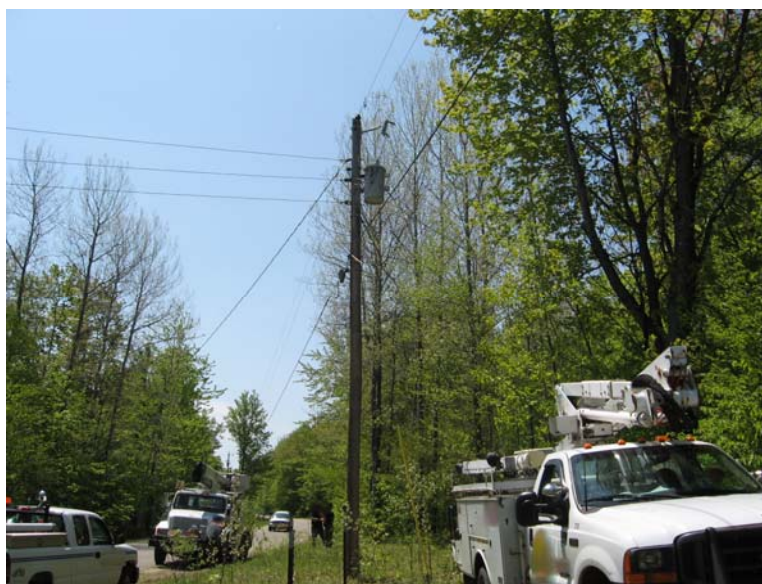
Figure 2. Location of bucket truck near guy wire, looking south

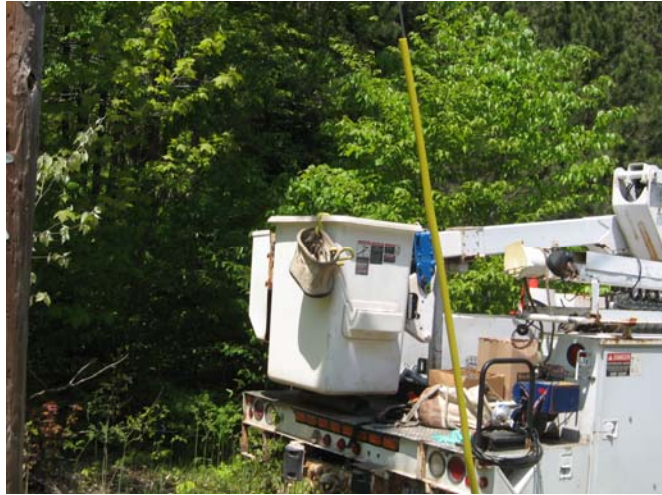
Figure 3. Bucket decedent was working in and glove bag to hang tools

The fourth-year apprentice (ground man) was near the truck standing on the ground assisting the decedent. He heard the line “burp” and then heard the decedent yell to bring him down to the ground. In the police report, the ground man indicated that when he initially lowered the bucket (Figure 3), the decedent was conscious, breathing and shaking. The ground man called to the other work crew, who ran to the scene and helped to lift the decedent from the bucket. After removing him from the bucket, the crew began CPR. In the police report, the ground man indicated he “was getting a very bad signal in the area with his cell phone,” but he was able to connect with his supervisor. The supervisor called for emergency response. Emergency response arrived within six minutes, continued CPR and transported the decedent to a local hospital where he was declared dead. The cotton glove was still on the decedent's right hand and the left hand glove had been blown off (Figure 4).

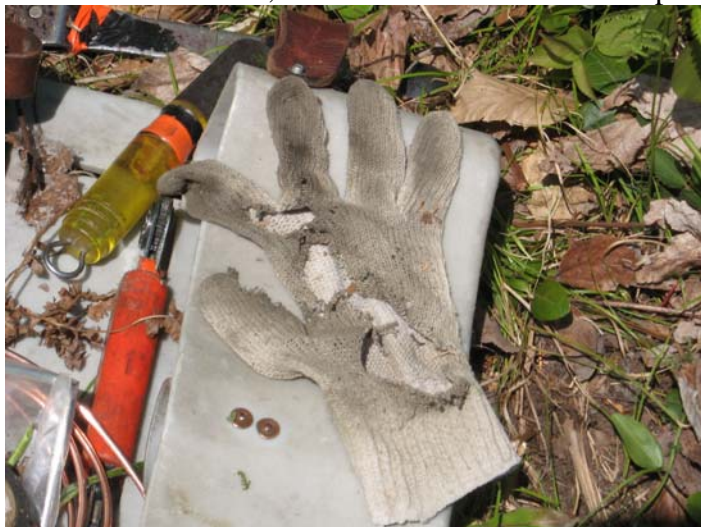
When the decedent was raised up to work, he was wearing cotton gloves under his lineman gloves and lineman sleeves. At some point during the switch change out, he removed his lineman gloves but still wore his cotton gloves and sleeves. The decedent began to remove the bolts holding the existing can arrestor to the transformer to remove the switch. The employer postulated that when the decedent removed the first bolt (bottom bolt) from the transformer, that this loosened the can arrestor and the can arrestor tipped over. The decedent might have instinctively grabbed the can arrestor (still energized) with his right hand. The electricity entrance was through the decedent's right hand, across his chest, exiting from his left hand.

Figure 4. Right hand cotton glove after electrical contact

At some point during the work, the decedent removed his protective gloves, which allowed him to become a path to ground. Employers should stress the need for and mandatory use of required personal protective equipment. Additionally, appropriate tools, such as insulated tools, should be utilized when appropriate.
