# MIFACE INVESTIGATION REPORT: # 08MI010

## SUBJECT: Manufacturing Traffic Supervisor Dies When Struck By Forklift

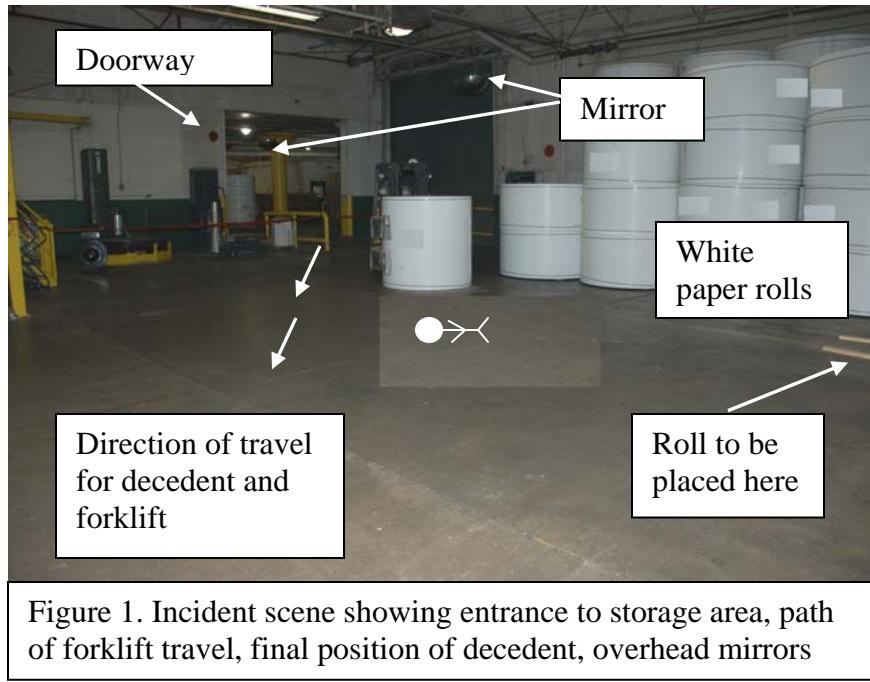
Figure 1. Incident scene showing entrance to storage area, path of forklift travel, final position of decedent, overhead mirrors

was walking through the forklift travel area of the paper roll storage warehouse on his way to the shipping and receiving offices. The driver, who had entered the roll storage area through the doorway, was traveling in a forward direction (not trailing the load). He intended to place the roll in its appropriate place on 2- by 4-inch pieces of wood. The clamp truck/paper roll struck the decedent. The driver looked to his right on the ground and could see the decedent's body to the right of the truck's right tire. He immediately backed up and called for emergency assistance. Emergency response arrived. The decedent was declared dead at the scene.

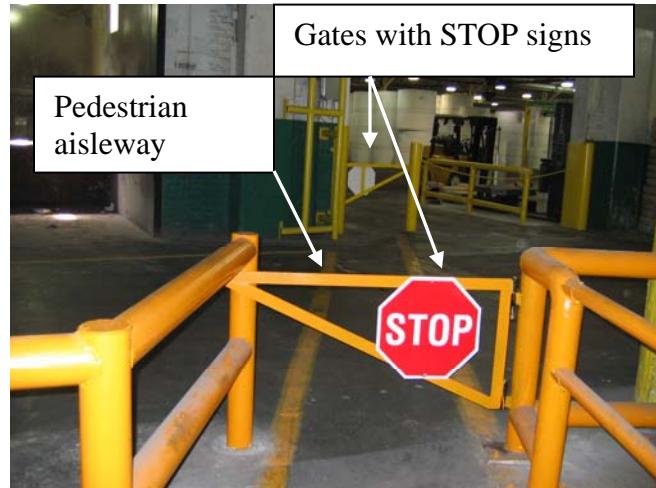
Figure 2. Building modifications made after incident, looking from supervisor's office toward roll storage warehouse

Figures 2 and 3 show the structural modifications made to the incident scene area after the incident. The company installed an overhead hanging STOP sign at the entrance to the roll storage room, and added pedestrian protections, including a marked pedestrian aisle way in the main corridor, gates with posted STOP signs at the entrance to forklift travel areas, and a chain that must be removed by the forklift operator before entering the roll storage area.

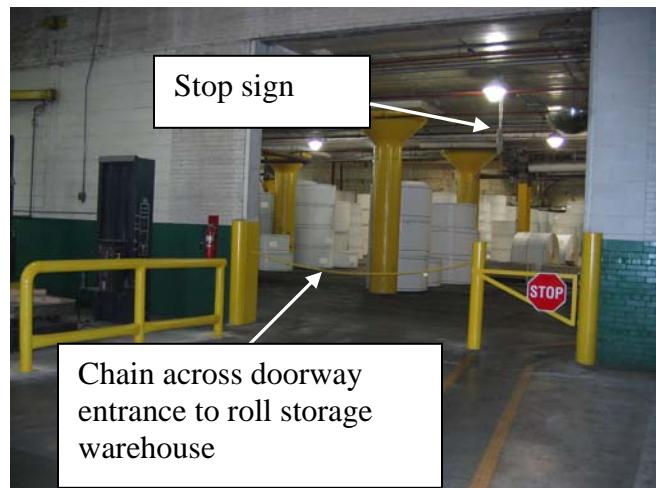
Figure 3. Building modifications looking from roll storage warehouse towards supervisor's office

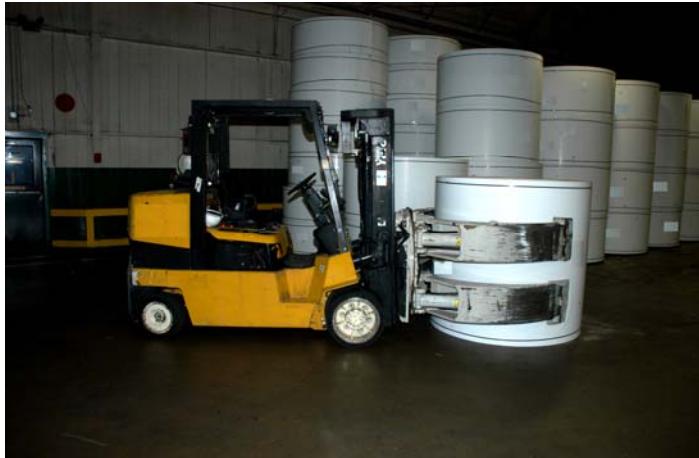
A 7,700 pound capacity Yale clamp truck with a 7,500 pound capacity clamp attachment was involved in the incident. The truck had a functioning horn and head-lights mounted just under the overhead guard. The headlights turned on when the truck was started. After the incident, no mechanical issue was found concerning the truck. The truck with clamp attachment was transporting a 59 1/2 inch tall by approximately 50-inch wide paper roll weighing 4,847 pounds from one area of the plant to a roll storage area. Forklifts were required to be checked each day. If all control and operational checks were satisfactory, the driver did not need to check anything on the forklift checklist form. The checklist was marked only if the forklift needed maintenance.

Figure 4. Yale clamp truck with paper roll involved in incident

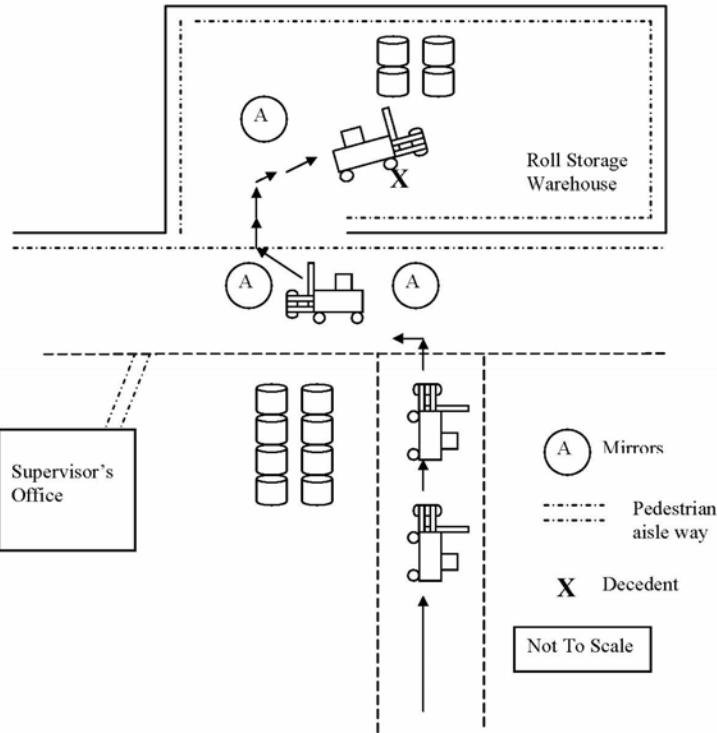
designated storage location, indicated by 2- by 4-inch wood planks in one of the paper storage rows (See Figure 1 and Drawing 1). The police report stated that the forklift driver indicated it was the company's policy to honk the horn on the forklift every time the forklift came to a mirror. The driver indicated he had complied with this policy and honked his horn at all of the aisle intersections and at the entrance to the roll storage area. The driver had been carrying the paper roll between 6 inches and 12 inches from the floor. The top of the paper roll was estimated to have been 66 to 72 inches above the floor.

Drawing 1. Overview of incident scene showing Yale clamp truck travel path

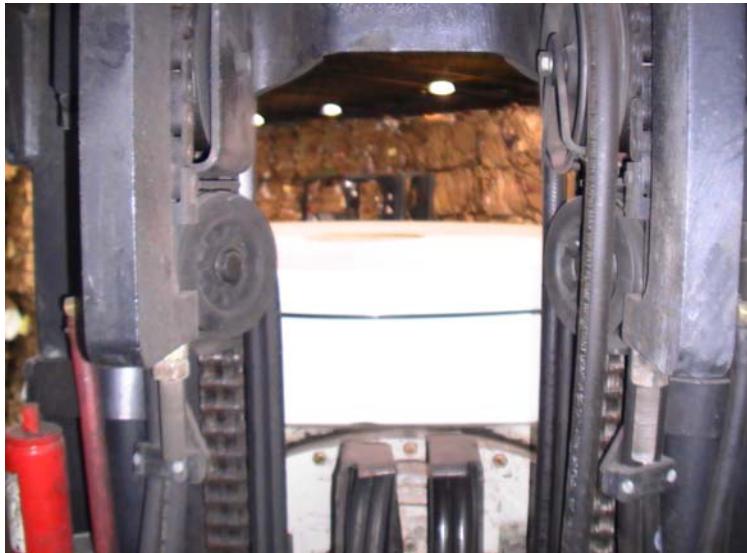
To simulate the forklift operator's line of vision, the firm representative raised the paper roll to six inches above the floor. Figure 5 was taken by the MIOSHA compliance officer as he positioned himself in the forklift to the approximate line of vision of the forklift driver. The officer observed that the roll obstructed forward vision – as the officer looked over the roll, the officer could not see the floor for the first 20 to 30 feet.

Figure 5. Simulated forklift driver forward view when seated in seat.

The decedent was 5 feet 6 inches tall, which placed the top of his head at the same height as the top of the roll if the roll was carried 6 inches above the floor. If the roll had been carried at 12 inches above the floor, it would have been 6 inches above the decedent's head.

- The employer should revise its forklift safety rule regarding driving the forklift in the direction that affords the “best visibility” to clarify and require the operator to trail a load when a driver’s forward vision is obscured.
