Flagger Fatally Injured When Struck by a Car at a Highway Work Zone in Washington State

FATALITY INVESTIGATION REPORT

Investigation: # 00WA01101
SHARP Report: # 52-14-2005

Release Date: January 31, 2006

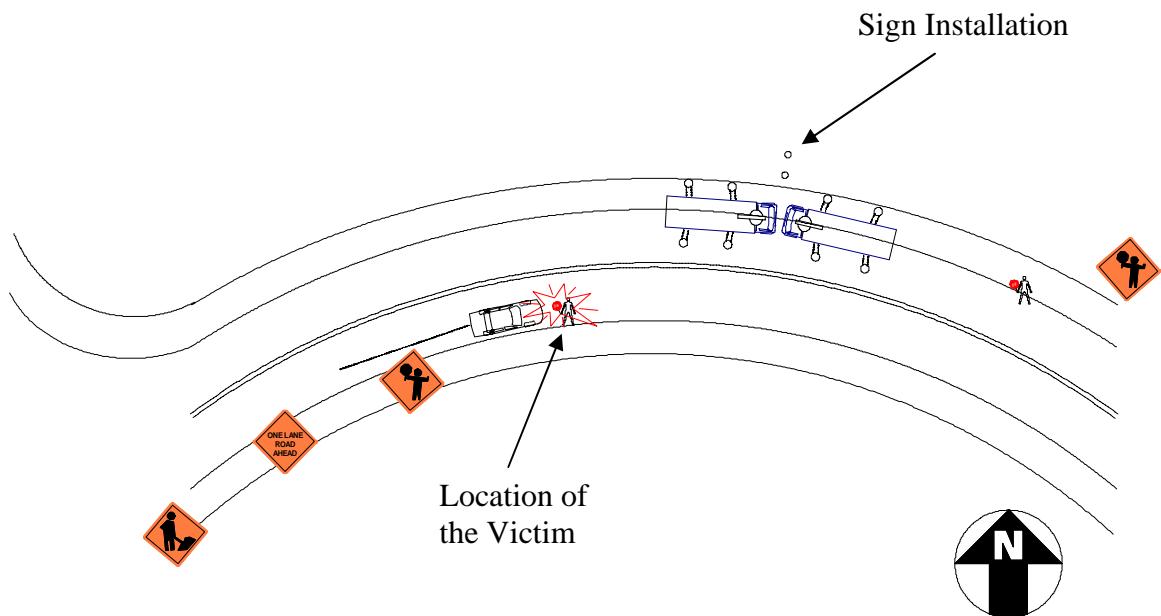
The flagging team established their flagging stations approximately 100 feet in advance of the work zone on both the eastbound and westbound lanes. As soon as the flagging team was in position, they informed the sign installation crew that they could move their trucks and equipment into position and begin setting up the work zone (figure 1 shows a schematic diagram of the work zone).

Figure 1. A schematic drawing of the incident scene (not to scale).

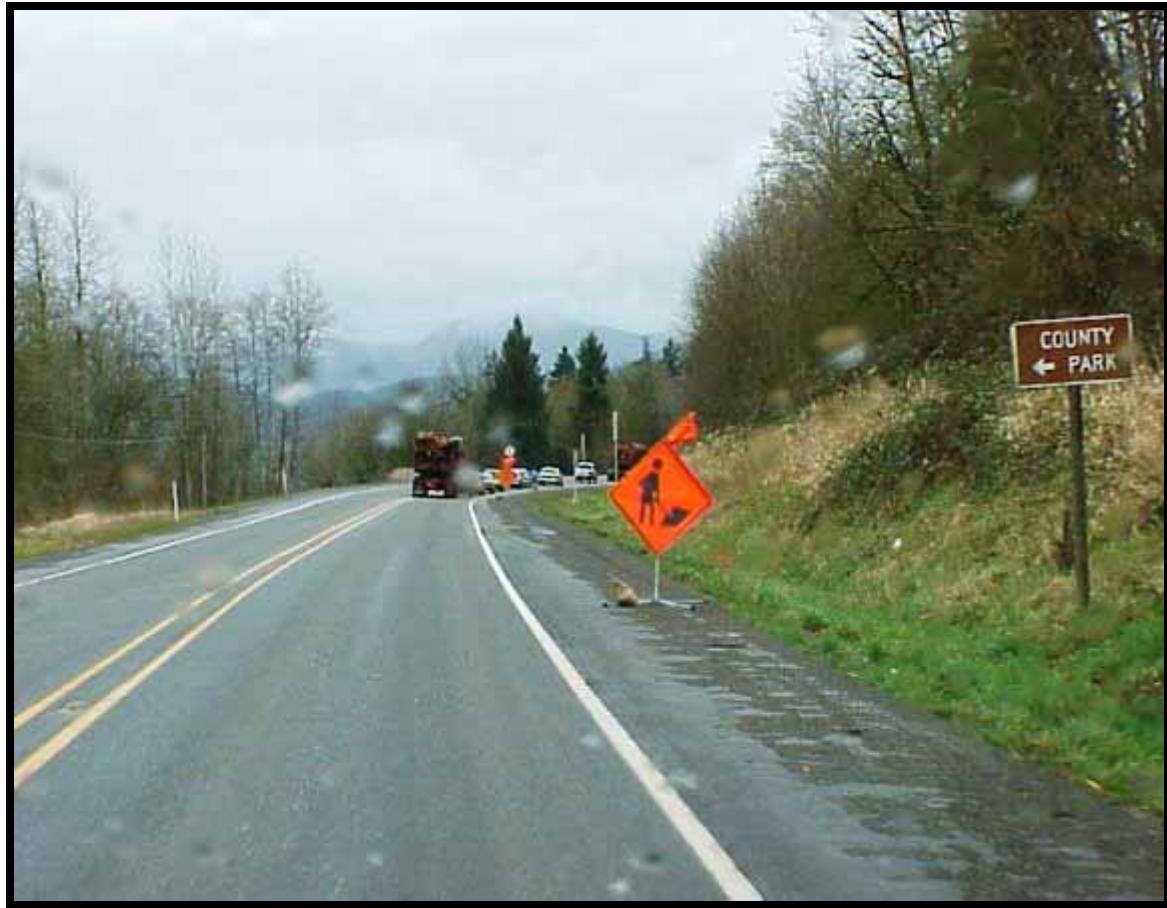
There was a long sweeping curve traveling east along the highway that preceded the victims flagging station. Although the curve was relatively gradual in nature, traveling at 55-60 miles per hour would bring a vehicle up to the flagging station fairly quickly before seeing the flagger. Traffic on the road that afternoon was moderate to heavy and consisted of a mix of private vehicles, commercial vehicles and large trucks/semi-tractor trailers all traveling at a fairly steady pace along this two lane highway. The speed limit for road was posted at 55 MPH.

Photo 1: Shows work zone signs traveling eastbound heading toward the incident site which is just beyond the curve on the highway.

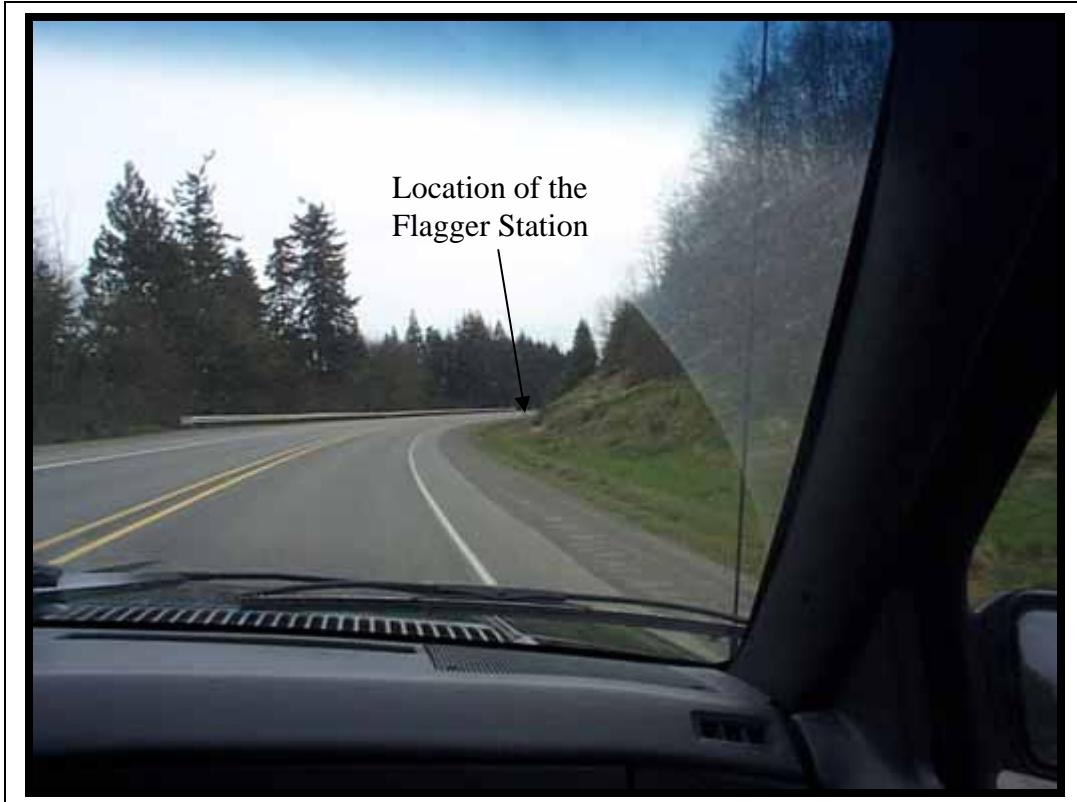
Photo 2: Shows the FACE Investigation vehicle traveling eastbound toward the flagger station and work zone during post incident FACE investigation.

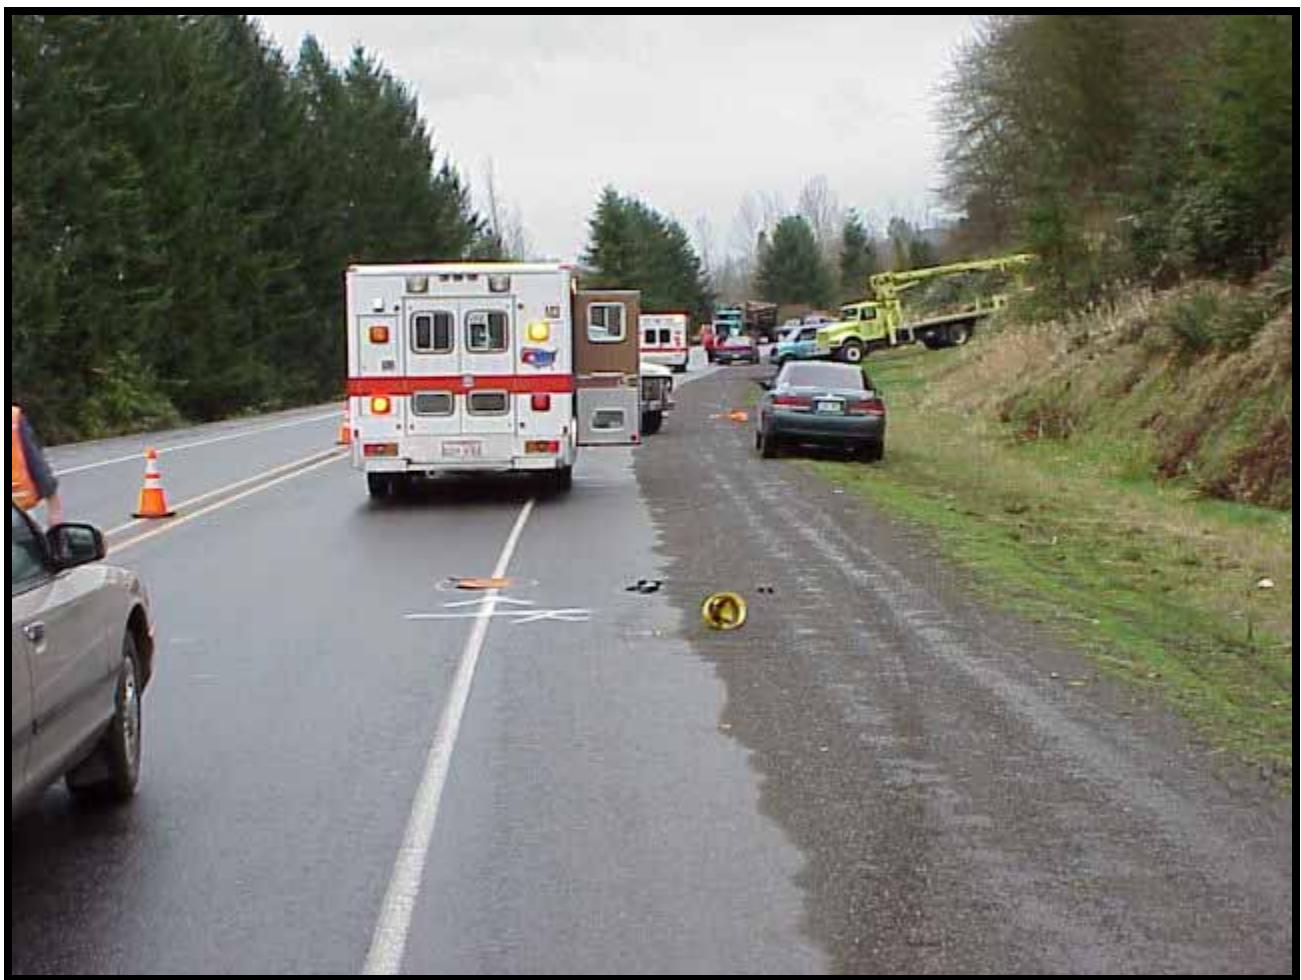
The highway had a paved shoulder that then gave way to a section of sloped packed soil and weeds. Witness statements and police reports indicate that the victim was perhaps standing in the eastbound traffic lane side of the highway fog line and was not facing oncoming (eastbound) traffic at the time of the incident.

Photo 3: Shows the incident site looking east on the eastbound traffic lane and the shoulder of the highway.

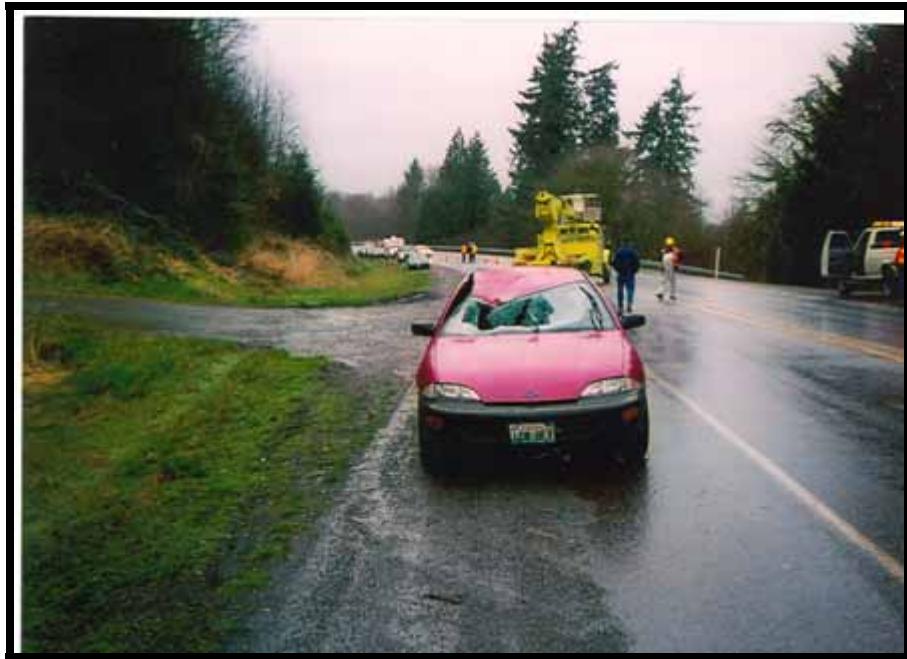
At that moment, an eastbound vehicle, a 1996 Chevrolet Cavalier was approaching the flagger station. It appears the victim did not see the approaching vehicle. The vehicle was traveling at an estimated 50–55 mph when it entered the work zone and it was observed that the vehicle showed no sign that it was slowing down. The lead flagger witnessed the vehicle strike the victim. He indicated that he did not hear the car breaking nor did he hear any skidding sounds from the vehicle before impact. He observed the victim hit the windshield and then go flying into the air for about 15 to 20 feet. He landed on his side and slid another 10 to 15 feet along the asphalt pavement before coming to a stop.

Photo 4: Shows the vehicle involved in the incident looking west along the shoulder of the eastbound lane.

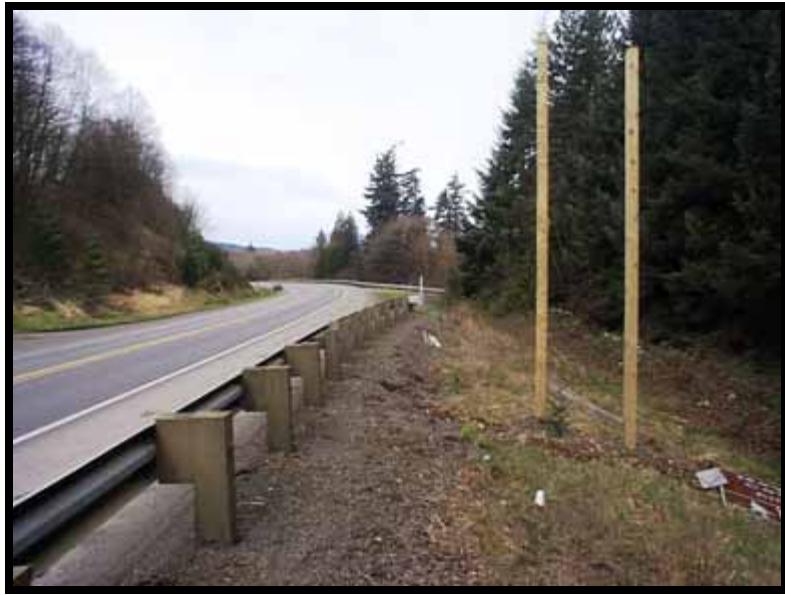
Photo 5: BEFORE- Shows the work zone site during 1st post-incident FACE investigation site visit, prior to fill, rock and gravel being brought in to augment the sign installation. Looking west along the eastbound lane of highway.

After this incident occurred, the organization decided to stop any further work on the county park sign installation until they had a chance to review all of the incident investigation facts and recommendations. After studying the incident and all the investigation reports and carefully assessing the work area, the company made the decision to bring in fill, rock and gravel so that they could safely park their work vehicles completely off the highway and

behind the guardrails at that location (photos 5 and 6 show the site before and after filling the slope).

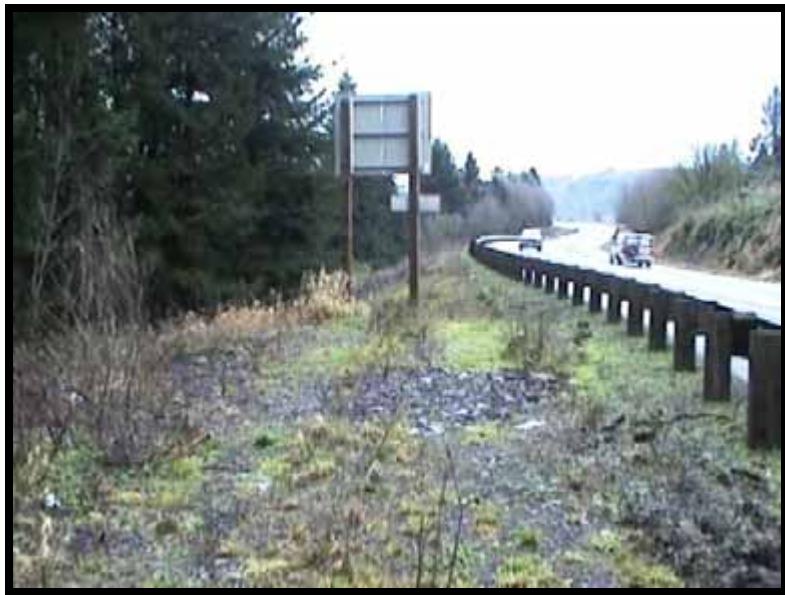
Photo 6: AFTER- Shows the work zone site during 2nd post-incident FACE investigation site visit, and after fill, rock & gravel had been brought in so sign installation could be completed off the roadway without impacting highway traffic. This view is looking east along the westbound lane of highway.

The organization, in essence, decided to follow some of the primary principles of the hierarchy of safety which were to eliminate/substitute and /or engineer out the hazard. They engineered out the hazard by redesigning the work zone and thus eliminating or reducing the hazard of the motoring public for the workers in the work zone. Rock and gravel fill was brought in to build up the berm along the inside of the guardrail so that work could be completed and any future maintenance would allow vehicles and workers to be protected by the guardrail and there would be no need to restrict traffic or establish any traffic control for the area. It was possible to complete the berm work off the roadway and behind the guardrail.
