# MIFACE INVESTIGATION REPORT: #08MI169

## SUBJECT: Air Museum Volunteer Died From Complications of a Head Injury Sustained After Falling From an Aircraft Tug

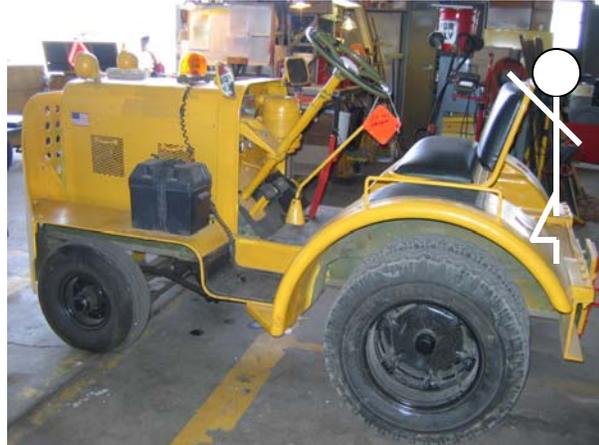
Figure 1. Aircraft tug and squatting position of decedent on back of tug

On the day of the incident, the ramp crew noted that an aircraft turned back toward the ramp. The decedent's ramp crew responded to assist the aircraft. Two individuals were seated in the front seat and the decedent was positioned on the back of the tug, squatting in the storage area. He was facing the driver's side; his right side was leaning against the back of the front seat. He held onto the seat frame for balance. The 10- to 11-foot tow bar was attached to the back of the tug.

It is postulated that while the tug was accelerating, a gust of wind caught the brim of the decedent's baseball cap and lifted the cap off his head. The decedent stood up from his squatting position in an attempt to grab his cap. He lost his balance and fell from the tug, and landed on the driver's side of the tug. He fell onto his side, then back, and struck the left side of his head on the pavement. The decedent was knocked unconscious from the impact. The tug stopped prior to reaching the end of the 10- to 11-foot tow bar.

- Air museum staff should update the Ramp Crew Safety Manual to:
  - Adopt a “No Seat – No Rider” policy,
  - Comply with requirements of MIOSHA General Industry Safety Standard, Powered Industrial Trucks, Part 21 and
  - Include industry best practices.

The front seat provided space for two passengers. The manual does not contain a statement prohibiting more than two passengers (riders) on the tug (No Seat – No Rider policy). The work practice observation evaluation form also did not address a trainer observing more than two individuals riding on the tug.

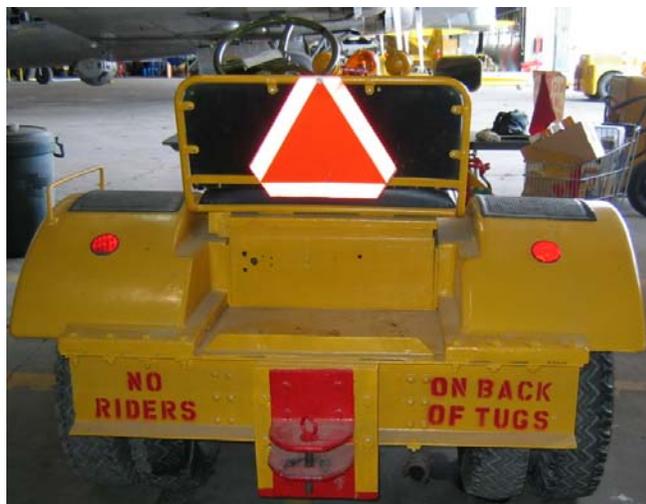
The aircraft tugs can either push or pull an aircraft to a designated area using a tow bar appropriate for the aircraft. The tug had a front seat designed for two passengers. At the back of the tug is an area for storage of equipment, such as wheel chocks and signaling wands, and the

Figure 2. Back of aircraft tug showing storage area and rider warning

attachment point for the tow bar. The tug did not have a suspension system or seat belts for the front seat passengers. The tug operated at a speed less than 5 mph.

Air museum personnel have spray painted the back of each tug with "No Riders on Back of Tugs."

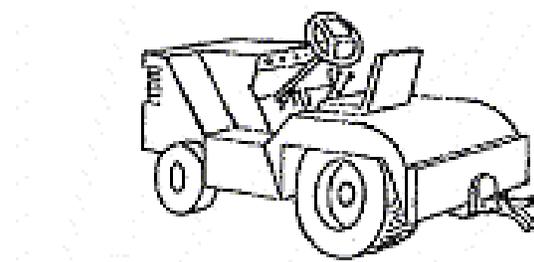
Drawing 1. Industrial Tractor,  
MIOSHA Part 21, Appendix A,  
Figure 5

MIOSHA General Industry Safety Standard, Powered Industrial Trucks, Part 21 provides safety rules for the care and use of powered industrial trucks and operator safety. The aircraft tug is considered to be an “industrial tractor” by MIOSHA. An industrial tractor is a “truck designed primarily to draw one or more non-powered trucks, trailers or other mobile loads.” Part 21’s Appendix A, Figure 5, and reproduced as Drawing 1 illustrates the type of vehicle included in this definition.

MIFACE recommends that the Ramp Crew operational division review the MIOSHA Powered Industrial Truck standard and update the Ramp Crew safety manual, including the observational checklists to include the missing MIOSHA requirements.
