MIFACE INVESTIGATION REPORT: #08MI134

SUBJECT: Farmer Entangled in Unguarded Rotating Motor Drive-shaft on Farm-Modified Ear-Corn Elevator

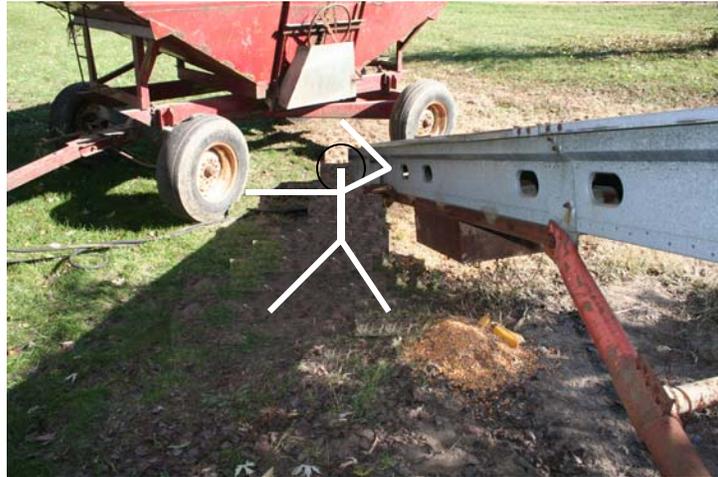
Figure 1. Position of decedent, laying on his back, head resting on motor facing south, left arm between his ear and the elevator

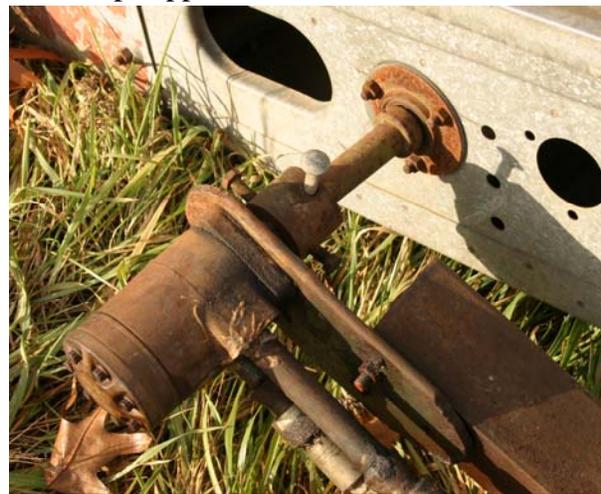
The ear-corn elevator was farm-modified, and had previously been owned by another farmer. Two hydraulic hoses, attached to the tractor and the motor, powered the motor. Four bolts, each extending at least two inches from the motor drive-shaft, were unguarded (Figure 2). The motor and its hydraulic connections were located on the east side of the elevator. The hydraulic hoses were haphazardly coiled at the south end of the elevator.

Figure 2. Motor, drive-shaft with bolts, two hydraulic hoses

- Farmers should inspect all farm equipment to ensure that all exposed rotating or moving parts are guarded/shielded. If guards/shields are missing, appropriate guarding should be installed.

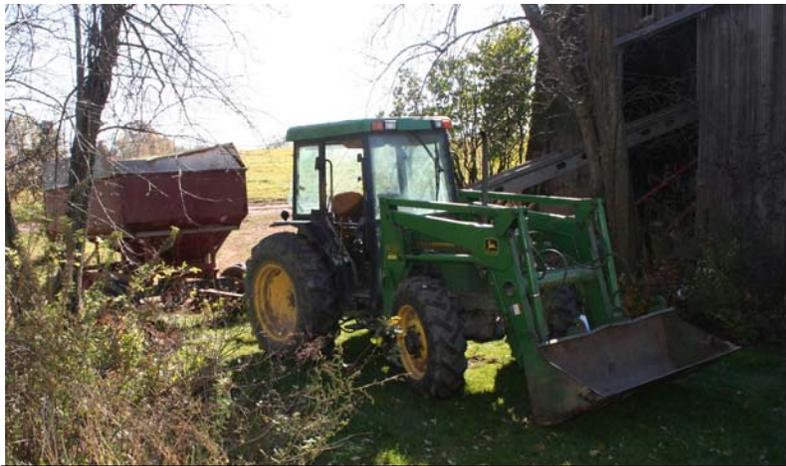
Figure 3. Positions of implement shed, elevator, gravity box and tractor

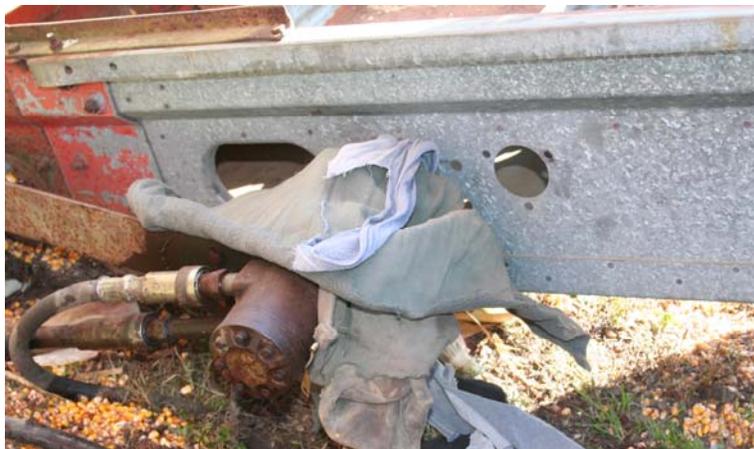
In the early afternoon, his son went out to the barnyard to help the decedent. His son found him lying on his back on the ground with his head facing southeast next to the elevator. The tractor was still running. The decedent's left sleeve of his Carhart® jacket had become entangled on the bolts of the motor drive-shaft. His head was resting on the motor, and his shirt was tightly wrapped around his upper torso and neck. His left arm was positioned above his head, between his head and the elevator (Figures 1 and 4). There was a pile of corn kernels and a couple of corn cobs near the decedent's left foot. After turning the tractor off, his son ran to the house and called for his mother to come outside. Emergency response was called. While the emergency response personnel were en-route, the decedent's son attempted to free him using a knife to cut away his clothing. He was unable to do so. When emergency response arrived, the decedent did not appear to be breathing. The responding Fire Department determined that

Figure 4. Decedent's clothing wrapped around motor shaft

- Machine operators should not wear loose-fitting or frayed clothing. Operators should be aware that jackets and sweatshirts with draw-strings can also be caught in unguarded rotating/moving parts

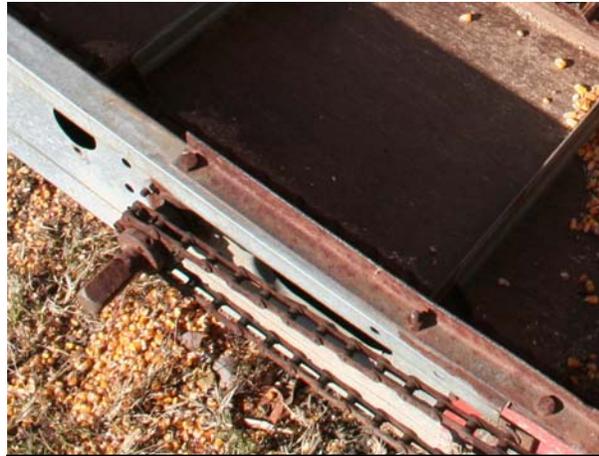
Any farm-made guards and shields that are designed and installed are considered a modification of equipment and should meet MIOSHA standards to provide appropriate worker protection. The portable ear-corn elevator had two unguarded entanglement hazards. In addition to the rotating shaft on the southeast side of the corn elevator, the southwest side of the corn elevator had an unguarded moving drive chain (Figure 5). Exposed rotating shafts and moving parts, such as belts, sprockets, and chains present hazardous situations that can cause serious injury or death to workers. Properly designed guards and/or shields should cover any rotating shafts or moving parts that a worker may be exposed to.

Figure 5. Unguarded drive chain

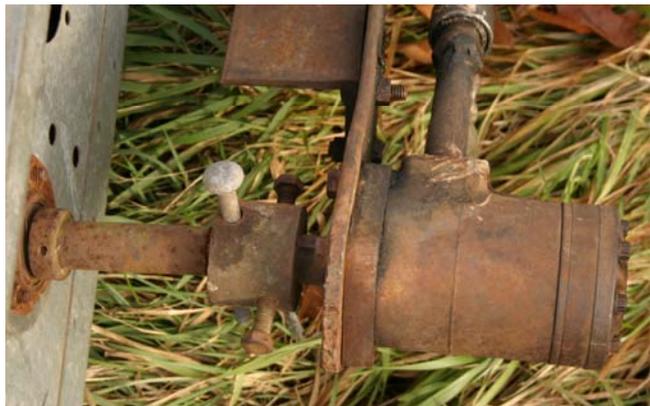
Although if adequately guarded, the excessive bolt length (Figure 6) would not have been a factor, farmers should inspect farm equipment, especially if farm-modified, to ensure that the best possible part selection was used and that a safety hazard was not created. In this incident, machine set screws could have been used instead of bolts and shield/guards installed.

Figure 6. Bolts on motor drive-shaft

Again the MIOSHA rules provide useful guidance. Part 7, Rule 736 states that projecting keys, set screws and other projections in revolving parts exposed to contact, shall be removed, made flush or guarded.
