Massachusetts Department of Public Health Occupational Health Surveillance Program Fatality Assessment and Control Evaluation Project

Municipal Laborer Dies after Falling Off the Back of a Forward Moving Refuse Collection Truck – Massachusetts

Investigation: # 09-MA-020-01 Release Date: November 6, 2009

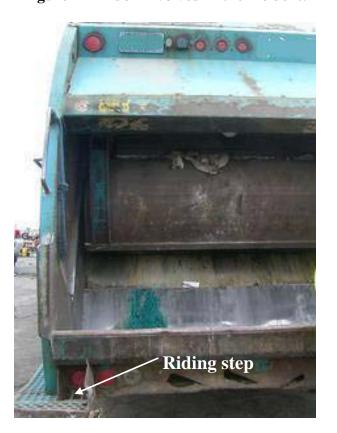
The truck involved in the incident is a cab-over design manufactured in 2001 with two bucket seats inside the cab. The truck's body is a rear loading compacting unit that was also manufactured in 2001. The truck is equipped with riding steps located on both the left and right rear sides of the truck (Figure 1). The riding steps start approximately two feet in from either side of the rear of the truck and wrap around the sides of the truck. Located at both rear corners of the truck are vertical grab handles. There are also horizontal grab handles located on the rear sides of the truck above where the riding steps wrap around from the back of the truck to the sides (Figure 1). On the day of the incident, the victim was working from the driver's side of the truck and the second thrower was working from the passenger side of the truck.

Figure 1- Truck involved in the incident.

Recommendation #1: Employers should ensure that employees are never located on refuse collection trucks' rear riding steps when the trucks are traveling faster than 10 miles per hour or traveling more than 0.2 mile.
