## **Massachusetts FACE • Occupational Fatality Report**

### **Mechanic Dies while Changing a Tire Mounted on a Multi-piece Split Rim Wheel - Massachusetts**

**Investigation: # 07-MA-058-01**  
**Release Date: October 20, 2009**

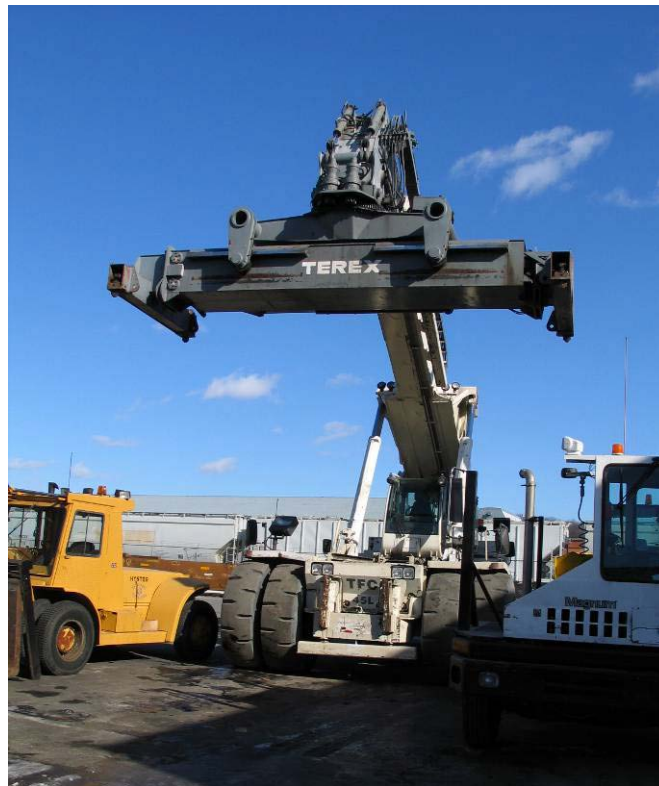
**Figure 1 – Container handler involved in the incident.**

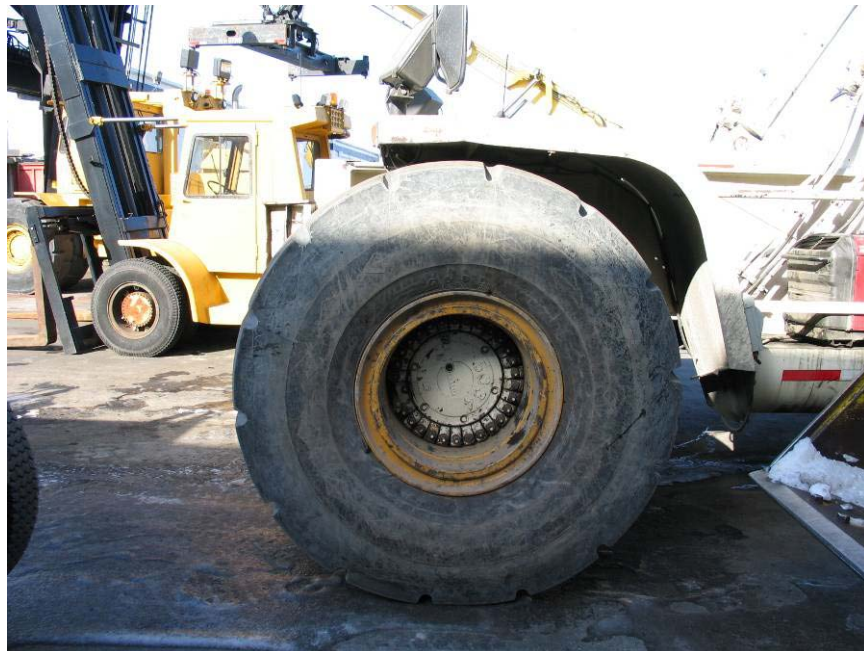
This container handler is equipped with six wheels, four in the front (dual wheels) and two in the rear. All of the wheels are multi-piece split rim wheels<sup>a</sup> with 21.00x25 size tubeless rubber tires (approximately 23 inches wide and 69 inches high) (Figure #3). These multi-piece split rim wheels consist of five components, an inner and an outer rim, a collar, and two rings, one of which is a locking ring. The front outer wheels of the container handler are each fastened to the vehicle's axle with 28 lug nuts and clips. The company reported that this container handler had not been altered and that maintenance schedules are followed for all equipment. Most of the equipment maintenance is performed onsite by the company's mechanics.

**Figure 3 – Container handler with replaced wheel.**

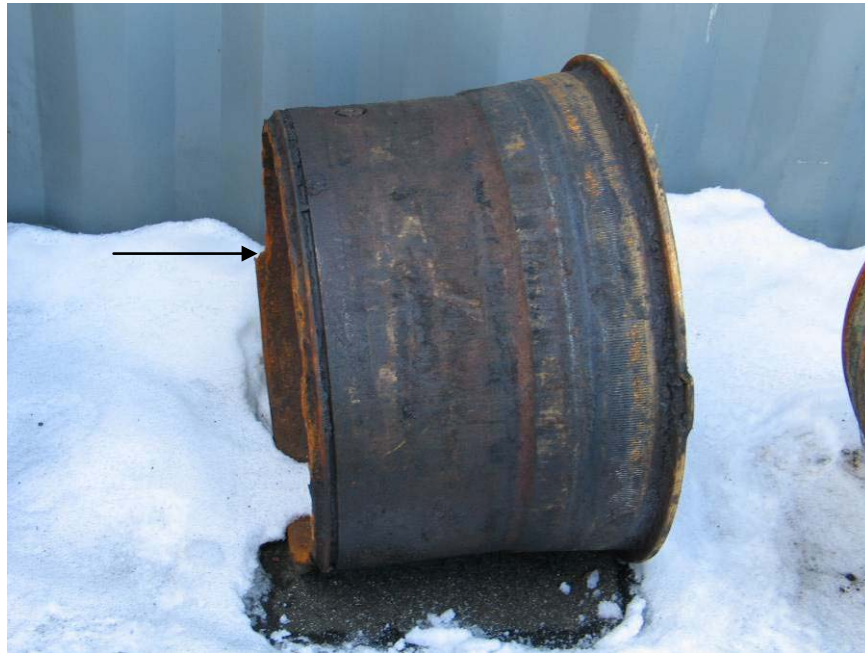
After the incident, it was discovered that the front left outer multi-piece split rim failed and had a crack within an inch of the rim's interior ring (Figure #4). During the site visit, the split rim that failed looked worn, rusty and had some pitting. The company stated that they were going to start conducting routine inspections of all of their multi-piece rim wheels. In addition they were now going to hire a tire company to maintain all of the container handlers' wheels.

In this case, the company did not perform routine inspections of their multi-piece rim wheels. If the employer performed routine inspections of the rim wheels then the cracked rim that failed might have been identified prior to the incident and taken out of service. In addition, if a visual assessment of the rim wheel was performed while it was still mounted on the container handler and prior to starting the removal of the wheel, it might have been noticed that there was some rusting and pitting present on the visible surface of the rim wheel. This visual assessment could

**Figure 4 – Rim component of the multi-piece rim wheel that failed.  
The arrow is pointing to the section of the rim component that cracked and failed.**

**Discussion:** Employers should ensure that routine inspections of multi-piece rim wheels are performed. Employees conducting the inspections should be experienced and trained on multi-piece rim wheels (Recommendation #5), and the vehicle to which the wheel is attached, and has the authority to take immediate action to correct any problems including stopping work and taking equipment out of service.<sup>2</sup> Rim wheel inspections should start with deflating the tire while it is still securely tightened to the vehicle's axle by removing the valve core and then removing the wheel from the axle and disassembling all of the rim wheel components. Then visual assessments of each rim wheel component for any damage and deformities, such as rust, pitting, excessive wear, corrosion, cracks, bent areas, and any other potential damage should be performed. Any damaged or questionable parts found during inspections should be tagged, removed immediately from service and discarded or returned to the manufacturer.

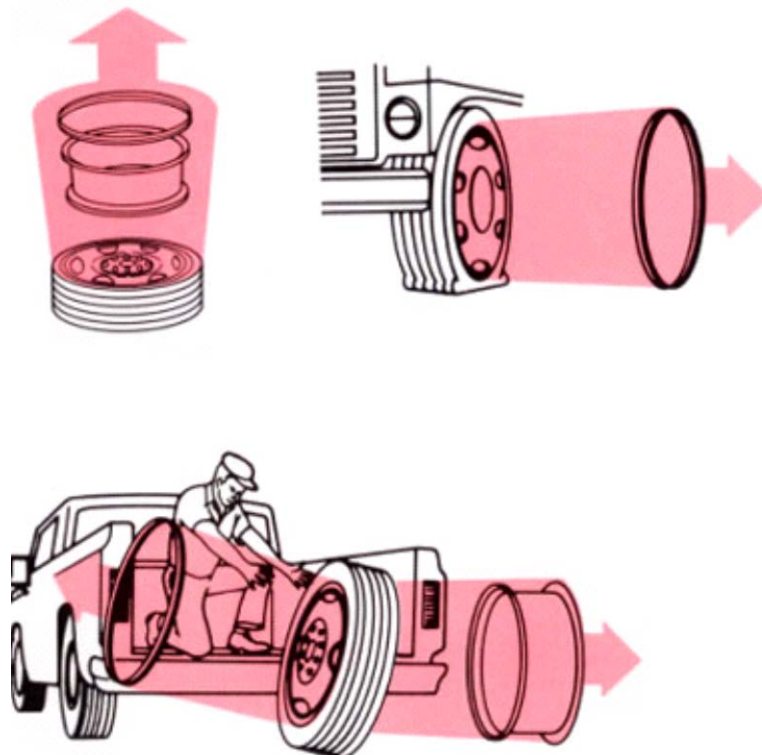
**Discussion:** OSHA's definition of trajectory is any potential path or route that a rim wheel component may travel during an explosive separation, or the sudden release of the pressurized air (Figure #5). Therefore, when a rim wheel with an inflated tire is mounted on a vehicle, to minimize the hazard of being struck by a rim wheel component during an explosive separation or sudden release when working on the wheel, it is extremely important for employees to always stay outside of the trajectory. During tire inflation a cage or barrier should be used to protect workers from the hazard of being struck by a rim wheel component during an explosive separation or sudden release.<sup>1</sup>

In this case, the victim was standing directly in front, within the trajectory, of a multi-piece rim wheel that had an inflated tire mounted on it. Reportedly, the victim was using a sledge hammer to strike the rim wheel to loosen it from the container handler's axle. If the victim had been standing off to the side of the wheel, outside of the trajectory, when the rim wheel failed and explosively separated, his injuries might have been minimized or prevented.

**Figure 5 - Trajectory of multi-piece rim parts in different scenarios.**

**Recommendation #2: Employers should ensure that employees never position themselves in the trajectory (in front of or over) of inflated tires mounted on multi-piece rims.**
