## Equipment Operator Killed by a Lock Ring Propelled from a Multi-piece Rim Wheel

Case Report: 07NY137

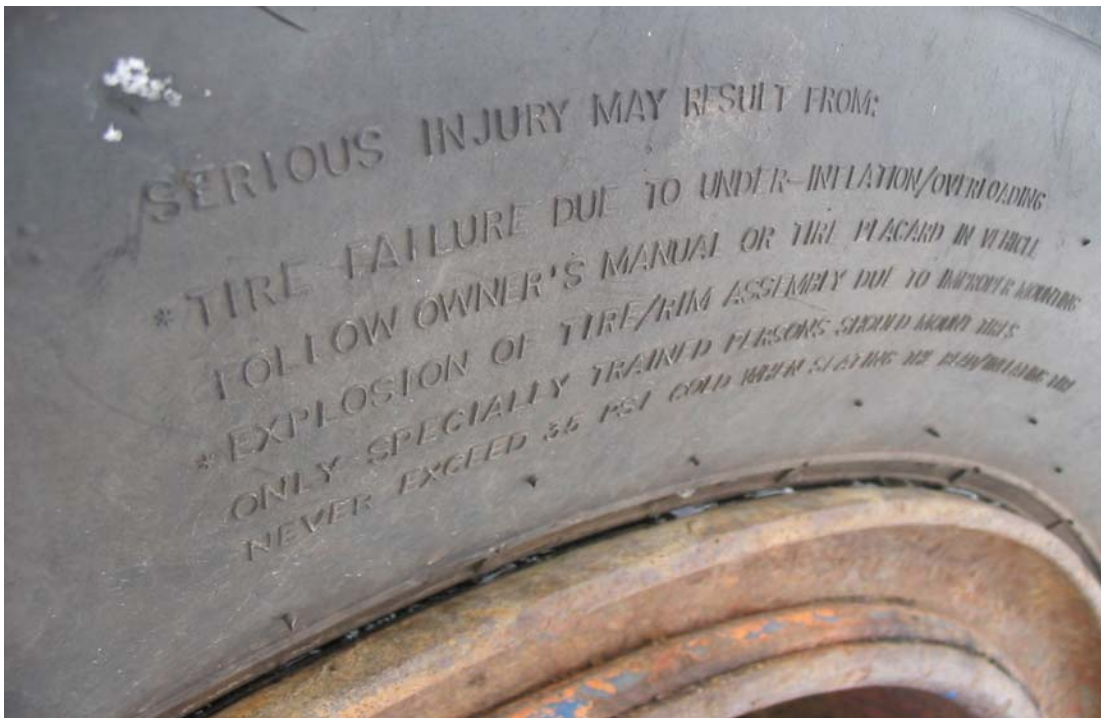
The victim operated a front-end loader that was a 1985 model. The loader was equipped with four pneumatic tires, size 17.5-25. The tires were 12 ply, load range F and equipped with tubes. The manufacturer specified 35 pounds per square inch (psi) as the maximum cold tire inflation pressure. The hazard warning on the tire stated that serious injury may result from under-inflating, overloading or improperly mounting a tire and that "only specially trained persons should mount tires"(Photo 1).

Photo 1. The warning on the tire addressing the hazards associated with under-inflating, overloading and improper mounting a tire (Photo courtesy of OSHA).

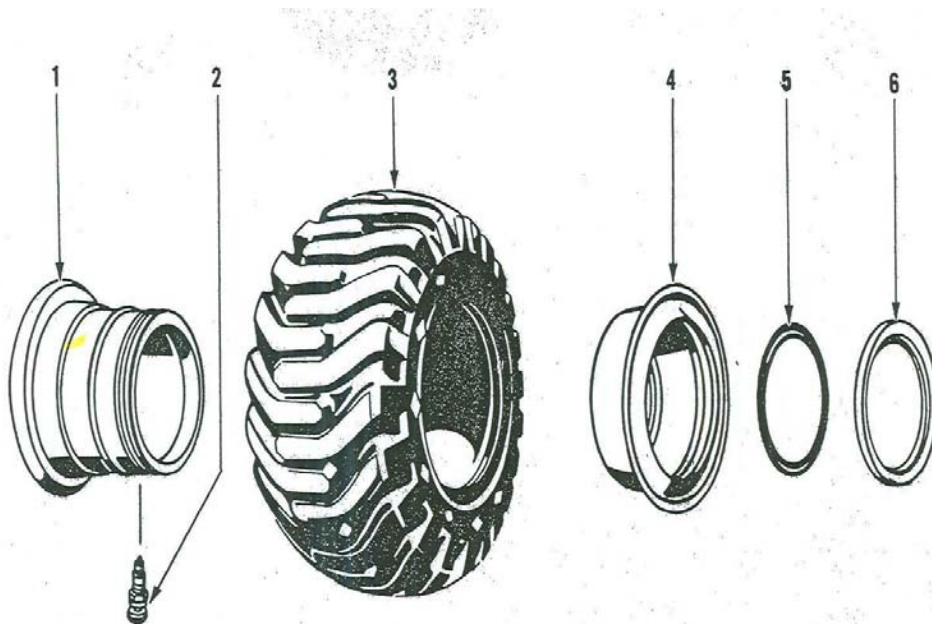
Three of the four tires, including the one that was involved in the incident, were mounted on wheels that were multi-piece type or split wheels. The multi-piece rim wheel in this case consisted of six components: the rim base, valve assembly, tire, side ring, O-ring and lock ring (Figure 1). The function of the lock ring was to hold the tire in place by locking and securing the other wheel components when the tire is inflated. The multi-piece rim wheel involved in the incident was installed in August 2006.

Figure 1. Components of the multi-piece rim wheel: 1. rim base, 2. valve assembly, 3. tire, 4. side ring, 5. O ring, and 6. lock ring (figure courtesy of OSHA).

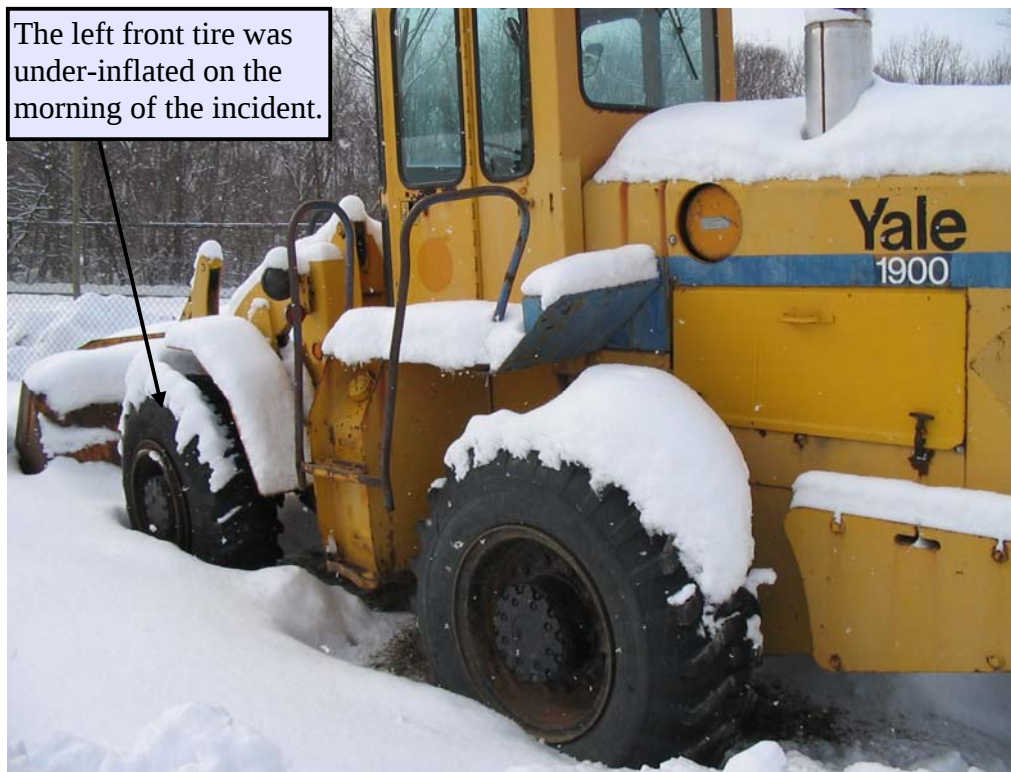
to warm up the machines. According to the co-worker, soon after the victim started his loader, he noticed that the left front tire on his loader was “soft” or under-inflated (Photo 2). The victim asked the co-worker, whose loader had an air compressor, to put air in the tire. After waiting for the machine to warm up, the co-worker backed his loader over to the victim’s loader and retrieved an air hose from his cab. The air hose was approximately 25 feet long and half-inch in diameter with a clip-on chuck on one end (Photo 3). It did not have an in-line pressure gauge. The co-worker connected one end of the air hose to the quick-connect fitting of the air compressor on his loader. According to the coworker, the victim was having trouble attaching the clip-on chuck to the tire valve stem. The co-worker attached the chuck to the tire valve for the victim. He then returned to his loader's cab and used the throttle control to maintain the airflow.

*Photo 2. The loader that was operated by the victim on the morning of the incident. The left front tire was under-inflated at the time of the incident. (Photo courtesy of OHSA)*

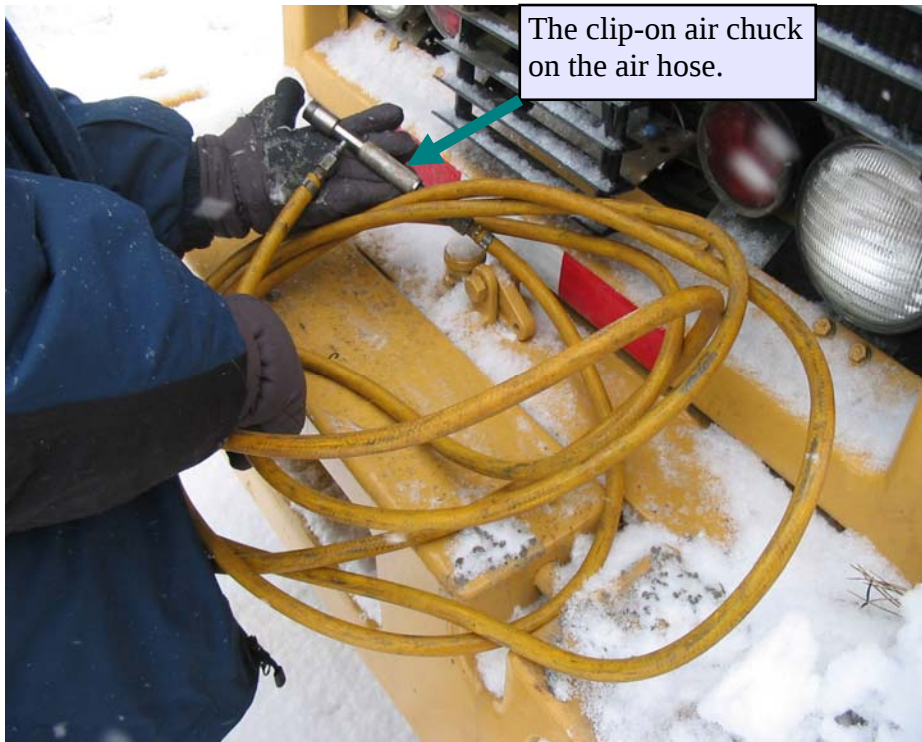
*Photo 3. The air hose that was used by the victim and the co-worker during the incident. The hose had a clip-on chuck on one end. It did not have an in-line gauge (Photo courtesy of OSHA).*

**Recommendation #3:** *Employers should provide an air hose that has an in-line pressure gauge and sufficient hose length between the in-line pressure gauge and the clip-on chuck to allow workers to stay outside the trajectory of the wheel components when inflating the tire.*

**Discussion:** Employers should provide every field equipment operator who may inflate a multi-piece rim wheel an air line assembly consisting of the following components: a clip-on chuck, an in-line valve with a pressure gauge or a pre-settable regulator and a sufficient length of hose between the clip-on chuck and the in-line gauge. Remote control inflation equipment may also be provided. All of this equipment enables the workers to stay outside the trajectory that propelled wheel parts may travel when inflating the tire.

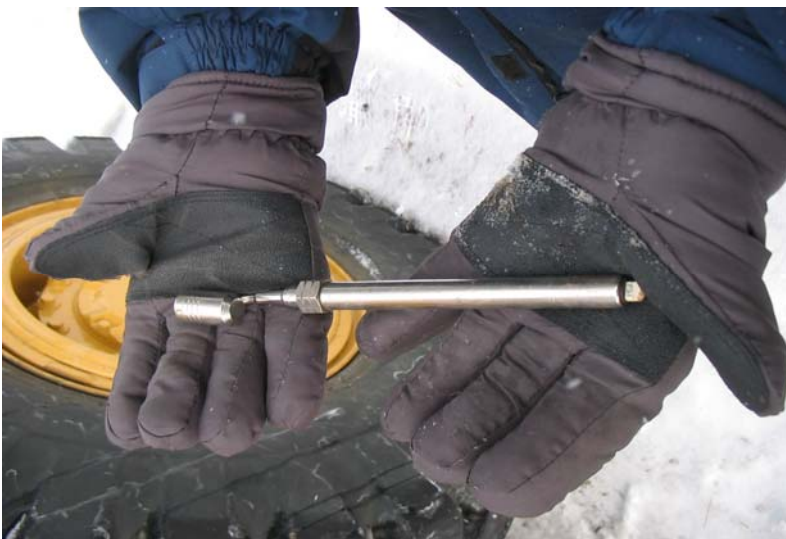
The initial tire pressure was not checked. Periodically, as the tire was being inflated, the victim checked the air pressure at the tire valve with a hand-held pressure gauge (Photo 4). According to the co-worker, the victim informed the co-worker that the air pressure in the tire was about 15 to 20 psi after a few minutes of injecting air into the tire. This was well below 28 psi, that was 80% of the manufacturer recommended pressure of 35 psi. The co-worker told the victim not to let the pressure exceed 30 psi.

*Photo 4. The hand-held air pressure gauge used by the victim during the incident (Photo courtesy of OHSA).*

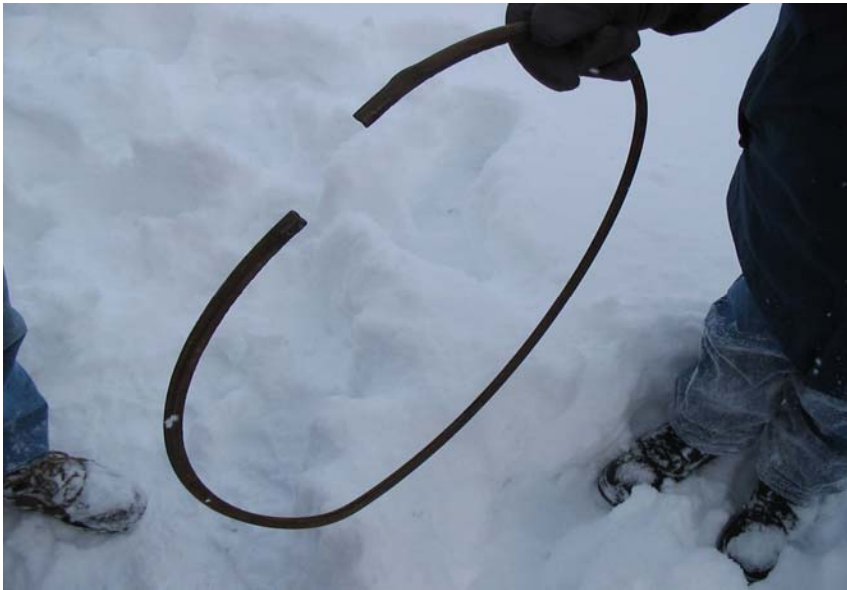
*Photo 5. The lock ring that was propelled from the multi-piece rim wheel; it struck the victim while he was inflating the rim wheel (Photo courtesy of OSHA).*

If a tire mounted on multi-piece wheel loses a significant amount of air, the wheel components that are secured in the rim base under the normal tire air pressure may be offset or dislodged. When the flat tire is inflated, due to the rapid increase of the air pressure and volume, the dislodged wheel components can be propelled at great distances with great forces and can cause serious injury or death to anyone in the trajectory area. The victim and the co-worker in this case apparently were not aware of the danger of inflating a multi-piece rim wheel.

OSHA requires that if the pressure in a multi-piece rim wheel is reduced to 80% or below the recommended operating pressure, the tire assembly shall be completely deflated, removed from the vehicle, disassembled, inspected and reassembled prior to inflation. These should only be done by professional tire services. Maintenance personnel or equipment operators should never attempt to perform the job in the shop or the field.

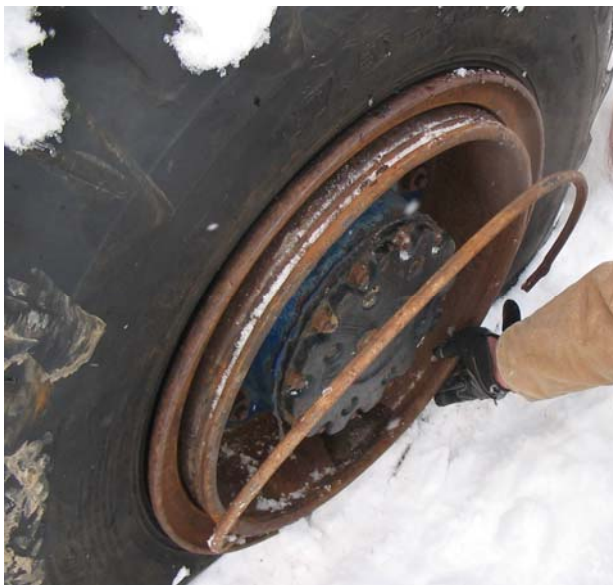
*Photo 6. The dislodged lock ring was being refitted to the multi-piece wheel that was involved in the incident (Photo courtesy of OSHA).*

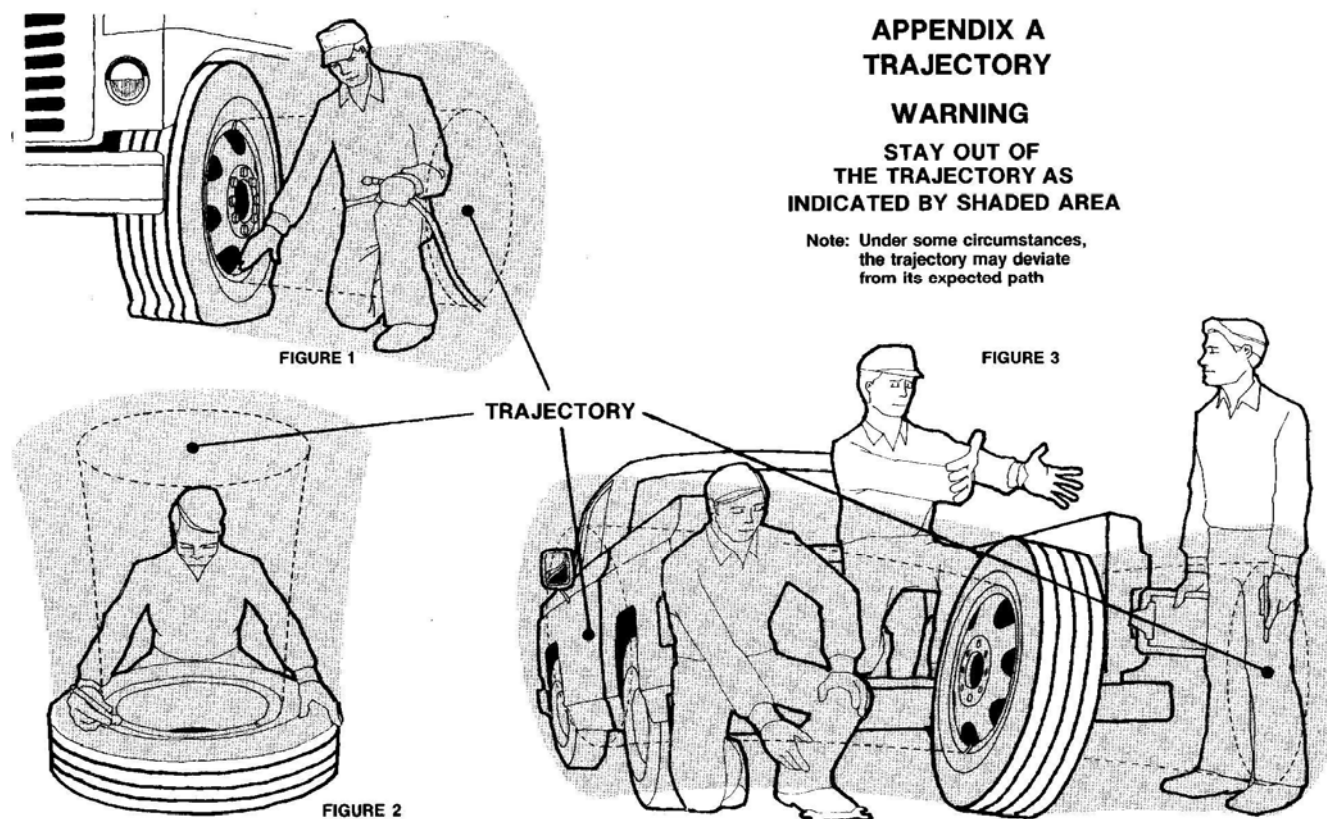
Figure 2. Trajectory of a multi-piece rim wheel parts (Source: OSHA 1910.177 Appendix A)

1. ***Stay out of the trajectory of rim wheel parts at all times while inflating a tire mounted on a multi-piece wheel*** because wheel parts may be propelled with great force and cause serious injury (Figure 2).
