Massachusetts FACE • Occupational Fatality Report

Two Hospital Workers Die when a Motor Vehicle Crashes into a Hospital Lobby - Massachusetts

Investigation: # 07-MA-040-01/02

Release Date: May 29, 2009

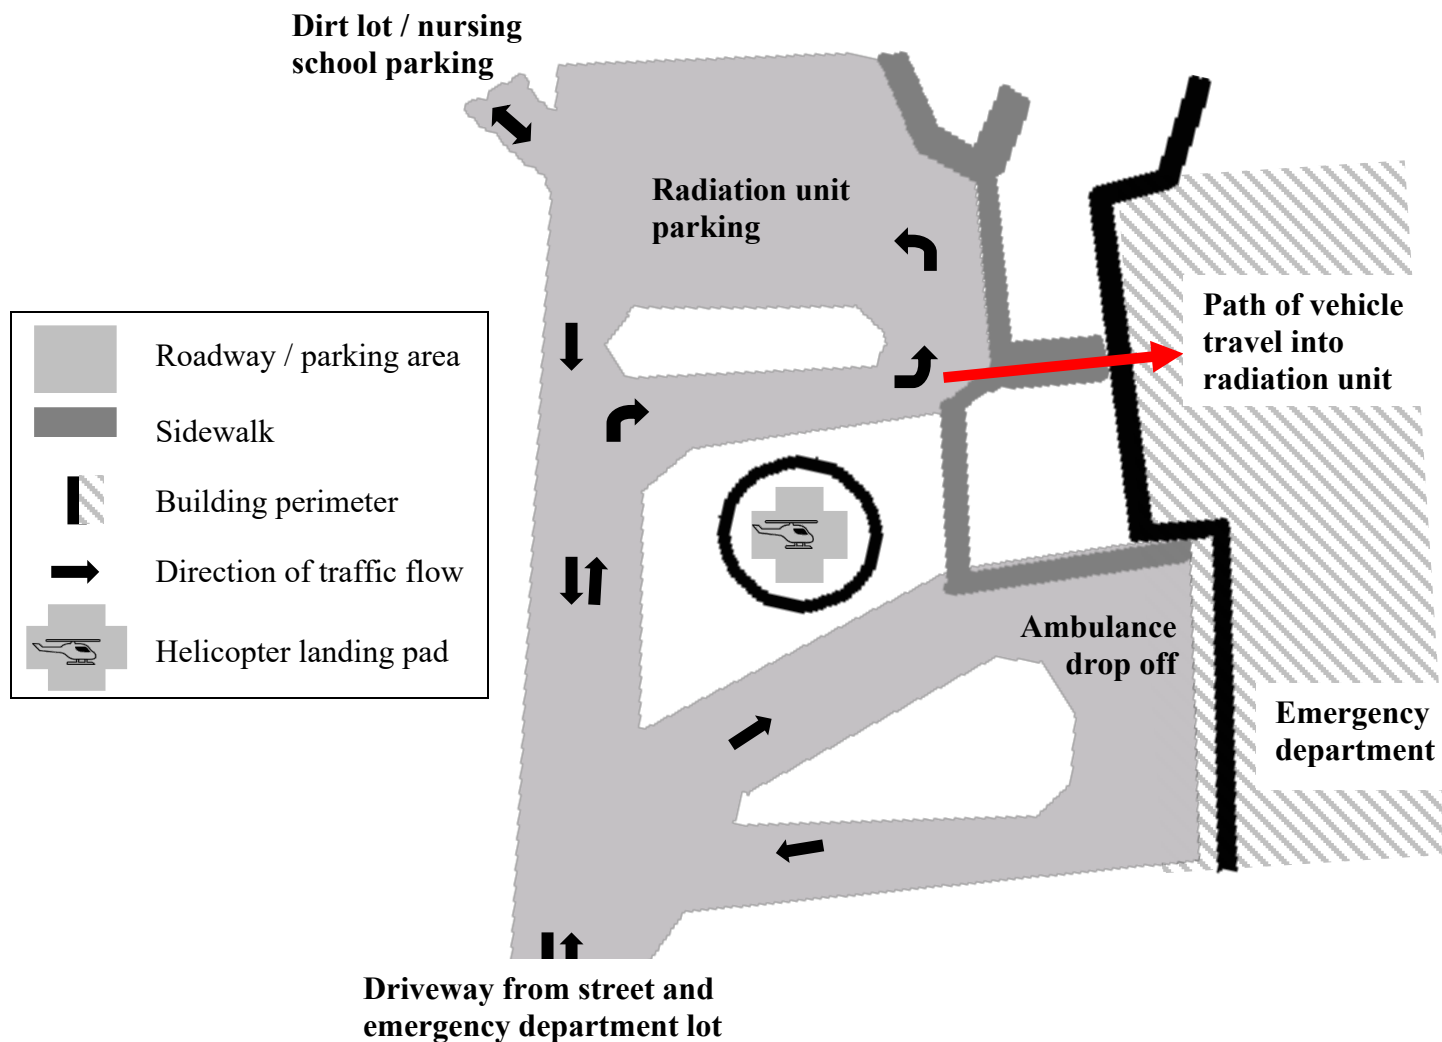
The radiation therapy unit has a separate parking lot accessed by a driveway that also provides access to the emergency department, ambulance drop-off area, helicopter landing pad, nursing school, and a dirt overflow parking lot (Figure 1). Drivers going to the radiation therapy unit or nursing school must drive past the emergency department, ambulance drop-off area and helicopter landing pad. Once past these locations, the driver must make a series of turns prior to entering the radiation therapy unit's parking lot. The first turn is a right-hand turn that positions vehicles directly perpendicular to (heading towards) the lobby doors. Two subsequent left-hand turns take vehicles alongside the walkway in front of the building and then into the radiation therapy unit's parking lot.

At approximately 1:30 p.m. on the day of the incident, an elderly patient was driving alone to the hospital's radiation therapy unit for a scheduled appointment. While attempting to access the radiation therapy unit parking lot, the driver completed the first 90-degree turn, but failed to negotiate the second turn. The vehicle, now positioned directly perpendicular to the lobby doors, traveled straight ahead, leaving the driveway and entering the pedestrian walkway leading to the radiation unit's main entrance. The vehicle entered the building by crashing through two sets of sliding glass doors separated by a distance of approximately six feet. The vehicle continued for an additional ten feet inside the radiation therapy unit's main lobby area before striking the reception desk and pushing it into a wall.

Figure 1 – Diagram of driveway layout
Black arrows indicate direction of traffic flow
Black line marks outside wall of building

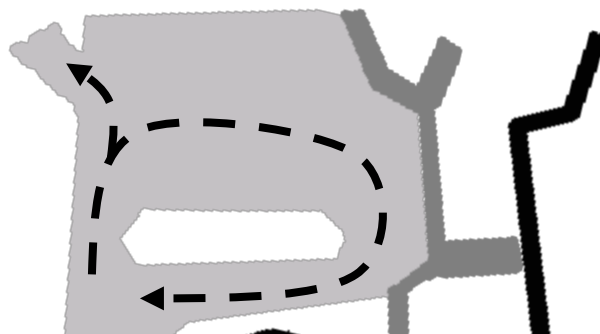
Figure 2 – Possible change to driveway layout

Discussion: An evaluation of the driveway and parking lot prior to this incident might have resulted in the rerouting of traffic to better protect the building and occupants. One solution would be to reverse the direction of travel around the parking lot. This would eliminate vehicles from driving straight at the radiation therapy unit's entrance while in the process of accessing the parking lot. By reversing the travel direction, vehicles leaving the parking lot would exit by way of the curved driveway, driving away from the building (Figure 2).

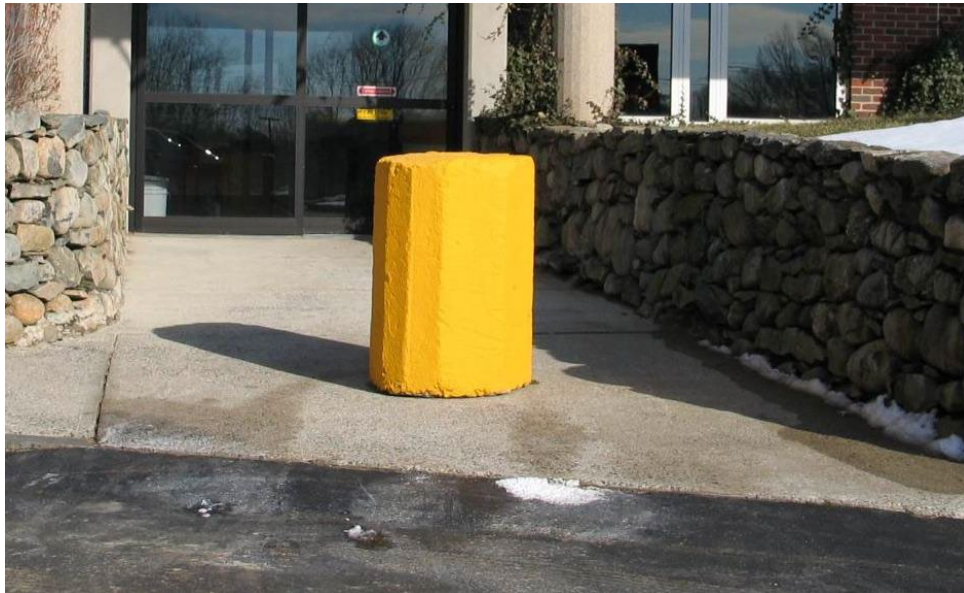
Figure 3 – Barrier installed after the incident

In the course of reconstructing the radiation therapy unit's main entrance, hospital management decided to move the reception area to the side of the main entry doors, reducing the risk of direct impact from an errant vehicle or debris. Hospital management also placed a concrete block in the middle of the pedestrian walkway in front of the lobby doors (Figure 3). The block is approximately four feet tall and weighs over one-and-a-half tons. This measure should effectively prevent regular traffic from striking the building.

Discussion: Strategically placed physical barriers, like the block installed by this hospital, can prevent vehicle intrusion while maintaining accessibility for workers, visitors, and for maintenance purposes (e.g. snow clearing or equipment delivery).² A number of different barrier types have been assessed as part of the national effort to protect federal properties. ASTM International, the General Services Administration, and other federal agencies have criteria and specifications for the use of various protective devices. Relevant documents published by these groups can be useful in assessing potentially vulnerable locations and developing site-specific protections.³ Any enhancements made to protect a site, including self-made physical barriers, should be in compliance with applicable building codes, accessibility guidelines and consensus standards.
