Massachusetts FACE • Occupational Fatality Report

A Painter Falls 12 Feet While Painting a Pump Hose Platform System - Massachusetts

Investigation: # 07-MA-025-01

Release Date: January 5, 2009

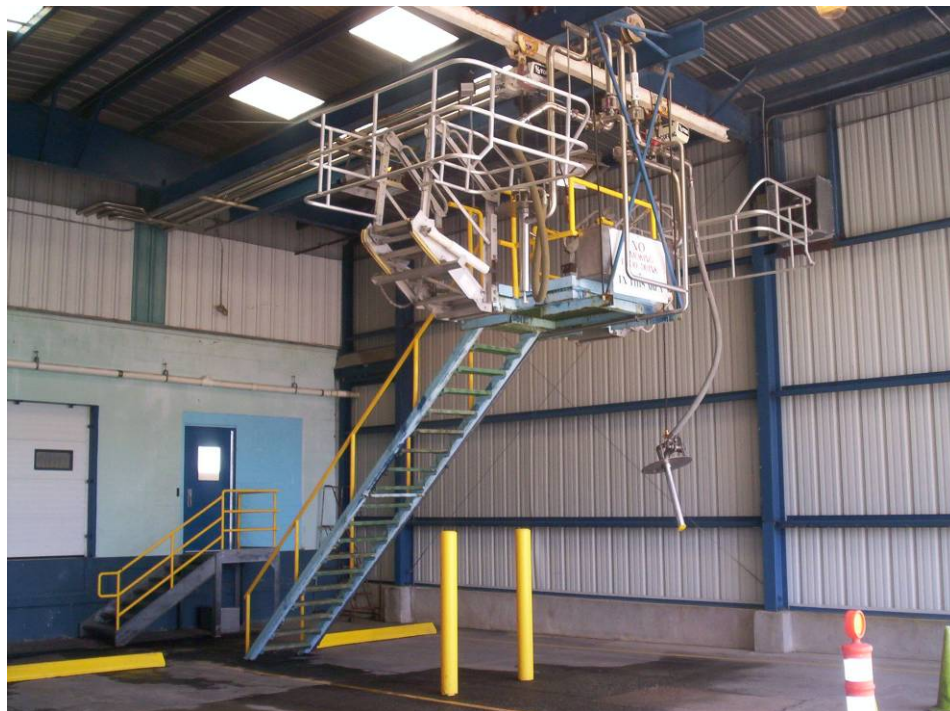
An agricultural cooperative had hired the painting contractor to repaint sections of their fixed raised metal pump hose platform system (Figure 1) and some structural steel beams in the section of building where the platform system was located. This section of building is a hanger style building with a roof and walls enclosing three sides. The fourth side of the building is open to create access for trucks to back under the pump hose platform.

Figure 1 – Pump hose platform system.

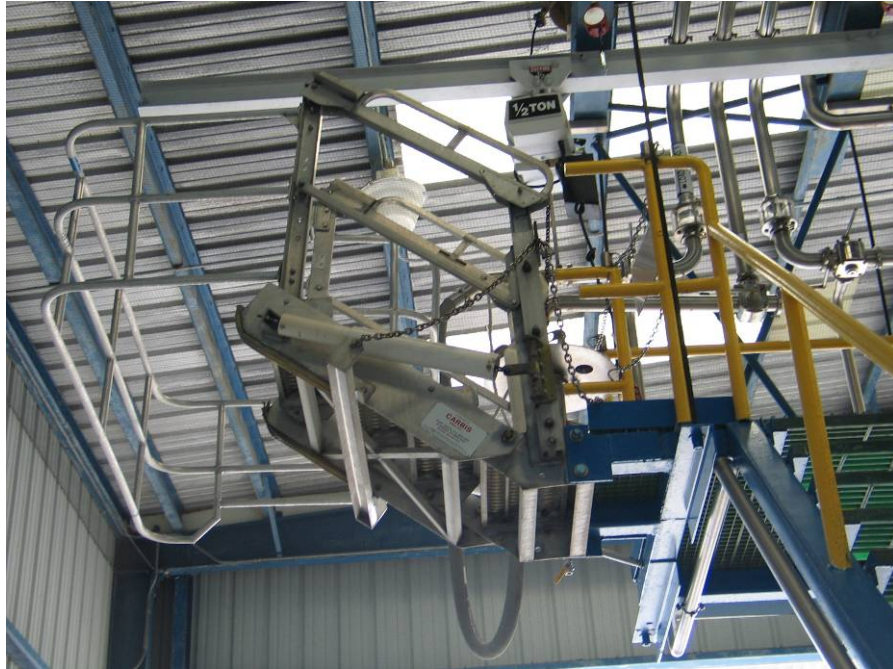
The platform system has one set of stairs that leads from the ground level to a raised fixed platform area located approximately 10 feet above the floor. Gangways are located on the left and right sides of the raised fixed platform area (Figure 2). The gangways have three hinged steps and are used to access ports located on the top of a tanker trailer when the trailer is positioned properly next to the platform system. The ends of the gangways are equipped with guardrails that enclose the end of the gangways where there is no flooring. These guardrails provide fall protection to the platform system user when a truck is in the appropriate position and the gangways are in use. When needed, the hinged gangways are manually lowered to a truck's tank enabling a worker to access the top of the truck's tank from the platform system via the gangway (Figure 3). When not in use, the gangways should be placed in the up or stored position and locked. The platform system is also equipped with a loading arm and a pump system. The loading arm and pump system are used to deliver liquid product into the truck's tank. The end of the loading arm is placed in the truck's port and the pump system is turned on to fill the tank.

Multiple witnesses did state that they heard a loud noise which caused them to look towards the platform system and then observed the victim falling. It appears that the victim had stepped from the fixed raised platform out onto the unlocked gangway that would have been to his left while standing at the top of the platform's stairs to reach a section of the overhead steel beam he was painting. When he stepped onto the gangway, the weight of his body may have caused the gangway to lower causing the victim to lose his balance and fall approximately 12 feet to the concrete floor below, landing head first.

At the time of this incident, the victim was working from one of the gangways in the stored position and was consequentially exposed to a fall hazard of more than six feet. Therefore, the victim should have been supplied with fall protection, such as a personal fall arrest system, and been provided training on the fall protection. Another option would have been to use the rented aerial lift that was onsite at the time of the incident. Management procedures should be in place to ensure that employees are following required safety practices. In either scenario, because of the nature of the work and the availability of an aerial lift for use by the painting contractor employees, training should have been provided by the painting contractor to their employees about personal fall arrest systems and aerial lifts.

Figure 2 – Platform system's gangway that the victim fell from in the stored position.

Recommendation #1: Employers should ensure that fall protection and relevant training are provided to employees who are exposed to fall hazards when working six feet or more above the lower level.

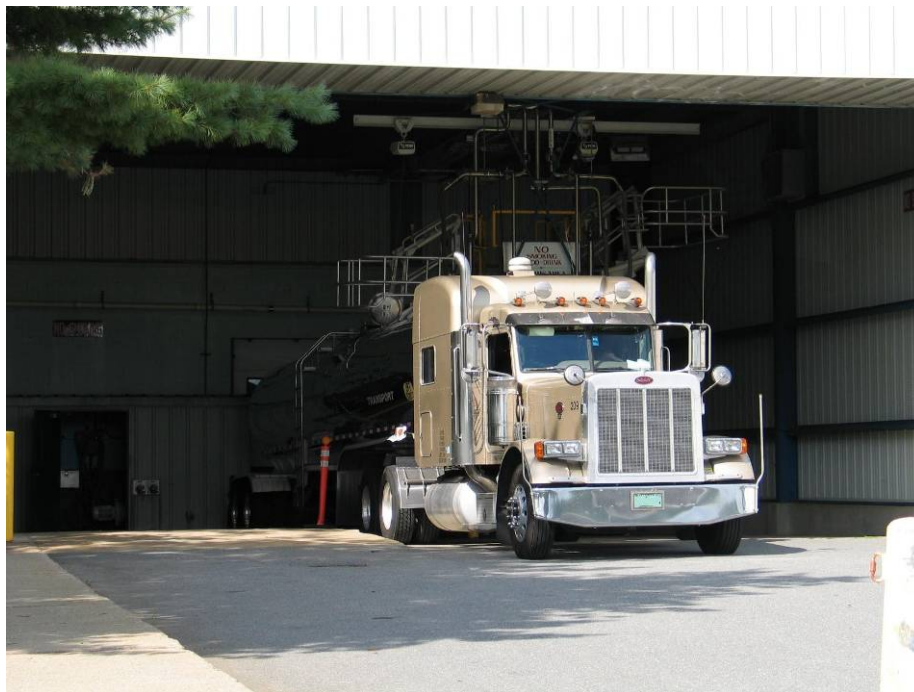
Figure 3 – Tanker truck positioned next to the platform system with a gangway lowered onto the truck's tank.

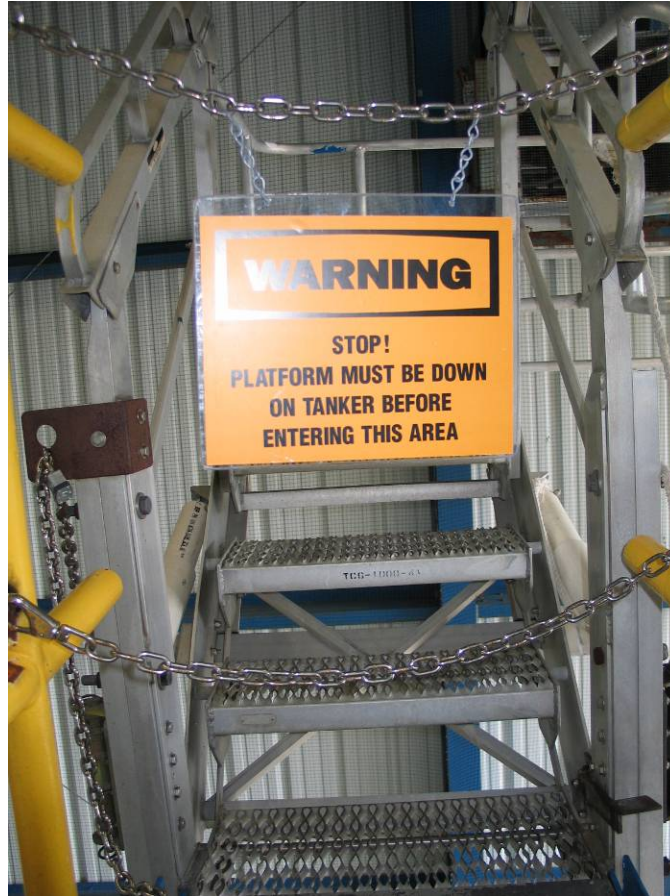
Figure 4 – Gangway entrance area with warning sign.

Recommendation #4: Liquid product manufacturers utilizing pump hose platform systems should ensure that when not in use gangways are locked in the stored position with warning signs posted at the gangway entrance areas.

Discussion: The pump hose platform system involved in this incident has raised platforms leading to gangways. When in use, these gangways are lowered to the top of tanker trucks. Since the incident, the agricultural cooperative has implemented procedures to be followed when the pump hose platform system is not in use. These procedures include, ensuring that the gangways are locked in the stored position and placing warning signs at the gangway entrance areas that state "Warning Stop! Platform Must Be Down on Tanker Before Entering This Area" (Figure 4).
