# Massachusetts FACE • Occupational Fatality Report

## Iron Worker Crushed in Collapse of a Telescopic Boom Lift - Massachusetts

**Investigation: # 07-MA-045-01**

**Release Date: December 3, 2008**

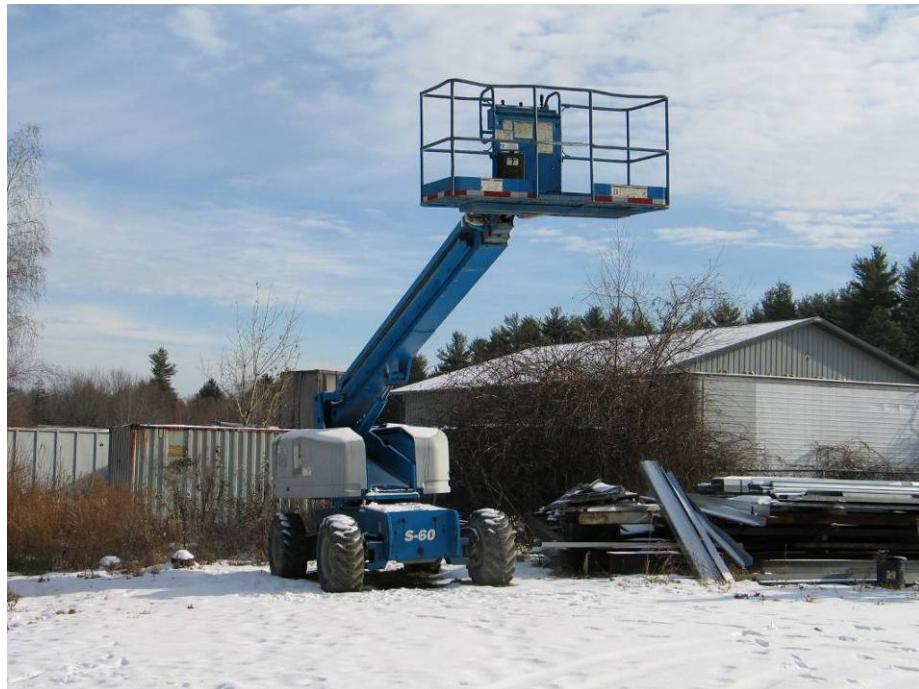
The company is a steel erection, welding, and steel beam manufacturer. The machine involved in the incident was a 60 foot telescopic boom lift (Figure #1). The lift was manufactured in 1999 and had been purchased by the employer in 2005 from an equipment rental company. The lift is equipped with a three cylinder diesel engine and a hydraulic-based boom. The work platform located at the end of the boom measures three feet by eight feet and has a 500 pound capacity. The lift weighs approximately 20,000 pounds, of which 2,000 pounds is the weight of the lift's boom. It was reported by the employer that the lift had not been altered and that it has not needed any major repairs since the date it was purchased. General maintenance and minor repairs, such as changing tires and grease and oil changes for the company's equipment, including the lift, were performed by the company's in-house mechanic. Repairs to equipment that were considered to be complex were typically contracted out.

**Figure 1 – Boom lift involved in the incident.  
This is looking at the front of the lift.**

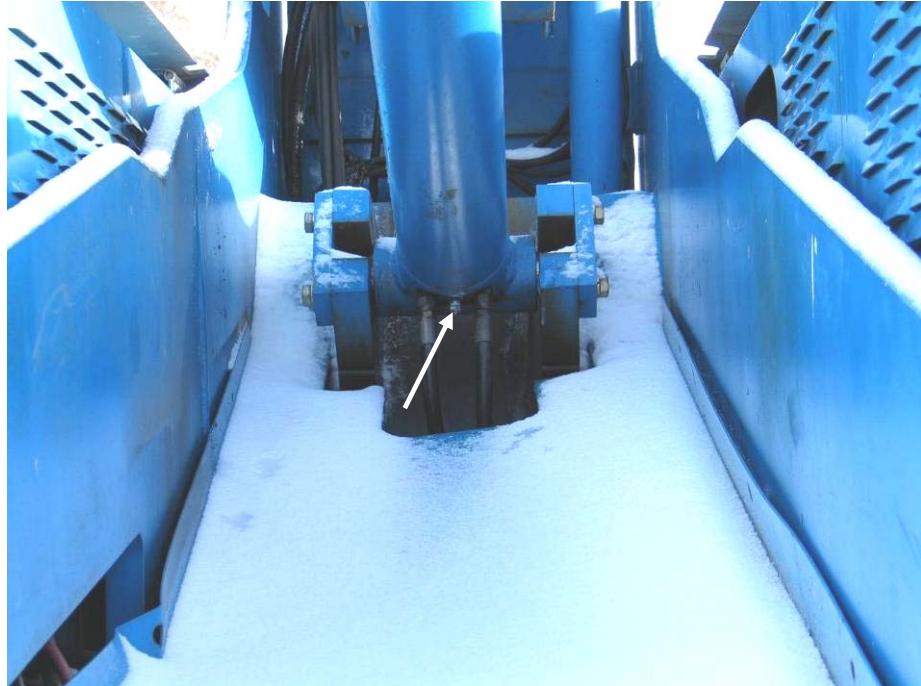
coming up and decided to have employees repair the lift during the expected slow period. A counterbalance valve (Figure #2) that was not operating properly was reported as the reason that the lift's boom was moving slowly. The counterbalance valve has two functions. One function is to control the amount of hydraulic oil present in the boom's pistons, which in turn control the raising and lowering of the boom. The second function is to prevent boom movement in the event of a hydraulic line failure.

**Figure 2 – Counterbalance valve is located between the two vertical hydraulic hoses.**

**Discussion:** One hazard common to hydraulic systems involves the unexpected loss of the hydraulic system's pressure. Manufacturers of hydraulic system components should consider including large bright colored hazard warnings when packaging their products. In this case, the hazard warning with the valve could have stated that a potential hazard existed during the replacement of the valve and that the hydraulic system must be locked out and any movable part of the equipment must be blocked and/or in the stowed position. The warnings could also refer back to the manufacturer's maintenance manual, which could explain the hazard in greater detail.

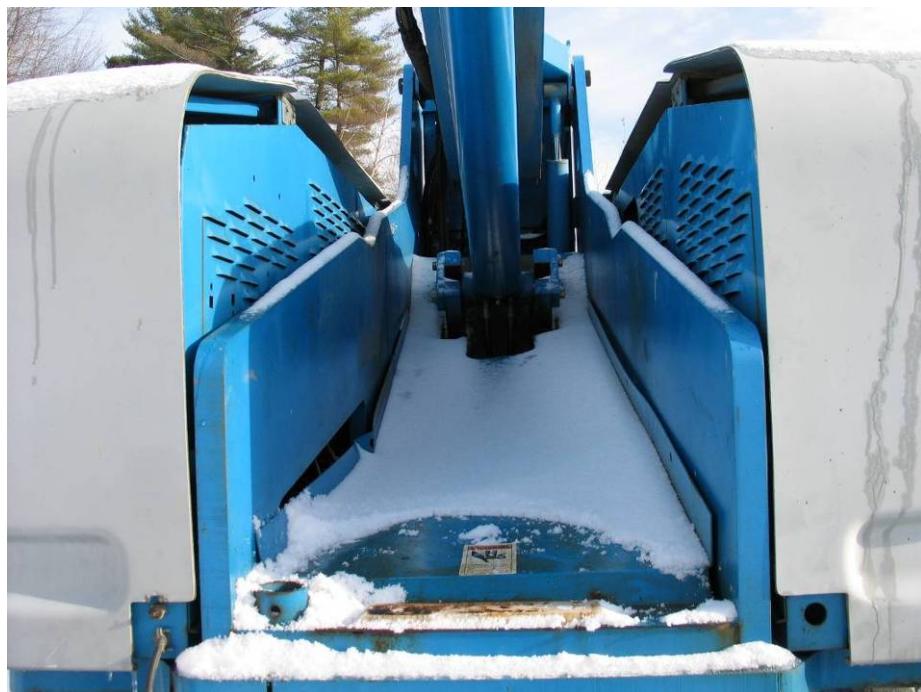
At approximately 8:00 a.m., the victim had started to loosen the counterbalance valve accessing it from underneath the rear of the lift. Once the valve was loosened, the co-worker went to take a restroom break. While the co-worker was away, the victim continued with the repair and climbed onto the lift's base to access the counterbalance valve (Figure #3) from the front of the lift. At the location where the victim would have climbed onto the lift's base, there was a manufacturer's decal that stated "Warning Crushing Hazard." While on the lift's base, which positioned the victim directly underneath the raised boom, the victim continued to loosen the valve. When the valve was loosened further this allowed the hydraulic pressure/oil to be released from the hydraulic system. As the hydraulic pressure/oil was released, the raised boom collapsed onto the victim, crushing him between the boom and the top of the lift's base.

**Figure 3 – Location where victim was crushed and a decal warning of a crushing hazard.**

**Recommendation #1: Employers should ensure that prior to starting work on hydraulic boom lifts that either the booms are properly supported or that the booms are in the stowed position.**

**Discussion:** Hydraulic systems need to be pressurized to have controlled movement of the hydraulic powered object, in this case the lift's boom. Prior to working on any component of a hydraulic system, the first steps should be to conduct a job safety analysis (Recommendation #3) and to implement lockout/tagout procedures (Recommendation #4). One of the next crucial steps, which should be part of the hazardous energy control program, is to ensure that any potentially movable parts are blocked and secured. In this case, the boom should have been either in the lowest position, the stowed position, or if the boom was required to be in a raised position during the maintenance task, the boom should be properly secured from moving with blocking.
