Massachusetts FACE • Occupational Fatality Report

Apprentice Electrician Electrocuted while Wiring an Elevator Disconnect Switch - Massachusetts

Investigation: # 06-MA-043-01
Release Date: December 23, 2008

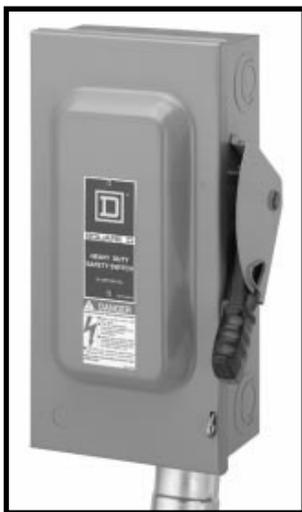
The three temporary feed wires that ran from the main electrical room to the elevator's mechanical room were installed into the top of a disconnect switch (Figure 1) located inside the elevator's mechanical room and attached to the disconnect switch's top mechanical lugs, the switch's supply side (Figure 2). Temporary wiring had also been installed from the bottom mechanical lugs of the elevator mechanical room disconnect switch to the control unit for the elevator that were also located in the elevator mechanical room. These were the wires being replaced at the time of the incident.

Figure 1* – Similar heavy duty disconnect switch with front cover closed
