**TO: Director, National Institute for Occupational Safety and Health**

**Case No. 2002IA030**

**Report Date: 31 August 2004**

**SUBJECT: Front Hopper Gate Operator Run Over by Chip Spreader during Street Resurfacing**

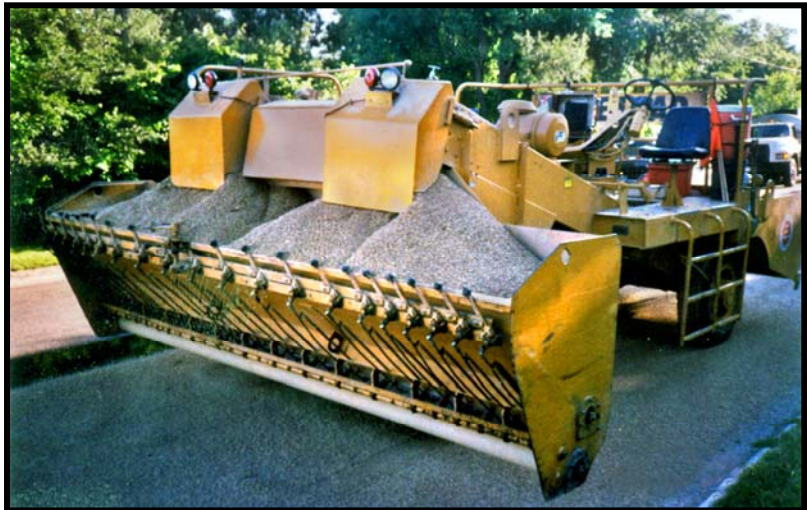
Photo 1 – Front view of the rock-chip spreading machine, showing the hoppers for the chips, the operator's seat position, and the inherent blind spot at the right front corner of the machine.

During normal operation the primary operator of the rock-chip spreading machine slowly drives forward on the roadway being resurfaced with a rear-facing dump truck in tow. The primary operator's station for this chip spreader is located at the left rear (Photo 1), resulting in a restricted view of the area to the right front of the machine. The dump truck driver remains in the truck's cab with the truck's transmission in neutral and raises the truck's box to control the transfer of aggregate to conveyors in the rear hopper of the chip spreading machine (Photo 4). The side-gate operator for the chip spreader is responsible for controlling the uniform, final flow of rock-chips applied to the roadway. Given the high noise level of the machinery in operation, hand signals were the means of communication between the primary operator, the side-gate operator of the chip spreading machine, and the driver of the dump truck.

**Recommendation #3** – *Manufacturers of chip spreaders should implement engineering controls to reduce excess noise and designs that do not require an operator other than the primary operator.*

**Discussion:** Engineering controls should be considered to reduce excessively loud noise from this equipment, which could result in improved communication. It is also possible that slip-resistant surfacing or additional safety railings at the side-gate operator's station on this chip spreader might have

prevented the victim from slipping and/or falling. However, designs that do not require an operator in this position should be the preferred means to prevent exposure.

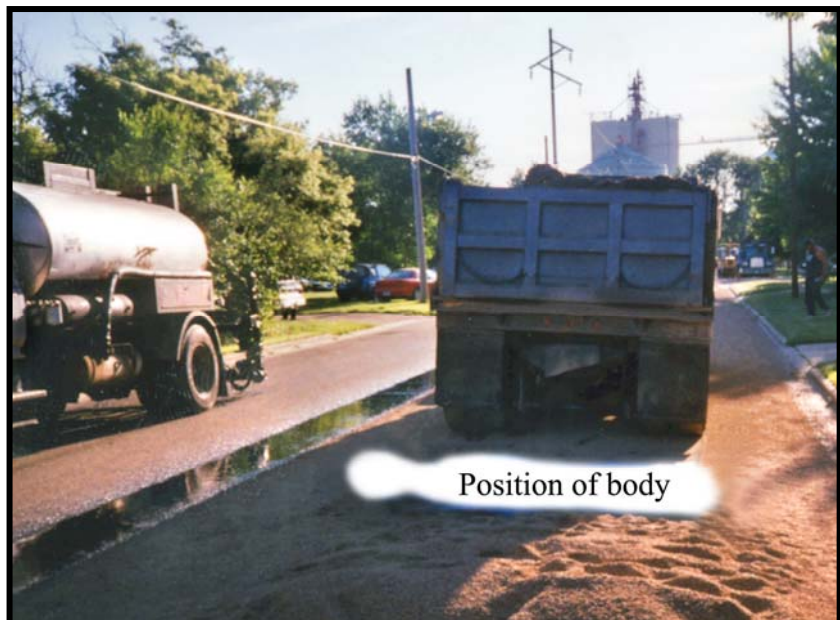
Photo 2 – Rear of the dump truck showing position of the victim's body.

Neither the primary operator nor the dump truck driver saw the victim fall. The victim was run over by the rock chip spreading machine and then by the duals of the rear axle of the dump truck trailing the chip spreader. The dump truck unhooked from the rock chip spreading machine and stopped moving as its rear dual wheels ran over the victim. The truck driver stopped his truck, got out of its cab, and immediately saw the victim between the first and second set of rear dual wheels on the driver's side of the truck.

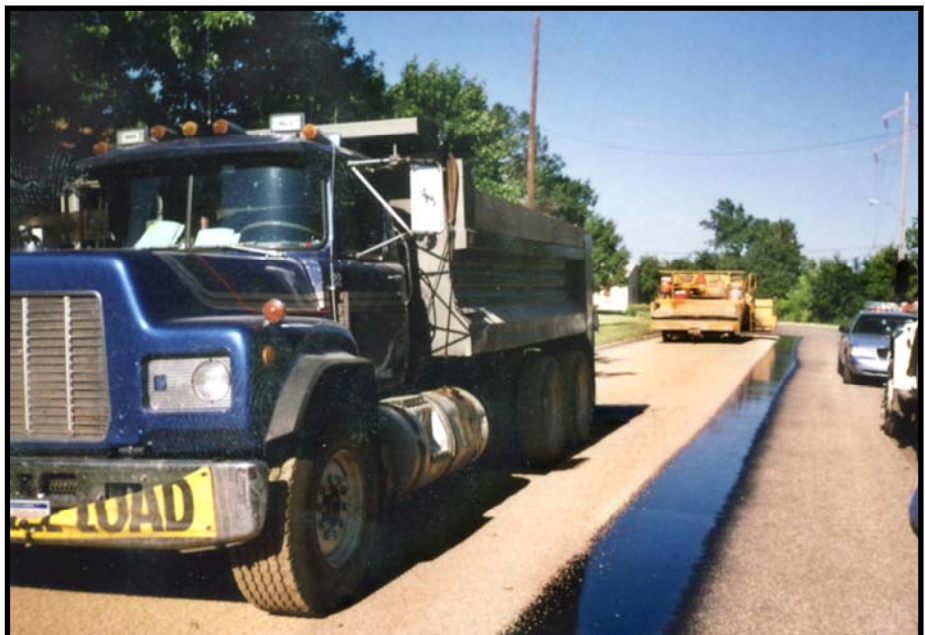
Photo 3 – View from the middle of the roadway showing the work area, with the dump truck unhooked from the rear of the rock-chip spreading machine.

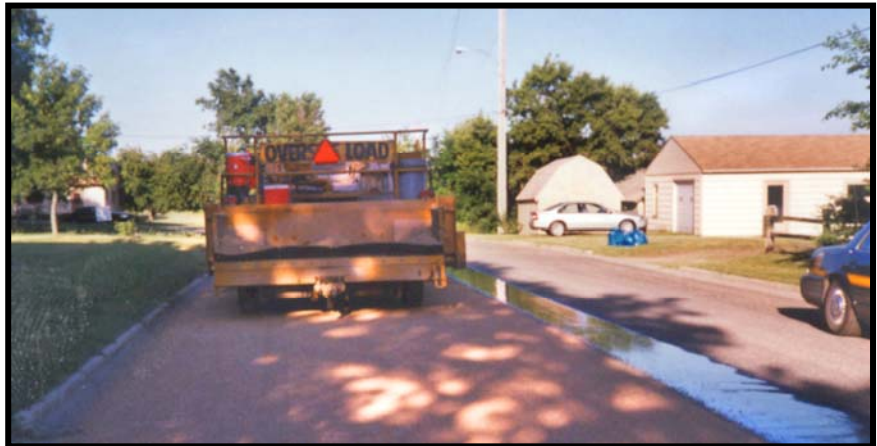
Photo 4 – Rear of the rock-chip spreading machine.
