# Roofing Foreman Dies from Telescopic Boom Lift Fall

**Incident Number: 08KY007**

**Kentucky Fatality Assessment and Control Evaluation (FACE) Program**  
**Incident Number: 08KY007**  
**Release Date: October 31, 2008**  
**Subject: Roofing Foreman Dies from Telescopic Boom Lift Fall**

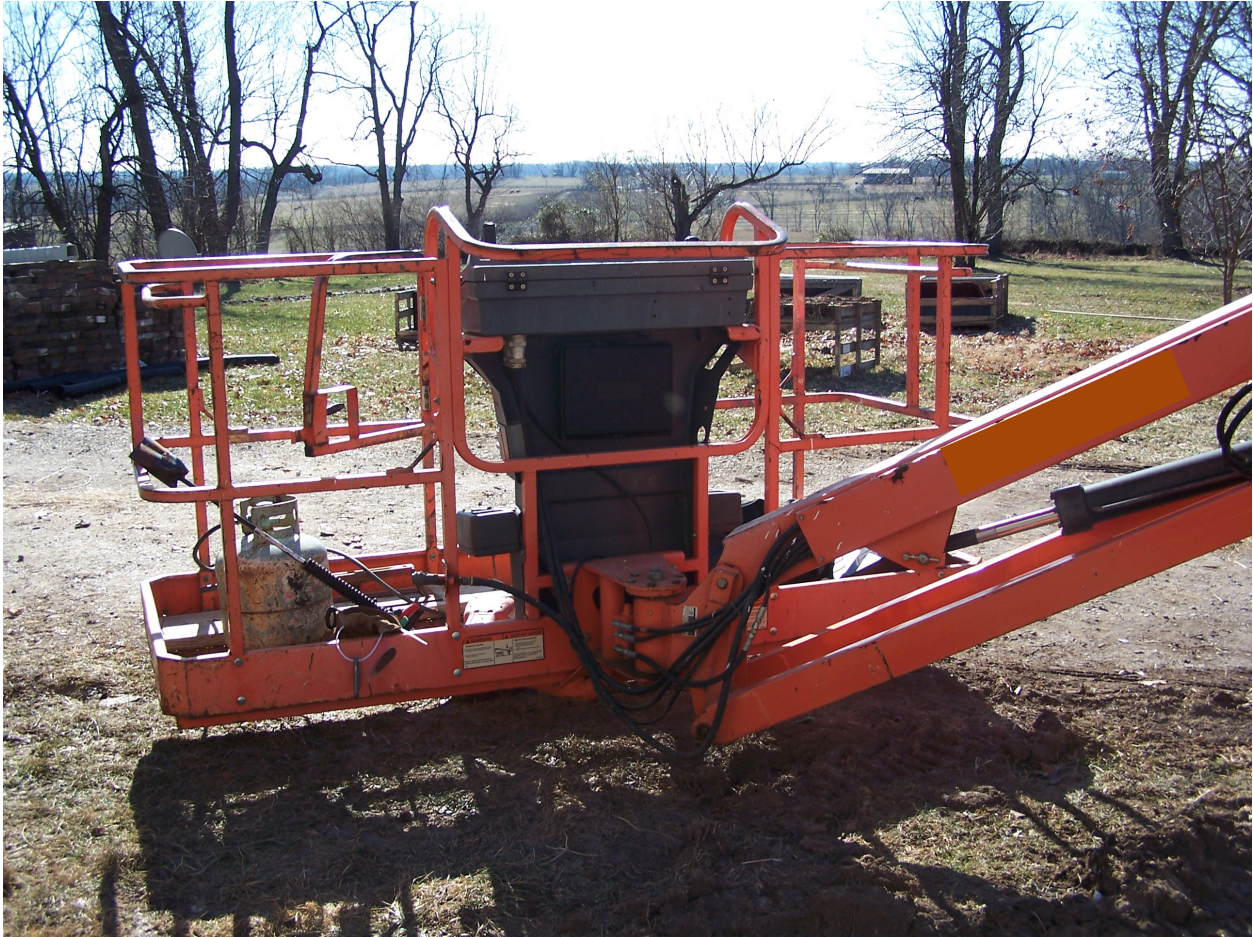
Telescopic boom lift similar to the lift the foreman fell from.

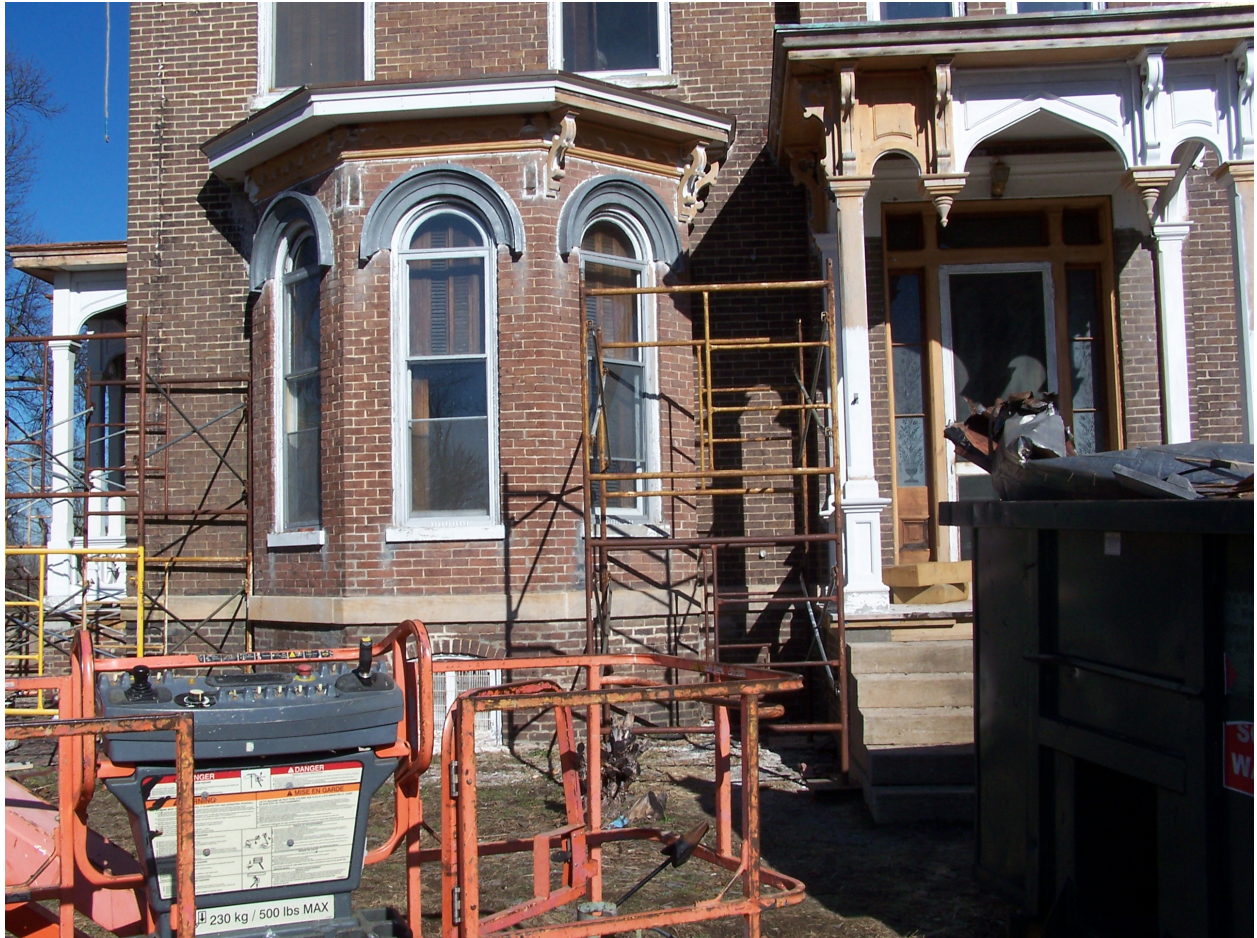
Alcove roofers were working on when foreman fell. Scaffolding was erected all around the alcove at the time of the incident.
