## MIFACE INVESTIGATION: 05MI065

### **SUBJECT: Hispanic Brick Mason Electrocuted When Rerod Contacts Powerline**

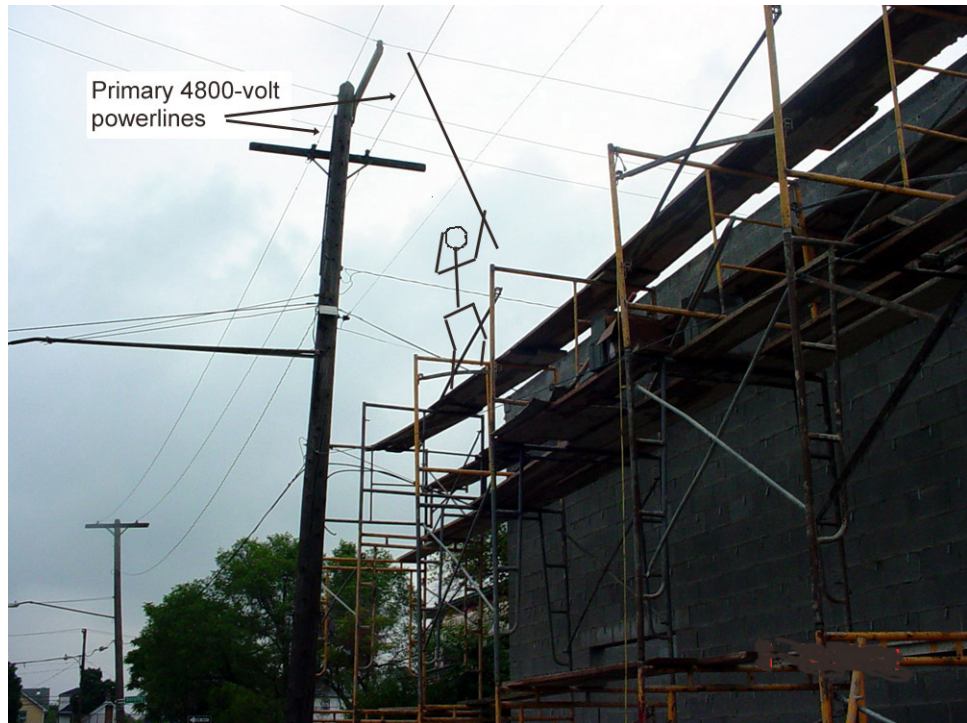
On Friday, July 1, 2005, at approximately 12:20 p.m., a 36-year-old Hispanic brick mason was electrocuted. The decedent was attempting to insert a 20-foot 2-inch rerod down through a grouted brick wall he and his coworkers had constructed when the rerod contacted an energized, primary 4,800-

Figure 1. Approximate position of mason (not to scale).

volt single-phase powerline (Figure 1). Emergency personnel arrived shortly thereafter and transported the decedent to a hospital where he was pronounced dead.

On the day of the incident the decedent and Coworker 1 were working together from the top of the scaffolding. Coworker 2 and another mason were working on the ground handing materials and equipment up to the decedent and Coworker 1 on the scaffold. The masons on the scaffold were pouring grout into the bricks after which the decedent would insert a 20-foot 2-inch rerod down through the grout in the bricks. The wall they were working on at the time was approximately 20-feet high. Coworker 1 was assisting him by handing him material. The rerod that the decedent was inserting into the grout was closer to the electrified powerline than the required 10 foot distance [MIOSHA Part 1. General Rules, Rule 115(4)].

According to Coworker 1, when the reroof the decedent was lifting to insert through the bricks contacted the 4,800-volt primary electrical line, the decedent uttered something and fell to the planks. Coworker 1 tried to help the decedent, but he was shocked, and he pulled away. When the decedent lost consciousness, he became disengaged from the reroof and fell to the next lower set of planks. Coworker 1 tried to help him while he was still on the lower set of planks on the scaffold, but did not know First Aid or CPR. Coworker 2 said he could not see what was happening on the scaffold from where he was on the ground, so could not see what had happened when the reroof the decedent was handling contacted the energized wire. He said he just heard him scream.

- Employers should conduct a jobsite survey during the planning phases of any construction activity to develop a written accident prevention plan to identify and remove potential hazards and to implement appropriate control measures for these hazards.

The jobsite had an identifiable hazard, i.e., energized primary electrical lines of 4,800 volts and secondary lines at 2,400 volts that a jobsite survey conducted by a competent person would have identified. The improperly erected scaffold was erected too close to the powerlines, so that the employees were working too close to the energized powerlines (approximately 9.5 feet). The MIOSHA standard General Rules, Part 1, requires a distance of not less than 10 feet between powerlines and work materials. Having to raise a 20-foot reroof to insert it into the grout in the bricks further exacerbated the problem. MIOSHA standard Scaffolds and Scaffold Platforms, Part 12, also addresses electrical safety when working on a scaffold. Because a safe distance could not be maintained between the materials and the energized powerlines, the electrical company should have been notified and appropriate action taken to eliminate the electrocution hazard.

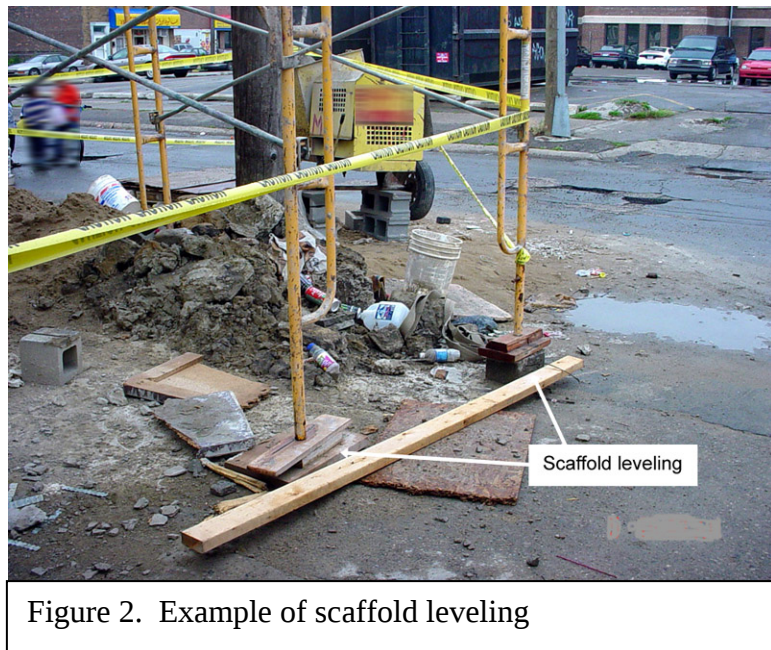
All four workers at the job site had set up the scaffolding for this job. The scaffold was erected improperly and was leaning. They had learned how to set up a scaffold on-the-job by helping others. They had erected it on concrete, so they felt it was secure, and they felt they did not have to level it more than they had (Figure 2). They thought they had done a good job. Apparently the superintendent and the general contractor were satisfied that it was sufficiently stable, because they had both looked at the scaffold and had not commented otherwise.

Figure 2. Example of scaffold leveling

The workers believed they had erected the scaffold safely, because it was erected on concrete, and they thought it did not tilt. They had erected it the way they had been taught to do so by others with whom they had worked. Although the faulty scaffold erection did not directly contribute to the electrocution, other than that it was erected too close to the powerlines, it was indicative of the inadequate training and understanding of safe work practices of the employees at the jobsite.

- Employees required to work from a scaffold should be trained by a person qualified in scaffold safety.

These workers were not trained to erect a scaffold properly, but perhaps the more important part of the training would have been that regarding recognizing the nature of and the correct procedures for dealing with energized powerlines.
