MIFACE INVESTIGATION: 04MI074

SUBJECT: Millwright Dies When Struck by Uncontrolled, Flailing Crane Cable

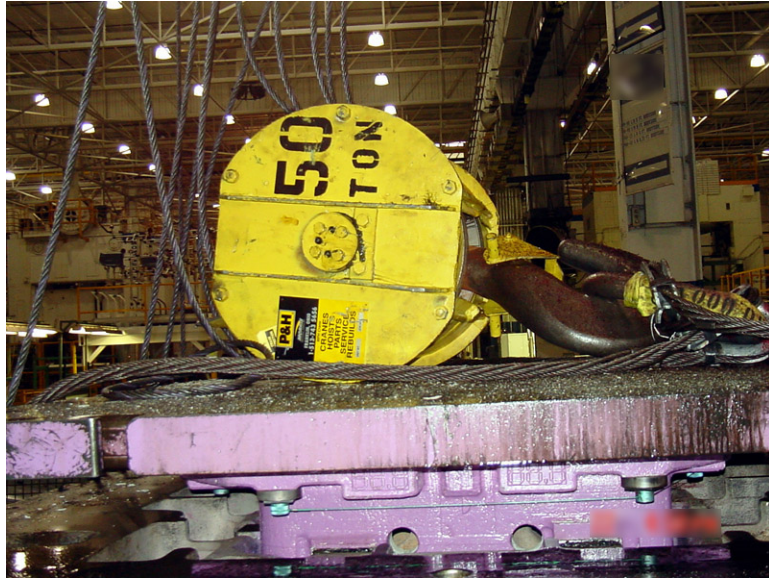
On Tuesday, June 22, 2004, at approximately 1:10 p.m., a 62-year-old millwright was fatally injured when the overhead crane he was attempting to troubleshoot malfunctioned during a lift. The crane had been used to lift a draw die weighing 42.5 tons to a height of between 15 and 25 feet above the plant floor (Figure 1). After the initial lift, the die setter found he was unable to raise or lower the load. This left the load

Figure 1. Crane hoist

On Tuesday, June 22, 2004, at approximately 1:10 p.m., a 62-year-old millwright was fatally injured when the hoist of the overhead crane he was attempting to troubleshoot malfunctioned during a lift. A die setter had used the 50-ton capacity model 1963 Whiting top running, double girder, center drive electric, overhead traveling crane to lift a three-piece die weighing approximately 42.5 tons (85,000 pounds) to a height of between

15 and 25 feet above the plant floor. The die setter called for crane repair when the crane hoist had stopped operating, leaving the load suspended in the air. The decedent and his partner responded to the call at approximately 11:45 a.m. The decedent climbed to the crane trolley while his partner remained at ground level spotting to keep people out of the way. He tested the controls, found the load would not move up or down and moved the crane to an aisle out of the way of other materials being moved in the plant. He believed the problem may have been electrical, so he descended to contact an electrician.

- When troubleshooting or making mechanical repairs on a crane, control all sources of energy. If the load is suspended, provide some means of support for the raised load to dissipate its potential energy.

- Transport all loads as close to the floor as possible and ensure that there are no employees or obstructions in the path.

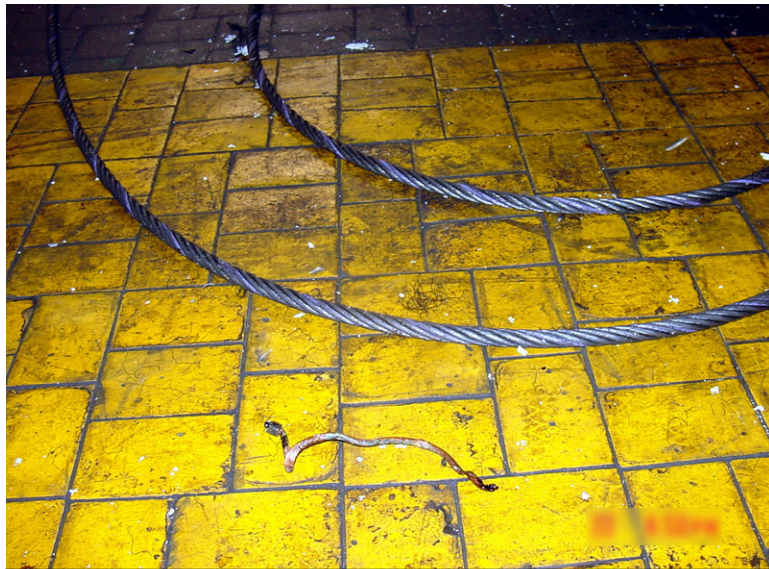
As he was attempting to dislodge the metal piece from the gear, a catastrophic failure occurred resulting in the suspended load falling to the plant floor. While the load was falling the wire rope drum cable was unreeling. The drum spun faster than the cable could unreel causing the cable to swing and jerk violently in the air near the trolley where the decedent was standing. The decedent was struck in the head and on his body by the flailing

Figure 2. Wire rope cables.

wire rope cables (Figure 2). These injuries were fatal. Fire personnel removed his body to an ambulance where it remained until the Medical Examiner arrived a short time later.
