Dump Truck Driver Dies After Being Entangled In Power-Take-Off Drive Shaft

Incident Number: 06KY079

Kentucky Fatality Assessment and Control Evaluation Program

Release Date: January 22, 2008

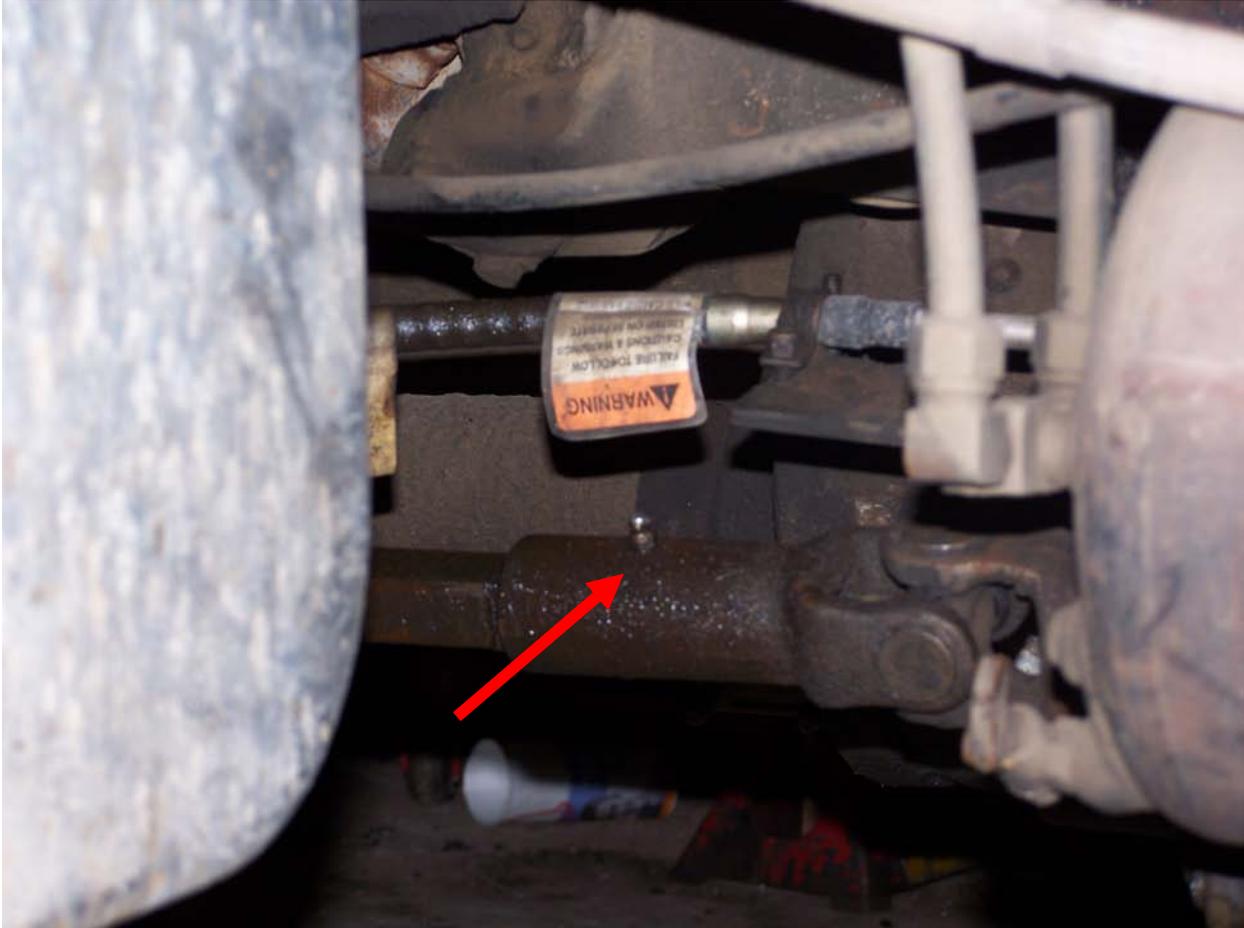
Photograph of grease fitting on universal joint power-take-off drive shaft that caught worker's coat

As Driver 3 lay under the idling truck's spinning PTO shaft, his coat sleeve became entangled in the grease fitting on the front universal joint. He was twisted onto the shaft and under the bed of the dump truck. When Driver 1 returned to his truck to wait for assistance from the company mechanic, he found the decedent caught in the PTO drive shaft underneath the truck. Driver 1 yelled to Owner 1 in the tower to call emergency medical services to the scene. While Owner 1 called 911, he called Owner 2 to the scene. Owner 2 found the decedent entangled in the PTO shaft and with the assistance from Driver 4, they proceeded to cut his clothing to free him from the shaft. Owner 2 tried to resuscitate Driver 3 (decedent) while EMS was enroute. Emergency medical services arrived six minutes later, determined the driver was in critical condition, and notified emergency air care. As emergency medical personnel placed Driver 3 in an ambulance and transported him to a nearby field where the air ambulance waited, he died. Air transport was cancelled and the local coroner was contacted who arrived and declared Driver 3 dead at the scene.

Recommendation No. 3: Loose clothing should not be worn while repairing machinery.

Recommendation No. 6: Consideration should be given to engineering machine guards for truck power take-off; equipment should be designed or retrofitted to shield any open, unguarded power take-off drivelines.

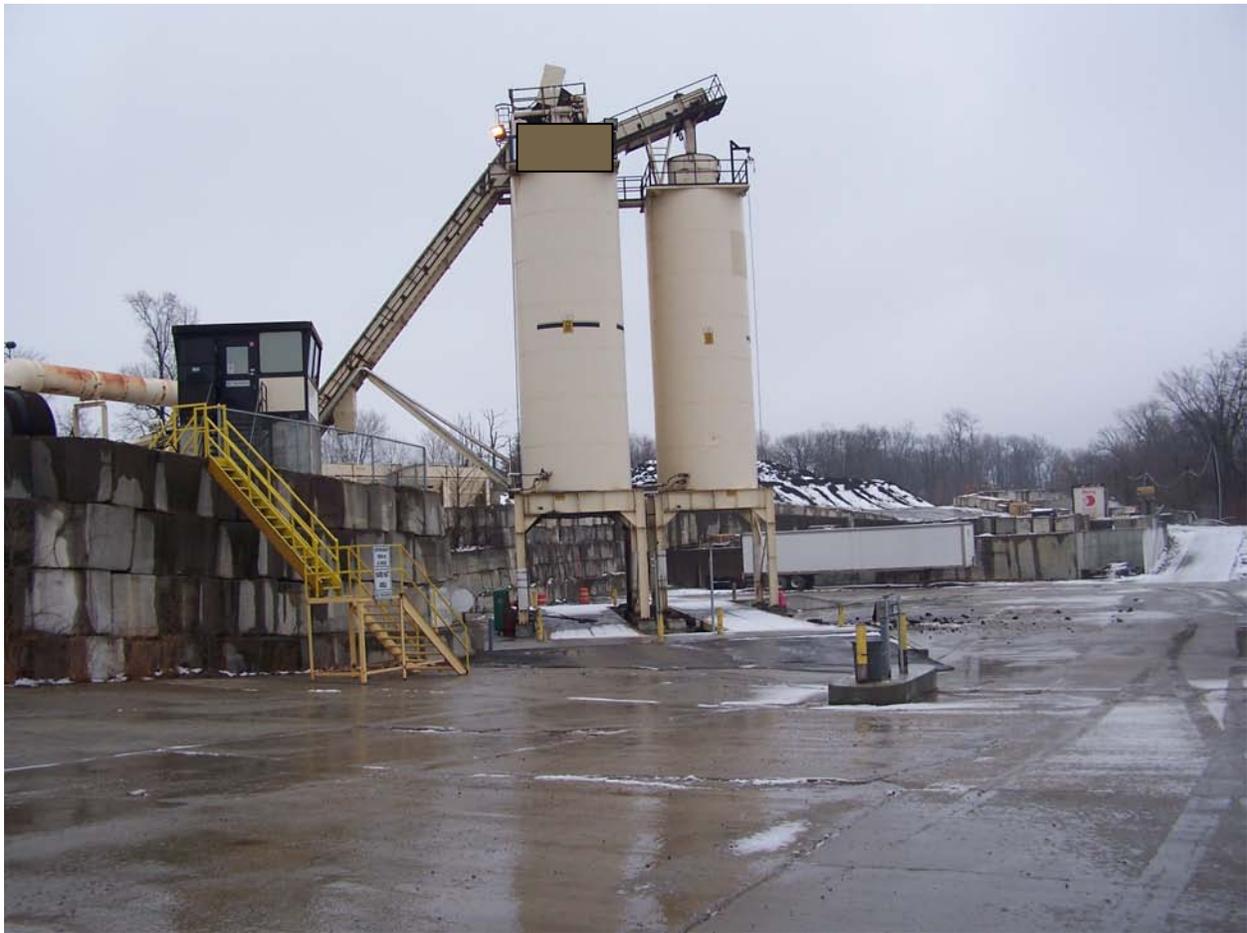
Attachment 2: Photo of asphalt plant. Diagram of how trucks were lined up on next page.

On this particular morning, at approximately 7:30 AM, the decedent and four other drivers arrived at the garage, inspected their respective dump trucks, and drove to the asphalt plant two miles away. Once at the asphalt plant, the drivers lined up their dump trucks in two lines and waited to be loaded (see Attachments 2 and 3). As they waited for the asphalt to be loaded, the

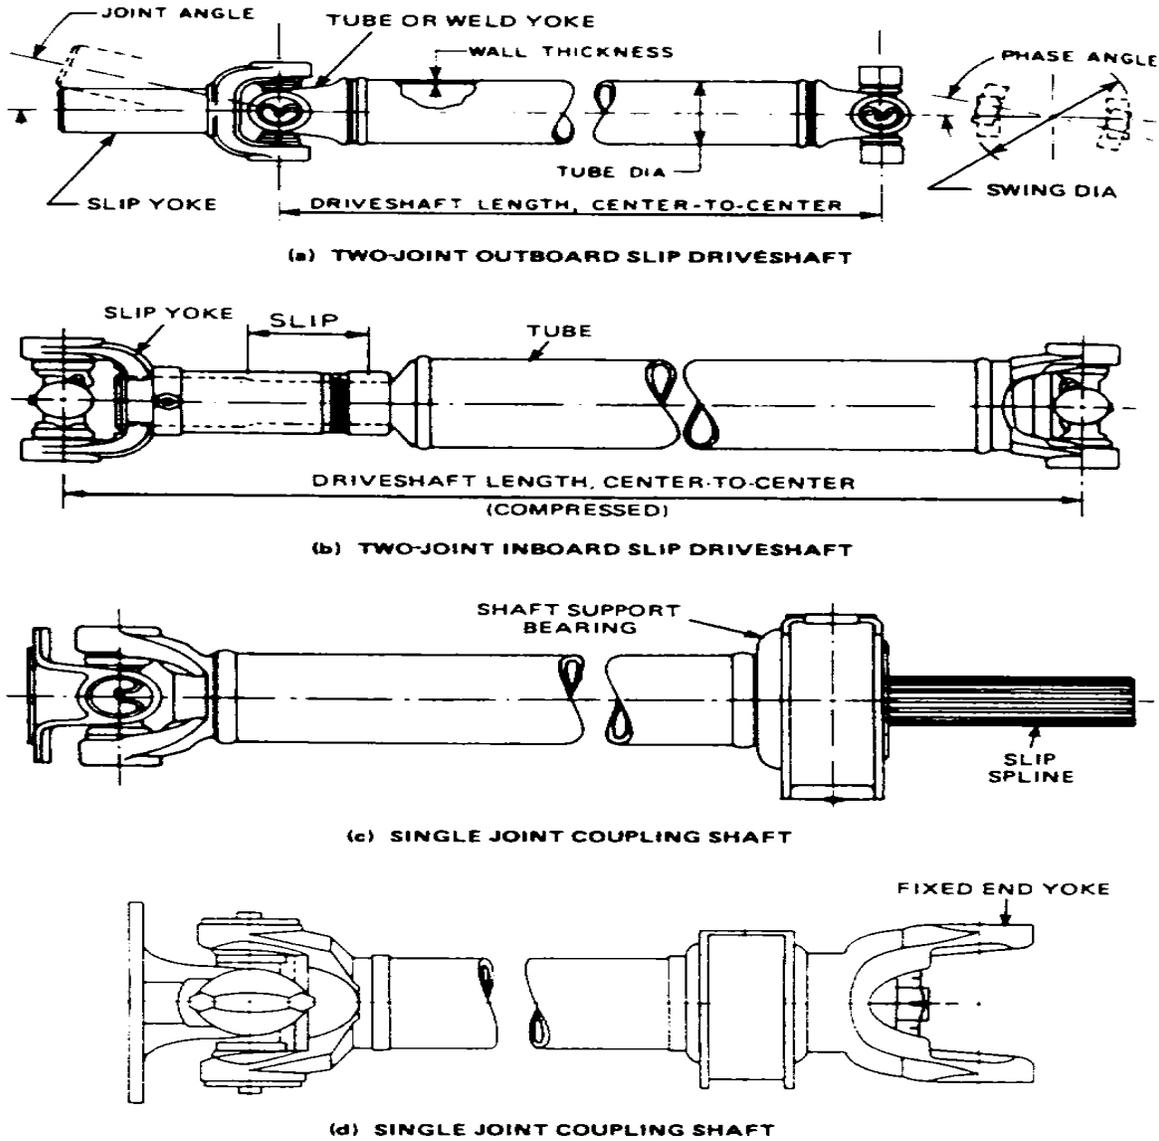
Attachment 4: Diagrams of power-take-off drive shafts

Currently, the model of truck involved in the incident does not have any guarding for the PTO. Consideration should be given to developing a guard that would prevent inadvertent contact with moving parts of the PTO. Although the primary prevention strategy for this fatality should be separating drivers from the hazard by eliminating unnecessary exposures, guarding would provide an added level of protection for mechanics, who cannot entirely avoid exposure to PTO's. For example, in this instance, the PTO had to be rotating in order to diagnose the problem. A simple metal covering could act as an effective shield for exposed parts of the PTO, thereby reducing the potential for PTO-related injuries. Since the year this truck was manufactured, the PTO shaft design has been changed and is now located where it is shielded and more difficult to be an entanglement hazard.

FIGURE 1—BASIC DRIVESHAFT CONSTRUCTIONS

Recommendation No. 6: Consideration should be given to engineering machine guards for truck power take-offs; equipment should be designed or retrofitted to shield any open, unguarded power take-off drivelines.
