# Hispanic Carpenter Dies After Falling From Homemade Platform

**Incident Number: 07KY008**

**Release Date: January 22, 2008**

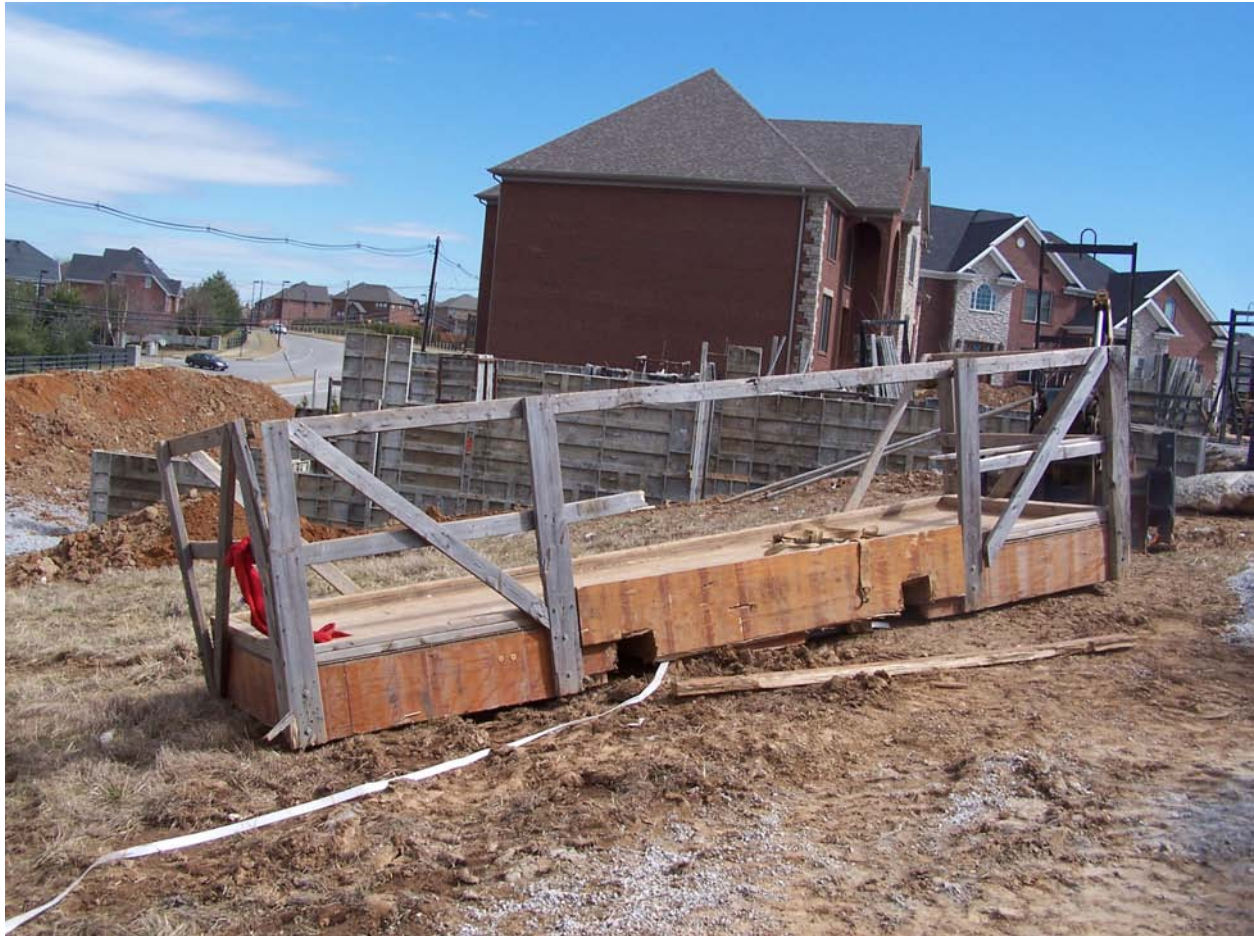
**Picture of homemade platform involved in this incident. Notice railing and cleats.**

**Recommendation No. 1:** Companies should not attempt to build any "homemade" type personnel platform for a forklift, all personnel platforms must comply with ANSI / ASME standards and the OSHA regulations.

ASME standards allow a company to construct and attach a personnel platform to a rough terrain forklift. There are rigorous guidelines for this, and it is, therefore, preferred that individuals consult with the forklift manufacturer for assistance, or better, purchase a factory-made and approved personnel platform designed for their particular machine. Requirements for an approved personnel platform include proper size, approved guard rails, rated anchor points for attachment of lifelines, and a safe method to secure the platform to the forklift. OSHA frequently writes citations for inadequate / home-made personnel platforms, deferring to the restrictions written into machine operator's manuals, which usually forbid using a homemade personnel platform on a forklift. Usually, the manufacturer's operator manual provides some guidance on this issue, therefore, companies desiring a personnel platform for a forklift should study their options carefully. In addition, personnel platforms must be securely anchored to the forks of a machine.

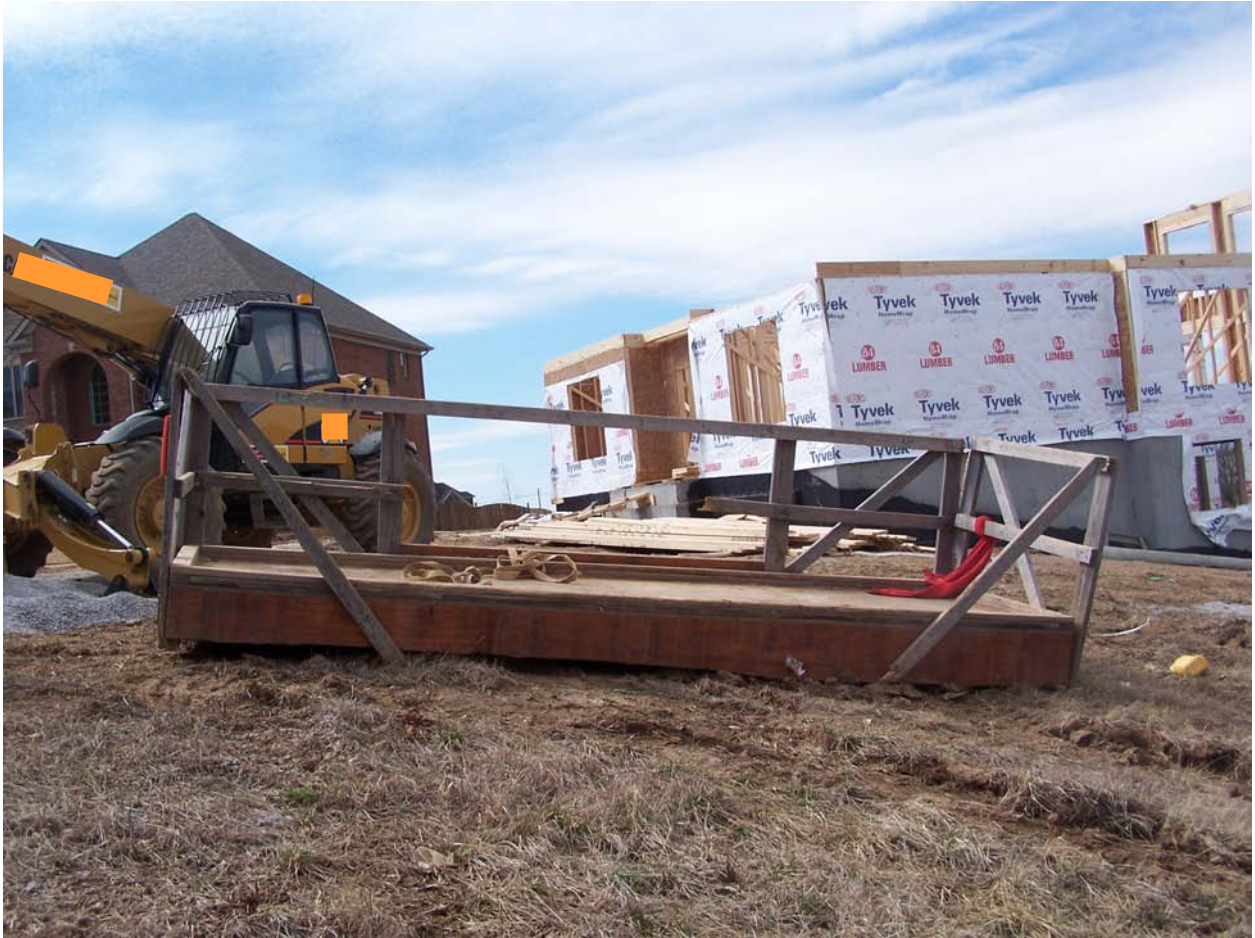
On the morning of the fatality, three Hispanic carpenters were framing a new, multi-story, single-family house. The terrain of the building lot was hilly, steep and rough with the backside of the lower level of the house open out of the slope. At approximately 7:30 AM, the three men were to erect a section of wall above the foundation of the lower level in the back left side of the house. According to an employee, the carpenters typically would have used ladders to reach the area to be framed. Because the terrain was rough and steep, and the work area was higher than the ladders could reach, it was decided to use a homemade materials platform to perform the task. The platform was constructed of wood, had railing on three sides with cleats on the bottom of the long side with railing. The cleats had been inserted on the railing side for stability when lifted. The operator of the forklift had inserted the forks under the long side of the platform without the cleats. This caused the platform to rest on top of the forks and be more unstable. The platform was not secured to the forklift.

The forklift operator elevated the three carpenters on the platform while they were holding the wall to be set in place. When the platform reached approximately seven feet high, it slipped off the forks and tumbled the three men to the ground. Two of the carpenters fell close to the house under the right side of the platform which fell on the edge of the foundation of the house. The third carpenter was struck by the left side of the platform as it slid to the ground. One of the workers called emergency medical services. The fire department and police arrived. Upon their arrival, they found the two carpenters alive and the third carpenter without vital signs. Both of the injured carpenters were transported to a nearby hospital where they were treated for their injuries. The local coroner arrived and declared the third carpenter dead at the scene.

Picture of side used to lift homemade platform. Notice there are no cleats for forks on this side.

1926.602(1)(viii)(A) states that when personnel are being elevated on a platform, it should be “firmly secured to the lifting carriage and/or forks”. Therefore, forklift operators should be trained to ensure platforms being used to elevate workers are properly secured to the mast. Also, the platform should be equipped with an appropriate guardrail with a locking gate. Elevated personnel should have controls on the platform that allow them to shut off power to the forklift. And, the forklift operator should not leave the controls of the forklift so that the elevated personnel can give instructions to the operator.

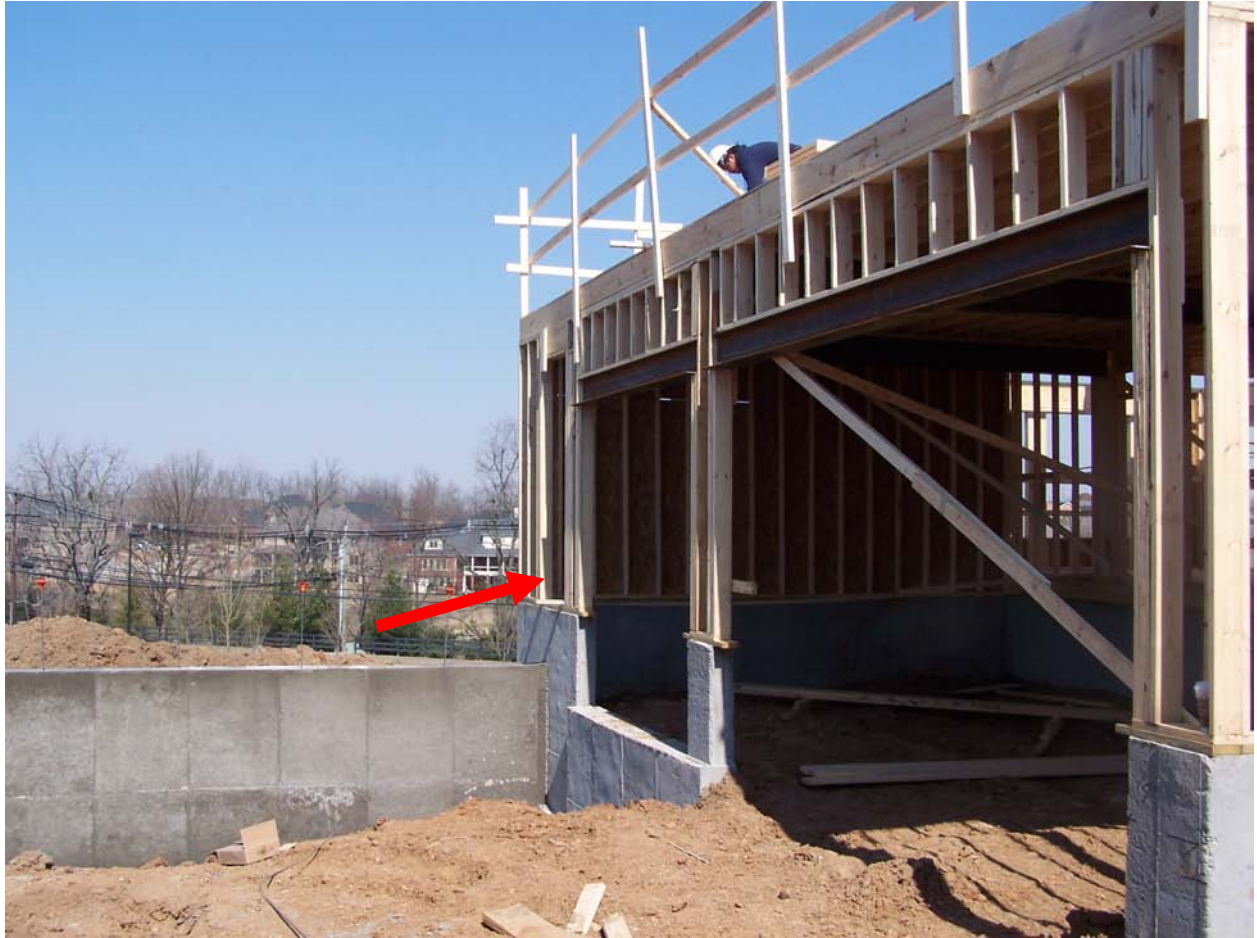
Corner of house where carpenters were to erect the wall. The concrete wall was not there at time of incident.

Construction workers should use appropriate tools to perform tasks. In this case, properly erected scaffolding would have provided an appropriate, safe and secure platform for the carpenters to frame the wall of the house. Some common types of scaffolding the workers could have used are system, or tubular. Scaffolding should only be erected under the guidance of a
