MIFACE INVESTIGATION REPORT: #07MI013

SUBJECT: Construction Foreman Dies from Fall While Climbing the Tower of a Hydromobile Scaffold

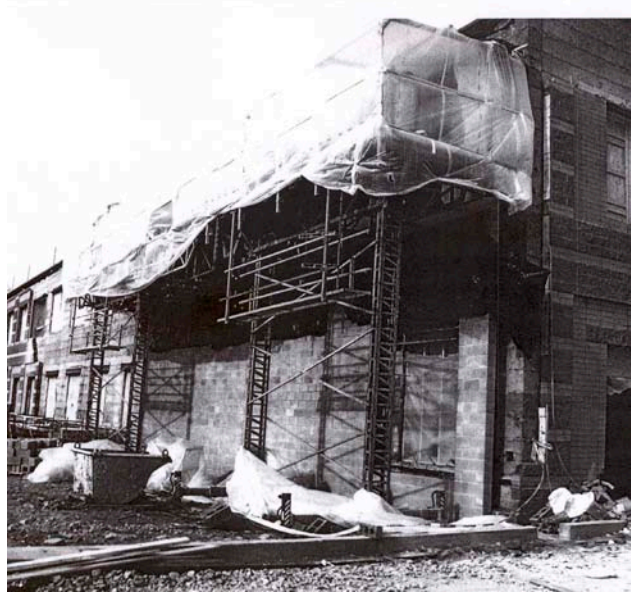
Figure 1. Incident scene

The decedent arrived and began to climb the tower to access the platform. When the decedent was approximately six to ten feet above the ground, Coworker #1 witnessed the decedent suddenly fall backwards from the scaffold to the ground and then roll to his left side. Coworker #1 descended from the scaffold to assist the decedent. The decedent was unconscious but still breathing. Coworker #2 descended to stay with the decedent while Coworker #1 ran to the general contractor's work trailer for assistance. Emergency response was called. Emergency response arrived, and after approximately one hour, the decedent was airlifted to a local hospital where he died two days later.

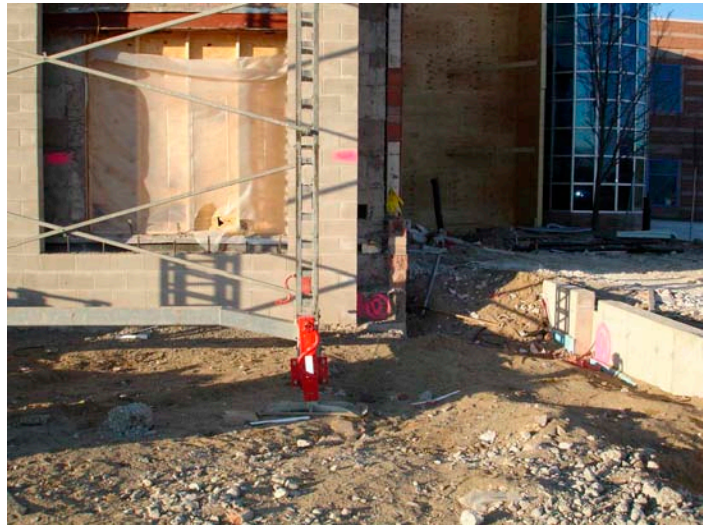
The decedent began to climb the tower to access the platform. After climbing six to ten feet, he suddenly fell backwards to the ground below. It was later learned that the decedent may have had a cerebral infarction as he was climbing the tower. When he fell, his head hit the ground, and may have also struck rocks and anchor bolts (Figure 2). He was wearing a hard hat and safety glasses. After landing on the ground six to eight feet from the scaffold and within six inches of the concrete foundation, he rolled over to his left side. His

Figure 2. Surface to which the decedent fell.

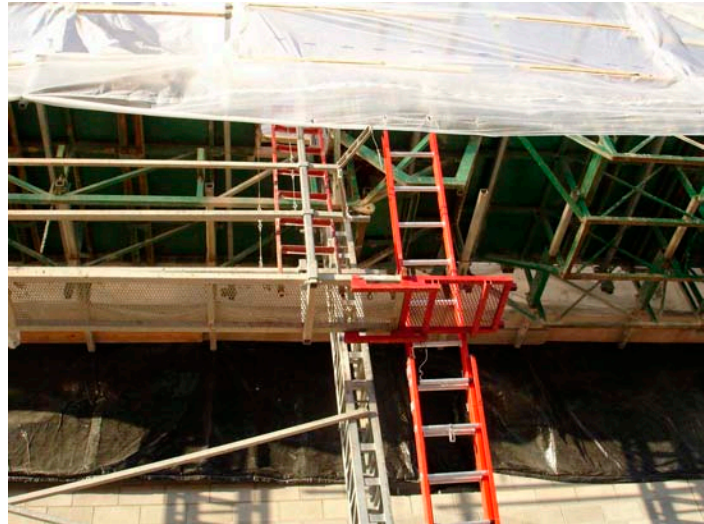
Neither the hydromobile ladder nor an extension ladder was available at the worksite at the time of the incident. The crew had been accessing the platform by climbing the towers. After the incident, an extension ladder (Figure 3) was brought to the site and appropriately affixed to the scaffold.

Figure 3. Extension ladder used to gain access to platform after the incident.

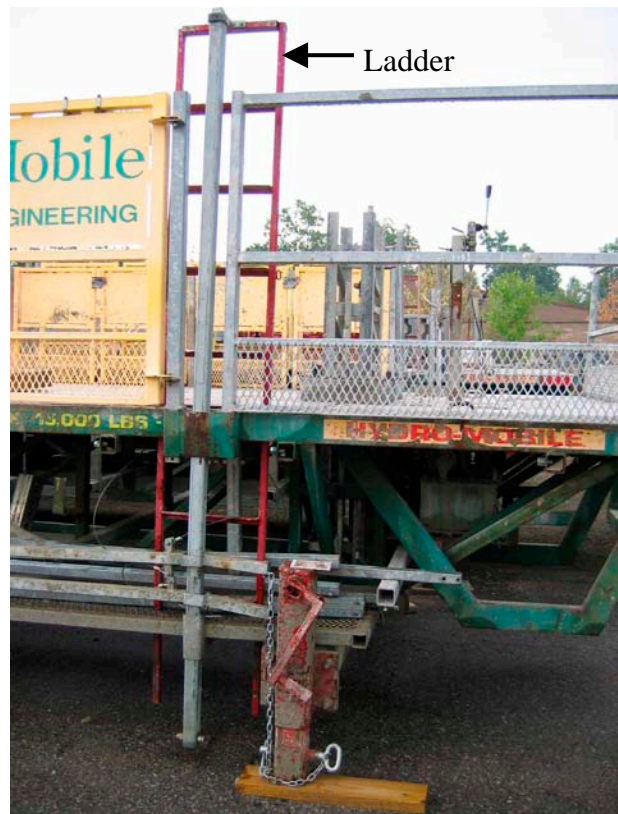
Figure 4. Ladder permanently affixed to the scaffold system.

- After meeting with employees, the company determined that the employees were uncomfortable using 40-foot extension ladders as a routine method to access the raised platform so the manufacturer's ladder system was purchased.
- Until such time that the scaffold system ladder was installed, the company required that an extension ladder be used to provide access to and egress from the platform area of the hydromobile scaffold.
- Refresher training on safe scaffold erection and use was provided to all employees.
- The company permanently affixed one section of the ladder to each scaffold system (Figure 4).
