Fatality Investigation Report

OR 2006-25-1

Ranch worker killed by pressurized water striking eye

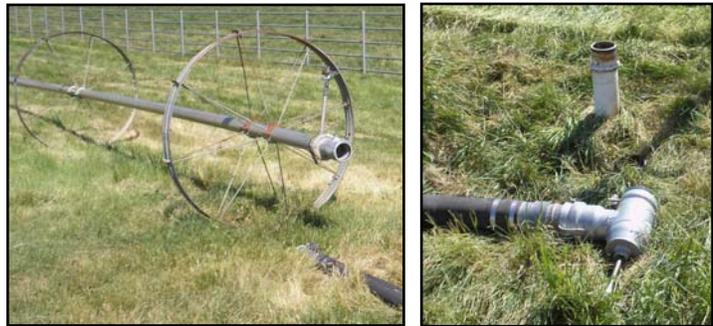
The irrigation wheel (left) connects to a heavy rubber supply line, which attaches to a removable valve (right foreground). The valve mounts over pressurized risers installed in the field, like the one shown here that failed (right background).

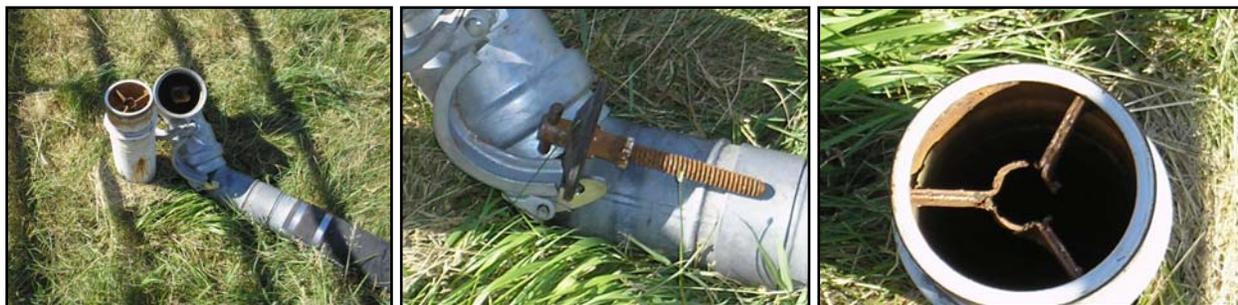
Following the incident, the entire irrigation system was immediately shut down and inspected. Examination of the riser shut-off cap showed heavy corrosion on the inside anchor nut, threaded stem, and metal retainer. The metal retainer had broken, allowing the stem to slip free and release the cap.

The corroded stem from the riser (middle), displayed in perspective with the connecting valve, shows the anchor nut screwed up tight under the shut-off plate, indicating the riser was closed when the incident occurred. The corroded retainer inside the riser failed (right).

Components in an irrigation valve are subject to corrosion and pressure damage. Defects in a stem, nut or retainer that result in a leak, can also result in an explosion as in this instance. The timing of this incident suggests a final twist or pull when a person is working on the system can trigger the failure. Employers should consider performing scheduled inspections and preventive maintenance on depressurized irrigation systems at least annually.

All riser caps on the ranch were opened and inspected for corrosion following this incident. Those with slack in the anchor nut or corroded elements were replaced.

Recommendation #2. Components of a pressurized irrigation system should be inspected for defective parts at least annually.
