Window Washer is Pulled Off a Roof and Falls 53 Feet when the Rolling Roof Outrigger to which His Lifeline was Attached Rolls Off the Roof - Massachusetts

Investigation: # 05-MA-038-01

Release Date: October 11, 2007

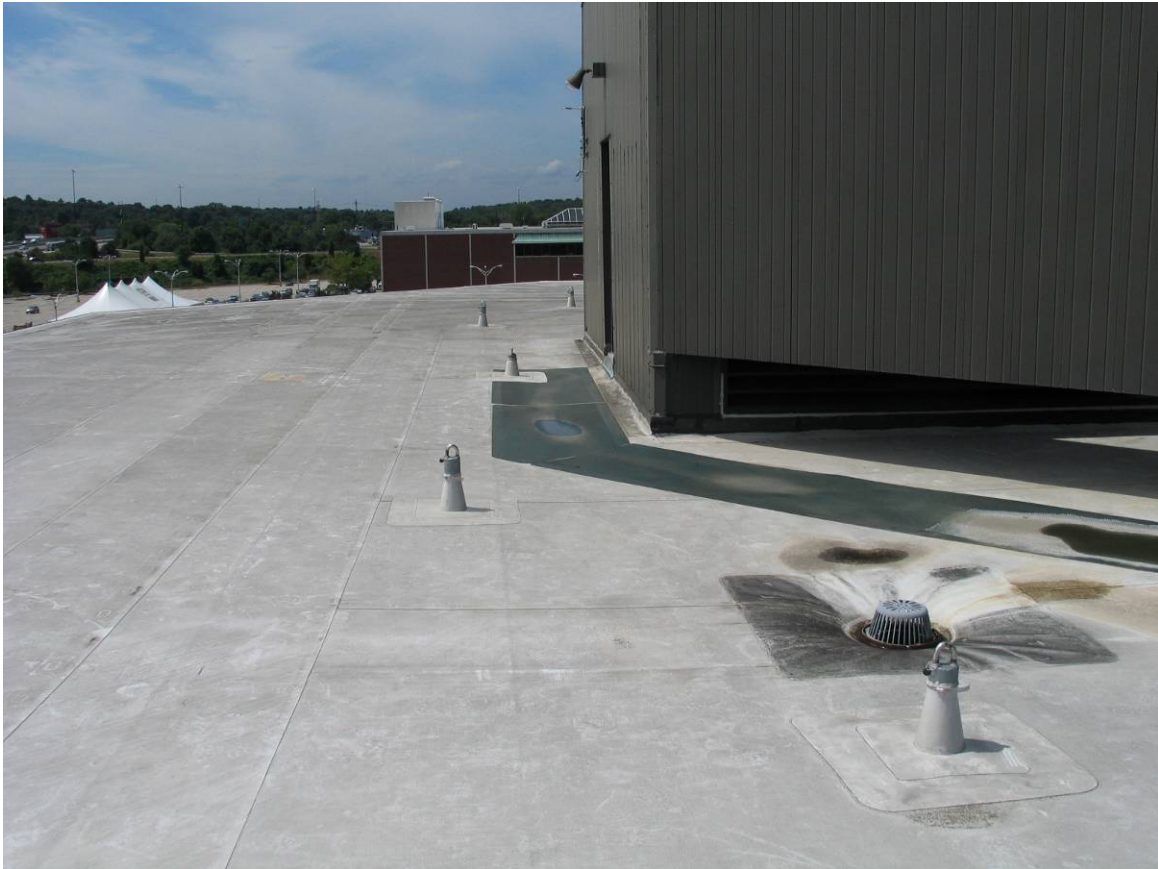
Figure 1 – Anchor points on roof of building

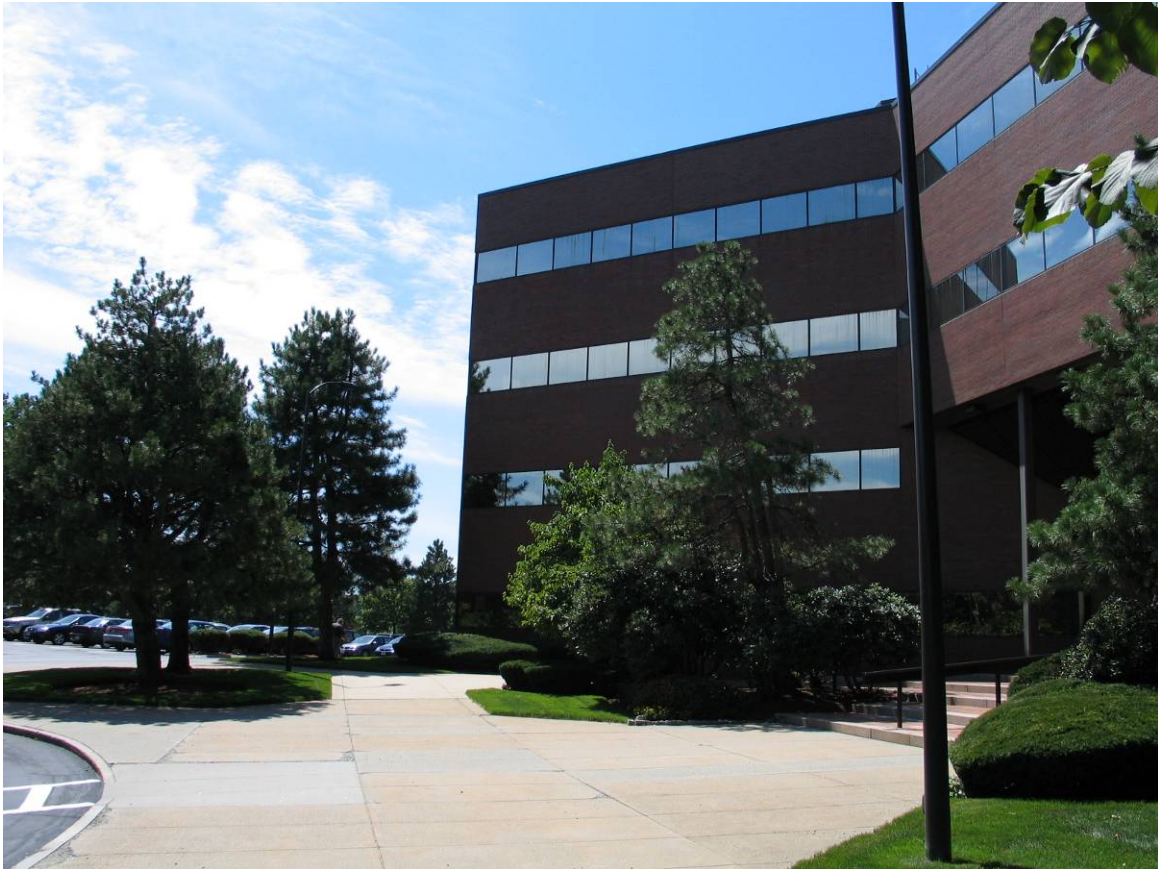
On the morning of the incident, the workers arrived at the company warehouse, the typical meeting location, at 6:00 a.m. The supervisor drove the work crew, via a company van, to the building (Figure 2), which was located in an industrial park approximately 16 miles away from the warehouse. Once onsite, the victim and co-worker brought the equipment they needed to the roof of the building.

Figure 2 – Building where the incident occurred

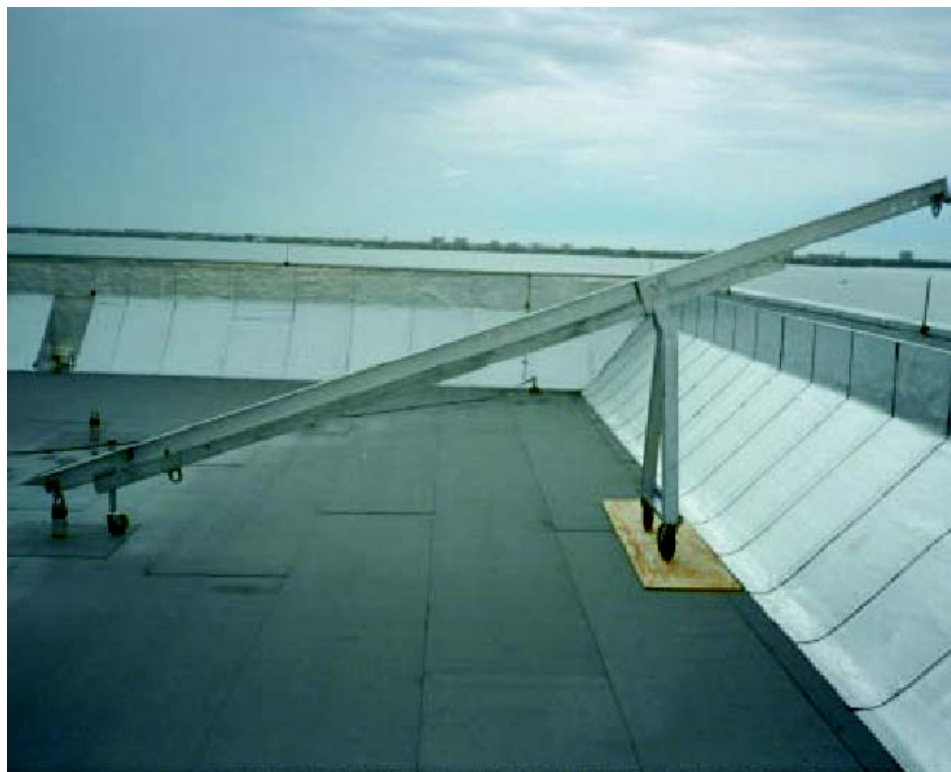
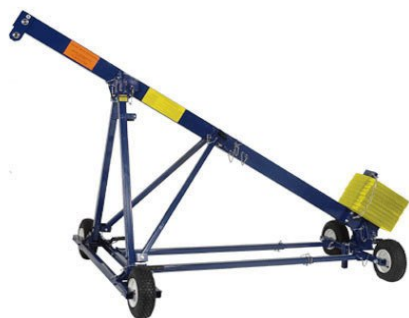
A portable rolling roof outrigger was the main piece of equipment being used at the time of the incident (Figures 3a and 3b). Rolling roof outriggers are designed to suspend a worker out over an edge of a building with a flat roof. The rolling roof outrigger involved in this incident had four wheels and was made of metal with a cantilevered beam. When positioned for use, the cantilevered beam would extend out over the building's roof edge. The end section of the cantilevered metal beam is the location where the control descent line for the suspended worker is attached. The cantilevered section allows the control descent line to clear the roof's edge. The suspended worker should also have a lifeline, attached to their body harness. This lifeline must be tied off to an independent roof top anchor point and not to the rolling roof outrigger or the anchor point that is used to tieback the outrigger. The manufacturer of the rolling roof requires that during use, the unit be attached to a permanent rooftop anchor point to prevent it from falling off the building's roof. The rolling roof outrigger involved in this incident also required the use of counterweights to help stabilize the unit.

Figure 3a and 3b – Similar rolling roof outrigger system

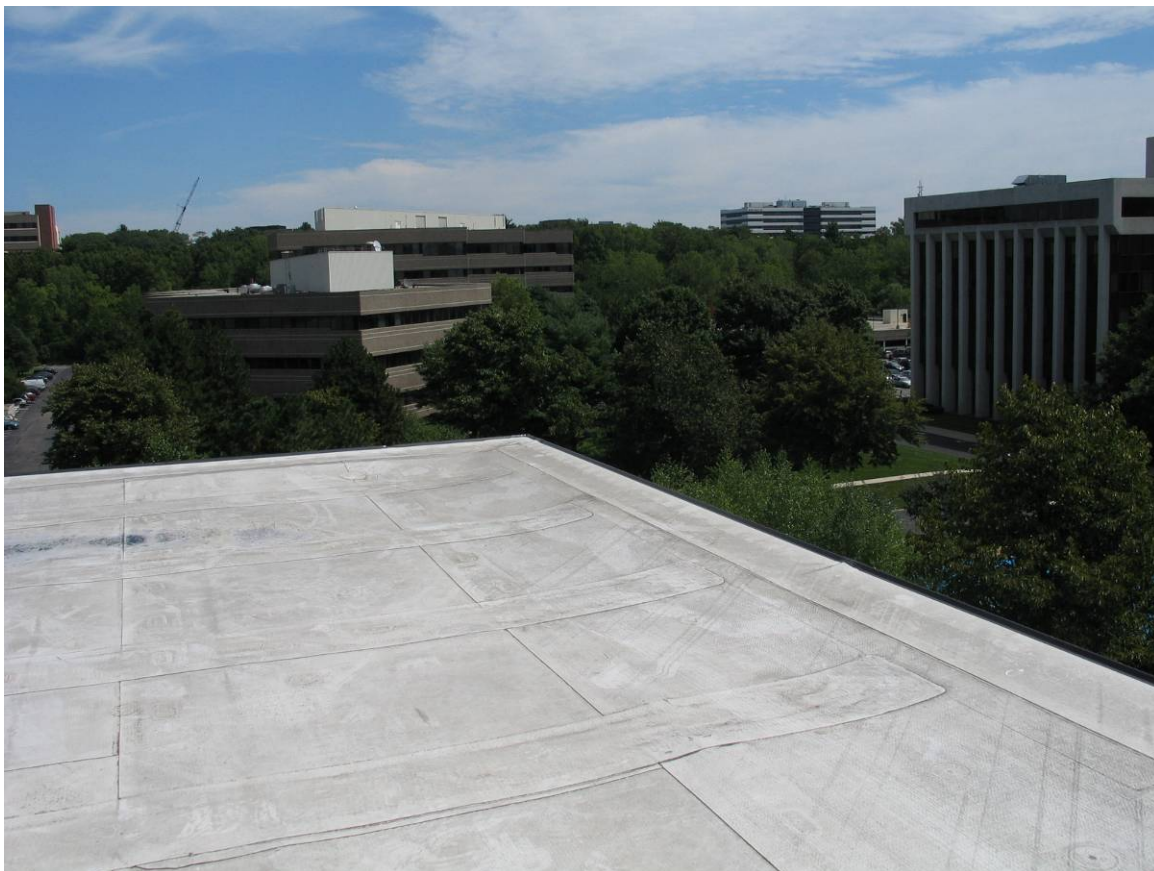
The morning of the incident, the work crew had made multiple descents using the rolling roof outrigger with four 50 pound counterweights equaling 200 pounds. The manufacturer's required counterweight was more than three times the 200 pounds that was being used. At the time of the incident, approximately 8:00 a.m., the supervisor was not in view of the work crew. The suspended co-worker finished cleaning the sections of windows located at a 45 degree angled corner of the building. It appears that the victim, who was alone on the roof, unlocked the rolling roof outrigger's wheels, unattached the rolling roof outrigger from the rooftop anchor point and started to roll the outrigger so the co-worker could make his way around the building's 45 degree angle to the next side of the building.

The rolling roof outrigger, with the co-worker suspended from it, rolled to the roof's edge (Figure 4) and then off the roof. As the outrigger fell from the roof, the victim, whose retractable lanyard was attached to his full-body harness at one end and to the outrigger at the other end, was pulled off the roof. The co-worker, who was suspended from the outrigger and whose lifeline was also attached to the outrigger, fell along with the outrigger. The co-worker fell 48 feet from his suspended location to the ground below. The rolling roof outrigger fell 53 feet from the building's roof and landed on top of the co-worker (Figure 5). The victim, who was pulled from the roof, fell 53 feet down and ten feet out from the edge of the building's roof (Figure 5).

Figure 4 – Location at edge of roof where the rolling roof outrigger fell

Discussion: While the co-worker was suspended from the rolling roof outrigger, the outrigger was disconnected from its anchor point. This allowed the outrigger to roll towards the edge and off the building's roof while the co-worker was suspended from it. Employers must make sure that rolling roof outriggers are always anchored while employees are suspended from them. Rolling roof outriggers should only be disconnected from anchor points when suspended workers are safely on the ground or a lower level and have been unattached from the descent control line.

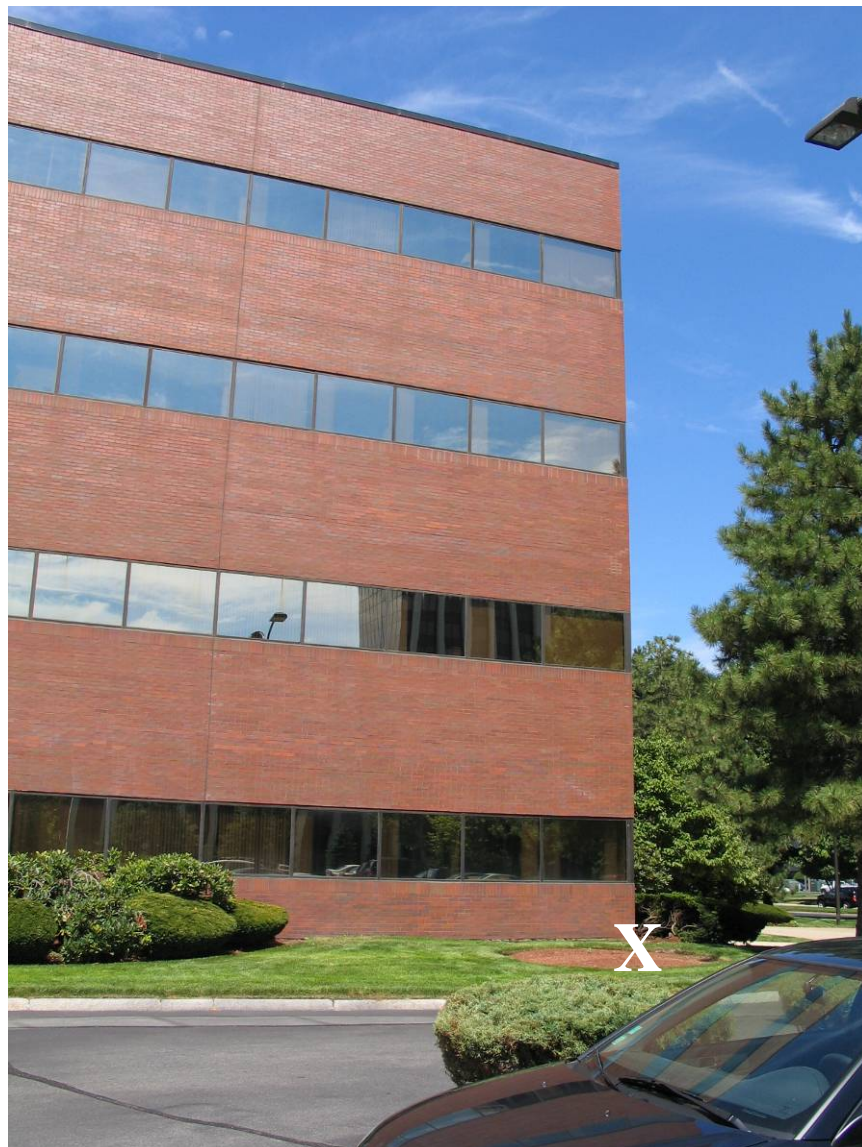
Figure 5 – General location where the victim, co-worker and rolling roof outrigger landed
