MIFACE INVESTIGATION #06MI207

SUBJECT: Apprentice Lineman Dies When the Vibratory Plow He was Operating Struck a High Pressure Natural Gas Line.

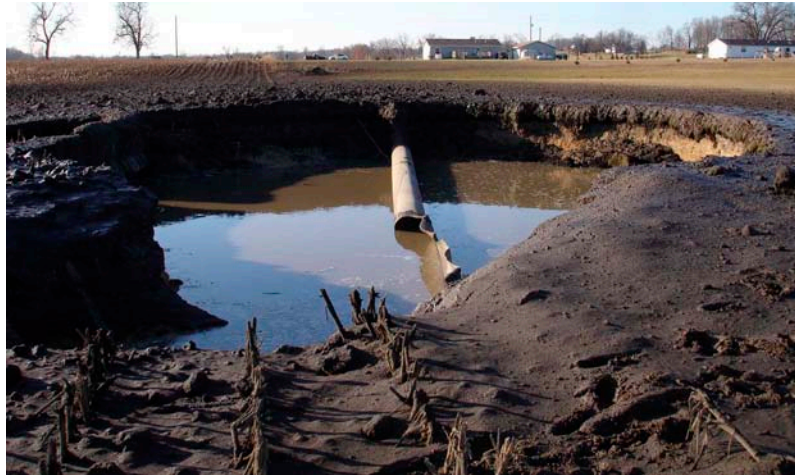
Figure 1. Incident scene showing crater and pipeline

Approximately 58 yards from the corner, the vibratory plow hit a 24-inch high-pressure natural gas pipeline belonging to the company that had not provided a Positive Response on the MISS DIG ticket. The pipeline was buried 36 to 40 inches below the existing grade. The rupturing pipeline created an explosion throwing dirt and debris into the air and created an 80-foot crater. Coworker #1 was knocked to the ground. Coworker #2, who was also thrown to the ground, found his way to a nearby truck and called a May Day on the truck radio. After Coworker #1 picked himself up from the ground, he turned to look at where the roaring sound was coming from and saw about 150-200 feet of dirt flying in the air. He crossed the street to the west side of Road A and dialed 911 on the cell phone provided by the electrical company. He told the dispatcher that he thought that a high-pressure gas line had been hit and gave the dispatcher the incident location. He then called the electrical company and informed his boss that they may have hit a high-pressure gas line and that the decedent was still in that location.

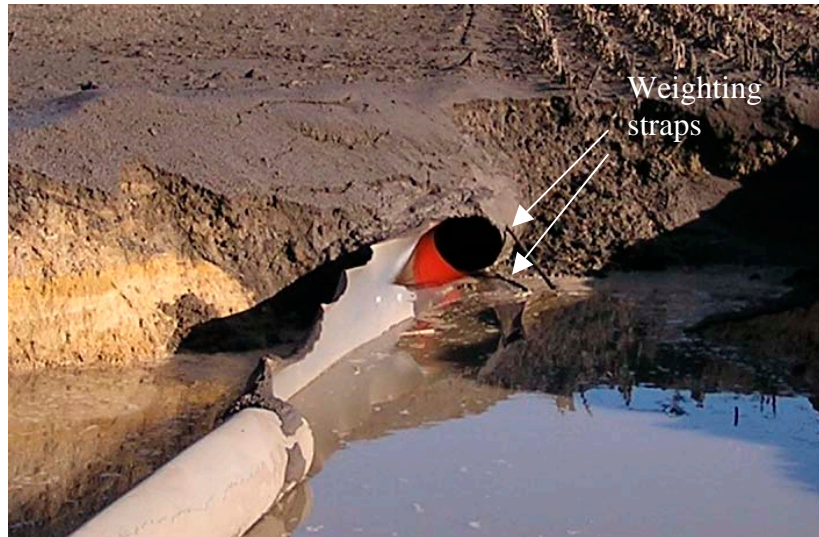
There were two natural gas pipelines in the construction area. One pipeline was 22 inches in diameter. The pipeline that was struck was 24 inches in diameter. The electric company indicated that the pipelines had been laid in the 1950s. The 24-inch pipeline was pressurized to 800 psi. Pipe composition, integrity, and maintenance are unknown. The electric company indicated that the area had a high water table and that the pipes were “held” in place by straps with cement weights. The electric company indicated that as part of their investigation of this incident, local farmers had stated that they had hit the pipes during plowing and had contacted the gas company to inform them that the pipes had been hit during plowing.

Figure 2. Weighting straps on pipeline.

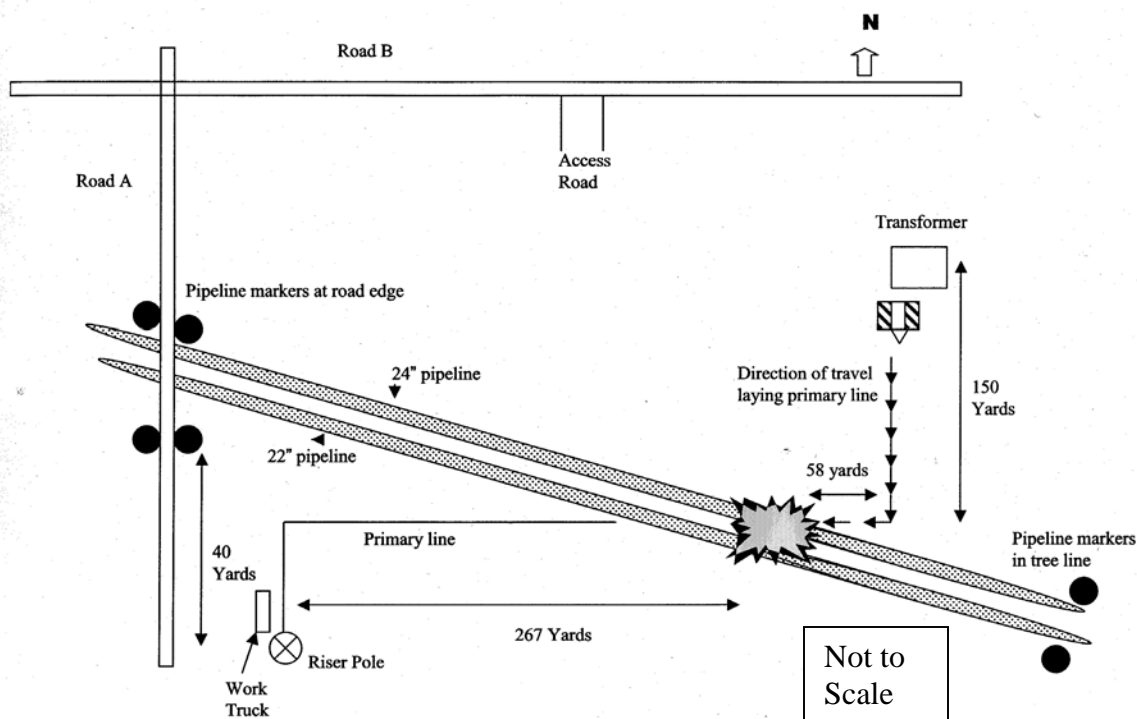
DIAGRAM A

MISS DIG is a non-profit entity that processes requests for the marking of underground utility lines and structures prior to construction. The MISS DIG ticket response inquiry indicated the street address on Road B (Diagram A) as the staking location. The MISS DIG ticket response indicated that two natural gas distributors, two cable companies, one electrical distribution company, two phone companies and the county road commission may have had underground facilities present. Three companies positively responded as indicated on the ticket; one cable, one telephone and one natural gas distributor (who contacted MISS DIG indicating no pipelines in the construction area). The natural gas distributor whose pipeline was struck did not positively respond, and the associated response box was blank, as were the boxes for one phone company, one cable company and the county road commission.

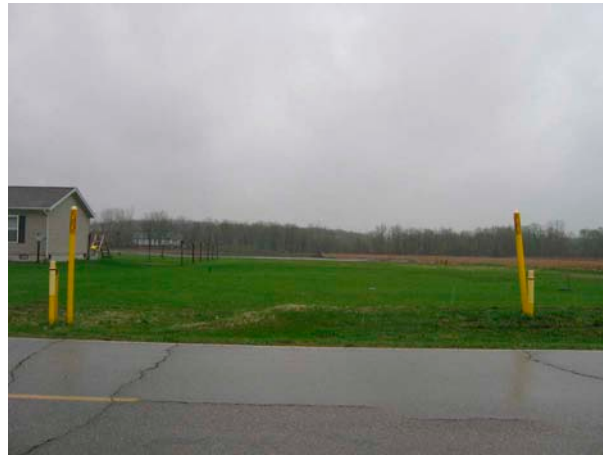
Following their training, electrical company personnel looked for and recognized utility MISS DIG flags, but did not appear to look for other markings for underground facilities, such as the high visibility yellow markers for the two underground, high-pressure, natural gas pipelines. Although the markers were in plain sight on Road A, apparently they were missed (Figure 3) or the workers may have thought that the lines were deeper than the level they were digging. Employers should include in their excavation training a segment that requires workers to look for all utility markers in addition to MISS DIG flags and to not assume lines are deep.

Figure 3. High visibility yellow markers on Road A

- Employers conducting excavating or tunneling operations should ensure employees receive hazard recognition training pertaining to utility markers.

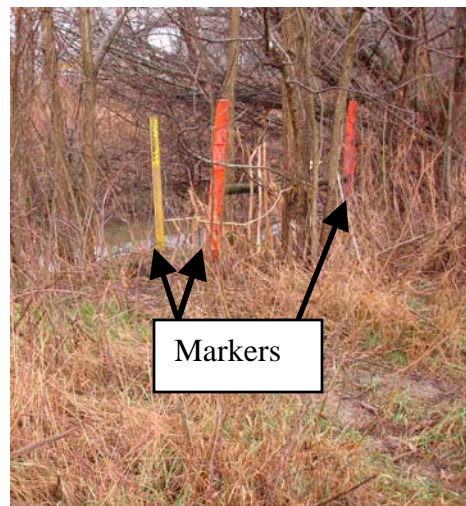
MIOSHA personnel, upon walking the field where the excavation was being performed, noted additional utility markers in the tree line.

Figure 4. Markers in tree line

the field where the excavation was being performed noted additional utility markers in the tree line (Figure 4). Prior to performing any excavation work, the crew should perform a walkthrough of the area to note any potential hazards or previously missed utility markers.

- Employers conducting excavating or tunneling operations should instruct and ensure employees conduct a thorough site inspection to determine if all potential underground utilities are marked prior to beginning digging operations.
