# MIFACE INVESTIGATION #06MI201

## **SUBJECT: Journeyman Pipefitter Dies When Struck in Chest While Removing Vic Fitting End Cap From a Pressurized Pipe**

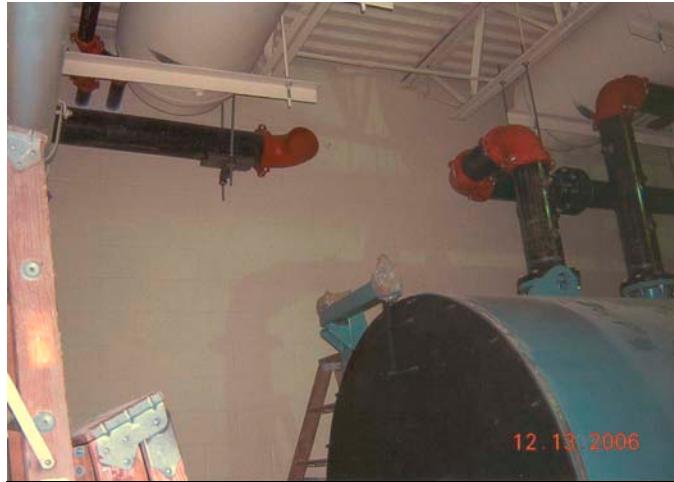
On December 13, 2006, a 41-year-old male plumber/pipefitter died when he was struck in the chest by a pipe cap that he was removing from a pressurized pipe. Some leaks had been identified in an 8-inch waterline that had been previously installed and which needed to be repaired. To aid in troubleshooting the leak locations, valves were closed off in the lines, creating sectionalized portions of air charged waterline. The waterline was pressurized to 80 psi. After pipe repair was completed, the air was released from the lines, except for a portion "downstream" of a closed valve, which left a section of line still pressurized to 80 psi. At the end of the 8-inch line, there was a vic fitting end cap (also referred to as a victaulic, groove lock or gasketed end cap). The decedent was removing the 25-pound vic fitting end cap from the 8-inch line in the main boiler room in preparation for continuing the waterline project. The metal cap struck the decedent in the neck and upper chest area when it blew off the end of the pipe. Fellow workers called 911. Emergency response arrived, and the decedent was taken to a local hospital where he was declared dead.

Figure 1. Incident scene

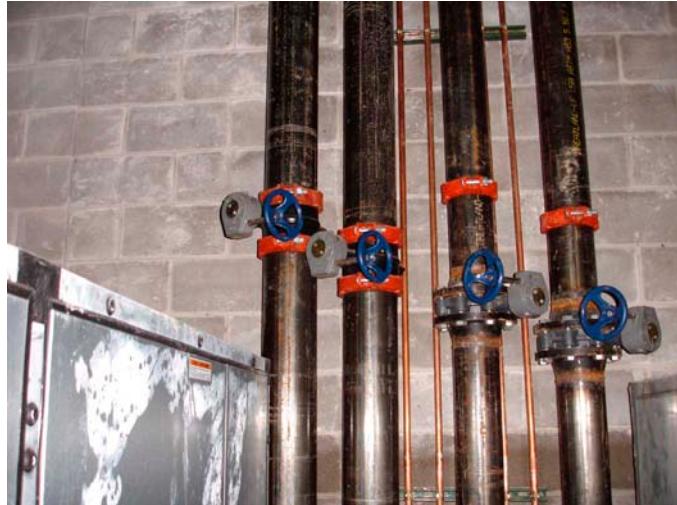
The decedent, a journeyman pipefitter, and his crewmembers, two apprentice pipefitters, had been installing 6- and 8-inch waterlines at a new high school between the second floor Mechanical room and the first floor Boiler room. After a portion of the lines had been installed, the lines were capped and sealed off, and then pressurized to 80 psi with compressed air to allow leaks in the lines to be identified prior to them being filled with water. The decedent and one of his coworkers conducted a pressure test on the piping. When the lines were pressurized, the decedent heard air leaks in the Mechanical room. The decedent closed a "steering wheel" butterfly valve in the Mechanical room on the second floor to stop the pressure from leaking out from the second floor mechanical piping (Figure 2). After repairs were made, the line was recharged, and the field foreman for the decedent's employer and the construction manager for the project completed a test report to verify that the lines were free of leaks. After the construction manager signed off on the form that the lines passed inspection, the field foreman told the decedent to release the pressure off all the piping. Air was released from the pipes, except for a portion of line "downstream" of the closed valve. This section of line was left pressurized to 80 psi. The reason for this is unclear. Pressure was released in the Boiler room, and the gauges that had been set up in the Boiler room read zero. It appears that after the successful pressure testing of the piping, the decedent did not go back to the second floor Mechanical room to open the valve that he had closed.

Figure 2. Valves in lines in Second Floor Mechanical Room

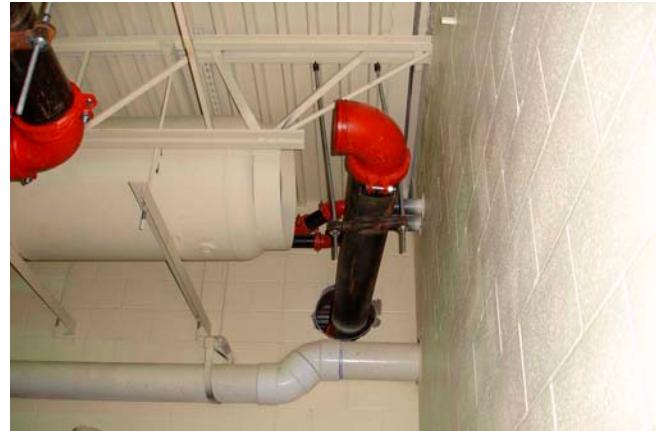
decedent stated to his coworkers that he was going to configure the run for the 8-inch pipe that was located approximately 12 feet from the floor. At the end of the 8-inch line was a vic fitting end cap that had to be removed. The cap that was used is also known as a groove lock cap, or gasketed end cap. These names describe a method of isolating a pipe that consists of bolting a coupling with a gasket in which the cap or plug is seated onto the end of the pipe by a two-piece clamp with a nut and bolt on each side. The incident occurred while the decedent was removing the 25-pound vic fitting end cap from the 8-inch pipe. While loosening the cap clamp, the cap blew off the end of the pipe, striking the decedent in the neck and upper chest area. It is unclear from the photos if the decedent was straddling a 10-foot ladder, standing on the top step of the ladder, or standing on top of the boiler, which was close to the capped pipe. It is also unclear if the decedent was directly in line with the end cap or if the cap blew off at an angle other than parallel with the direction of the pipe run.

None of the coworkers in the Boiler room actually saw the incident occur. Hearing a noise, they moved from their work area and found the decedent on the floor approximately 15-20 feet away from the end of the pipe. The end cap was found on the floor approximately seven feet from the decedent. The wrench the decedent was using to loosen the clamp was found caught between the boiler and its associated piping. One of the coworkers called 911. Emergency response arrived and transported the decedent to a local hospital where he died.

Figure 3. Pipe and elbow involved in the incident

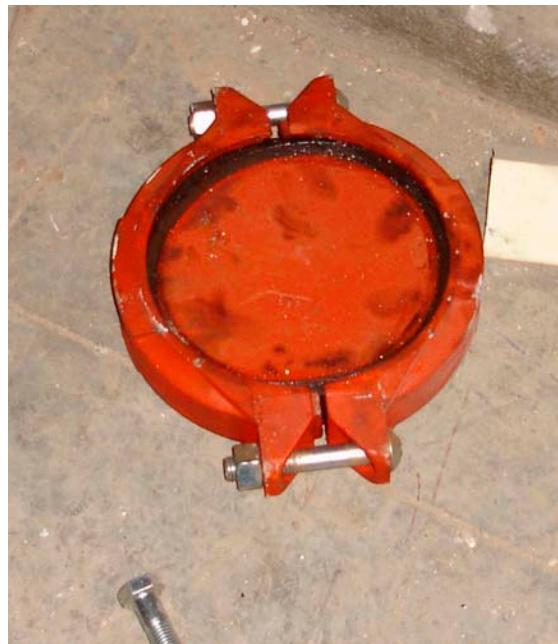
Figure 4. End cap that struck decedent

A threaded fitting may allow a worker to hear air escaping from the fitting, but with the “vic” end cap, the cap is clamped down on a groove in the pipe. When a vic clamp is loosened from the groove, a worker does not have time to accurately determine how loose the cap is or to hear air escaping before the cap releases from the groove. The company’s procedure now requires “installing a tee in place of a 90-degree elbow, or use of a tapped cap or plug with a valve. A boiler drain, coin vent, or a small ball valve, can then be installed to relieve pressure after a test has been successfully completed.” The employer could also consider using an end cap that remains attached to the pipe during

- Employers should use an end cap that remains attached to the pipe during loosening and prior to removal, or outfit the end cap with a pressure-relieving device.

loosening. Whichever method is used to guard against a cap exploding from the end of a pressurized line, the most important control is to make every effort and plan to ensure the line is depressurized before removing any end piece.
