MIFACE INVESTIGATION #05MI077

SUBJECT: Race Car Fuel Dispenser Operator Killed when Methanol Tank Exploded

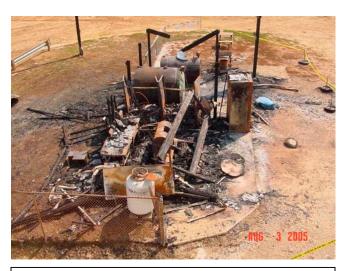
Figure 2. View of Concession stand and fuel storage from spectator stands.

own wiring system. There was a common wood wall (no firewall) separating the concession area from the fuel dispensing and storage area. The building had a peaked roof and a wood ceiling (Diagram 1 and Figure 2).

Entrance into and exit from the fuel dispensing and storage area was through a 6-foot-wide by 8-foot-high, hinged door at the southeast corner of the building. A non-explosion proof fluorescent light lighted the storage area. A 127-gallon propane tank was located outside on the west side of the building. Spectator stands were located close by (Figures 2 and 3).
